H30T Compression post cartoon...

Compression Post Disassembly of a 1991 Hunter 30T.

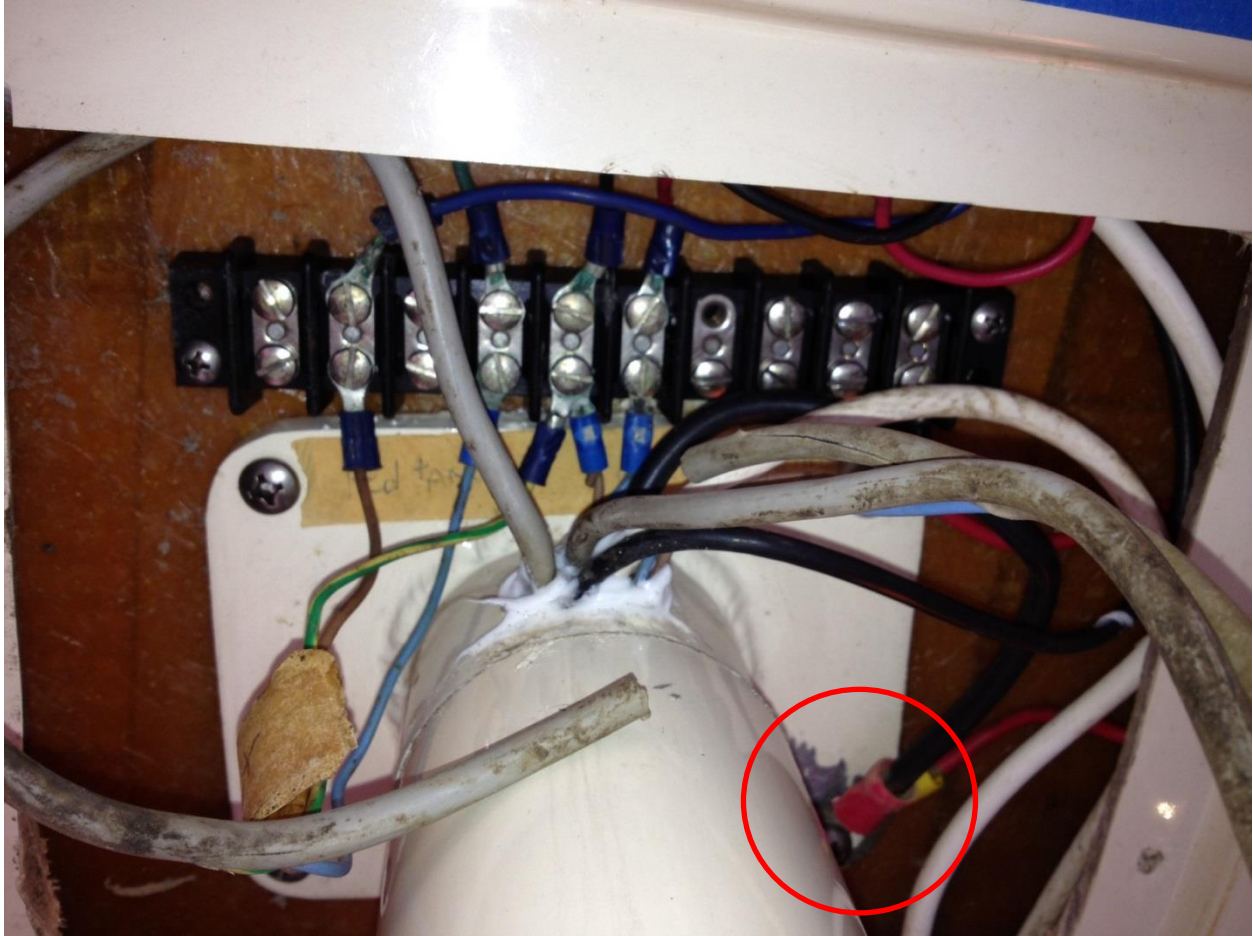
Salon roof post cover removed to get at mast wiring terminal strip. Note standard single crimp ring terminals, open to corrosion. #8 AWG black lightning ground wire came down from the mast base inside the post and out through the hole (filled with caulk) and was fastened to the upper post flange. Note Hunter at least ground off the paint where the wire is screwed into the post flange...(red circle). And at some point, the red wire was added as if the post was a DC ground point. That was removed!

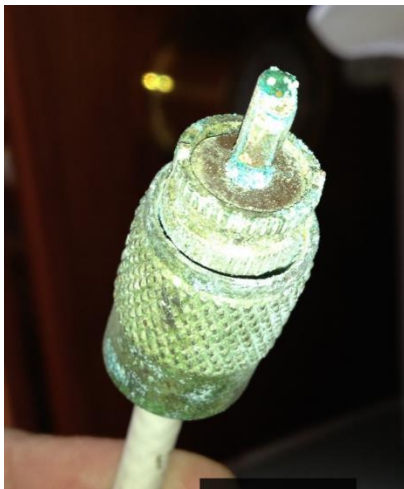
The coax connector that was cut from the coax (foreground) needed some work...(left). Well no wonder the VHF didn't work so well...It could receive within a mile or so but couldn't transmit across the marina...

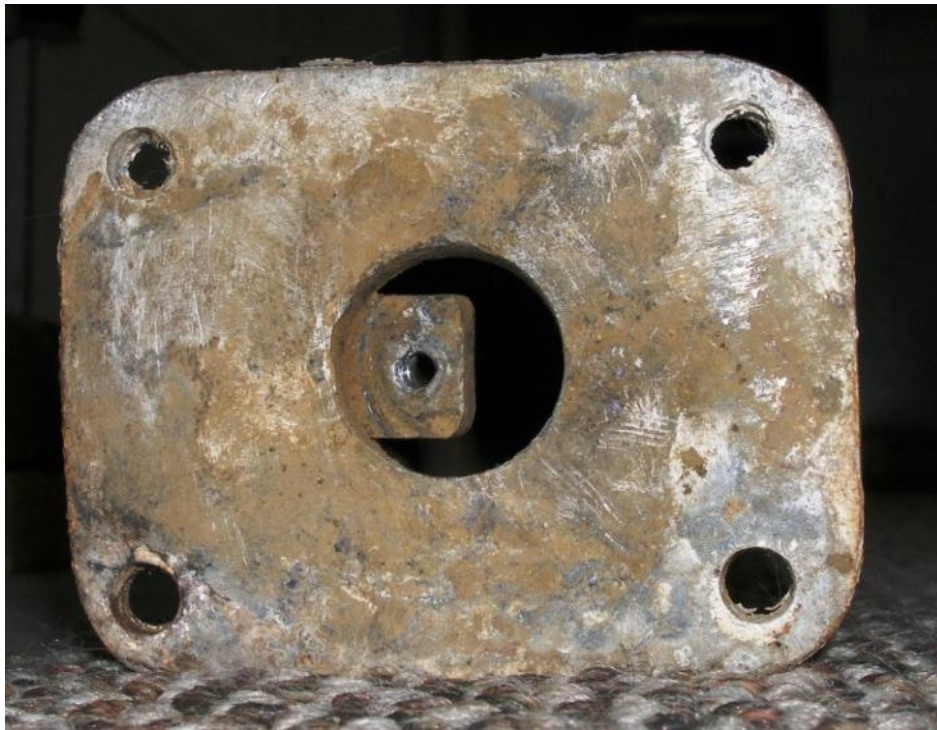
Foot of aluminum compression post. Note bonding tab for lightning ground wire to keel bolt.

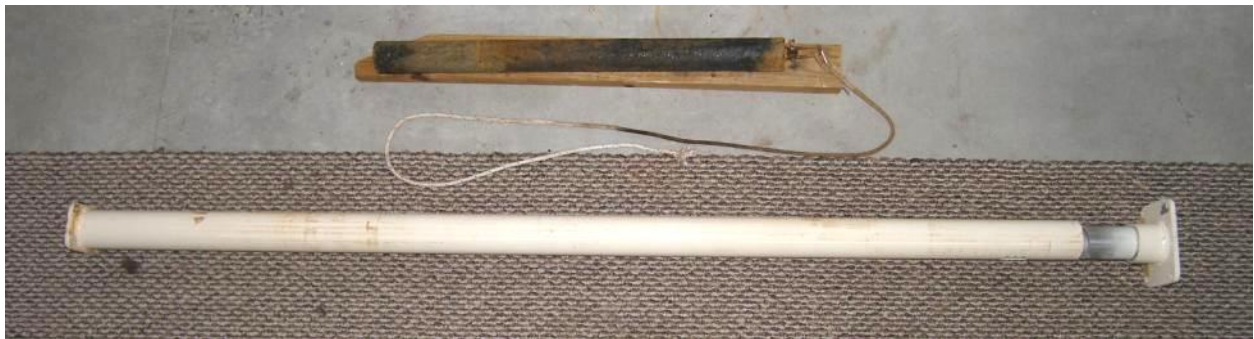
30-inch x 2.5-in diameter cast iron counter weight was rusted tight in the post. Water was coming in through the electrical wire conduit in the mast base since 1991.

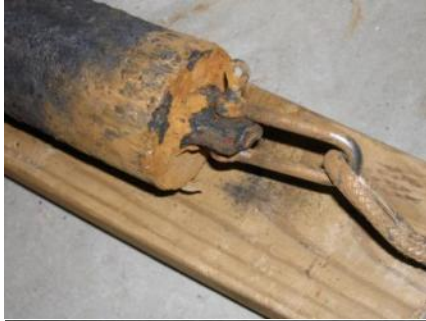
Detail of counter weight rope attachment point. The counter weight was sold for scrap. The table was easy to adjust without the counterweight.

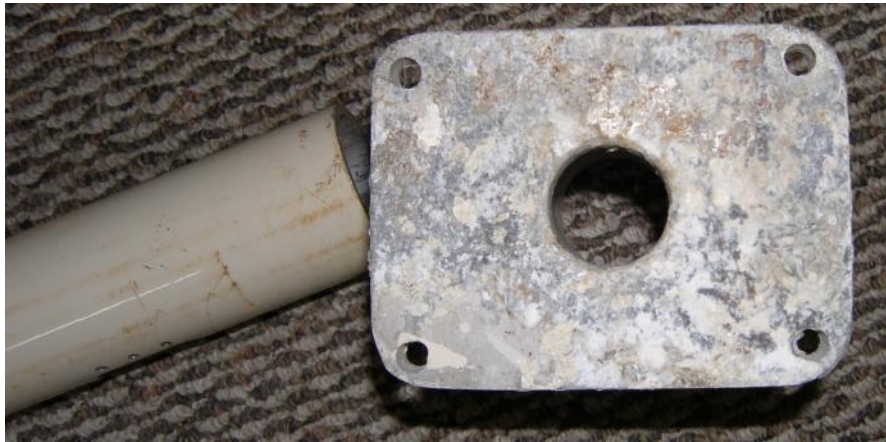
Top of compression post upper foot. Mast wiring enters through opening in top of flange and exits via the side opening. Post OD is 2 7/8-in and ID is 2.5-inch AL.

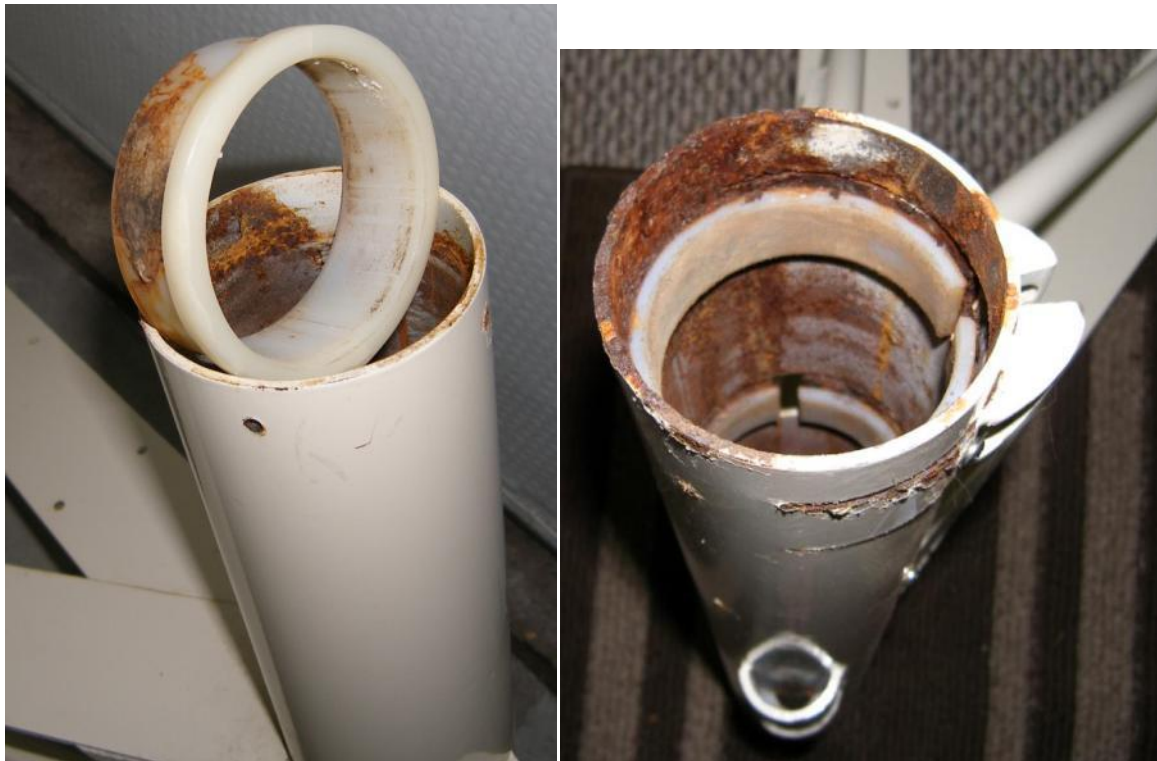
Upper nylon insert removed (left). It the inner nylon/plastic surface was actually flaking off. Bottom view of sleeve (right) showing lower two internal nylon slides. The rust on the inside of the sleeve actually compressed the nylon inserts to become an interference fit with the compression post.

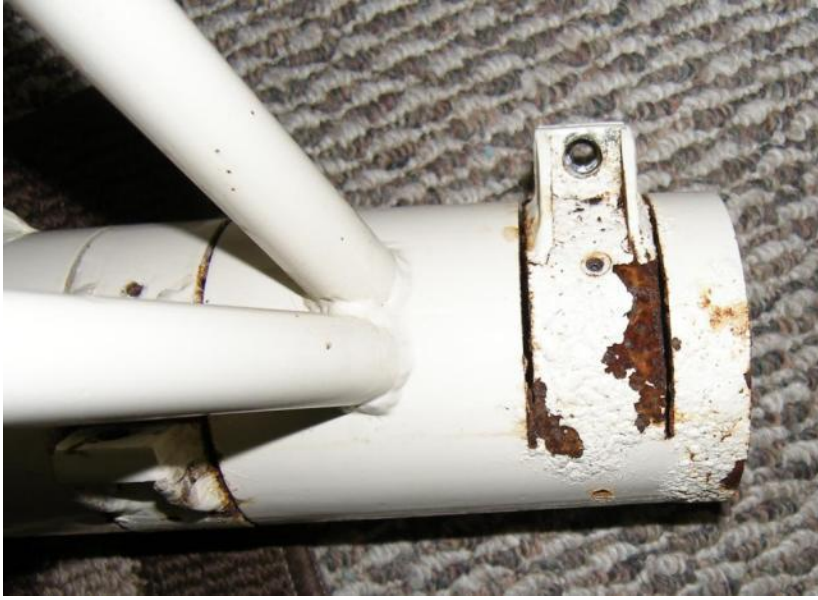
Most rust is at bottom of sleeve bands that tighten the sleeve to the post. One cause of rust is that it is unpainted steel (inner diameter surface).

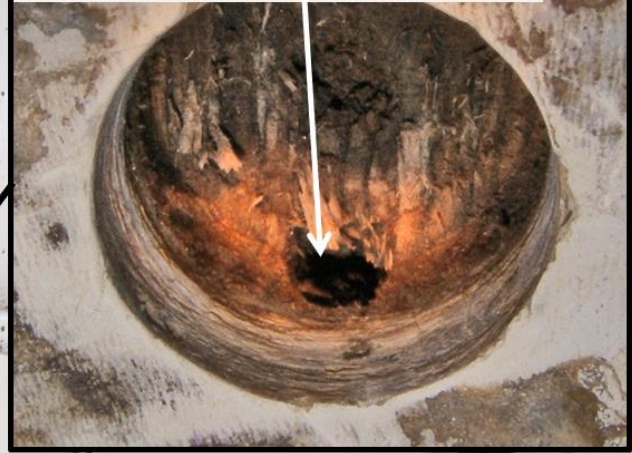
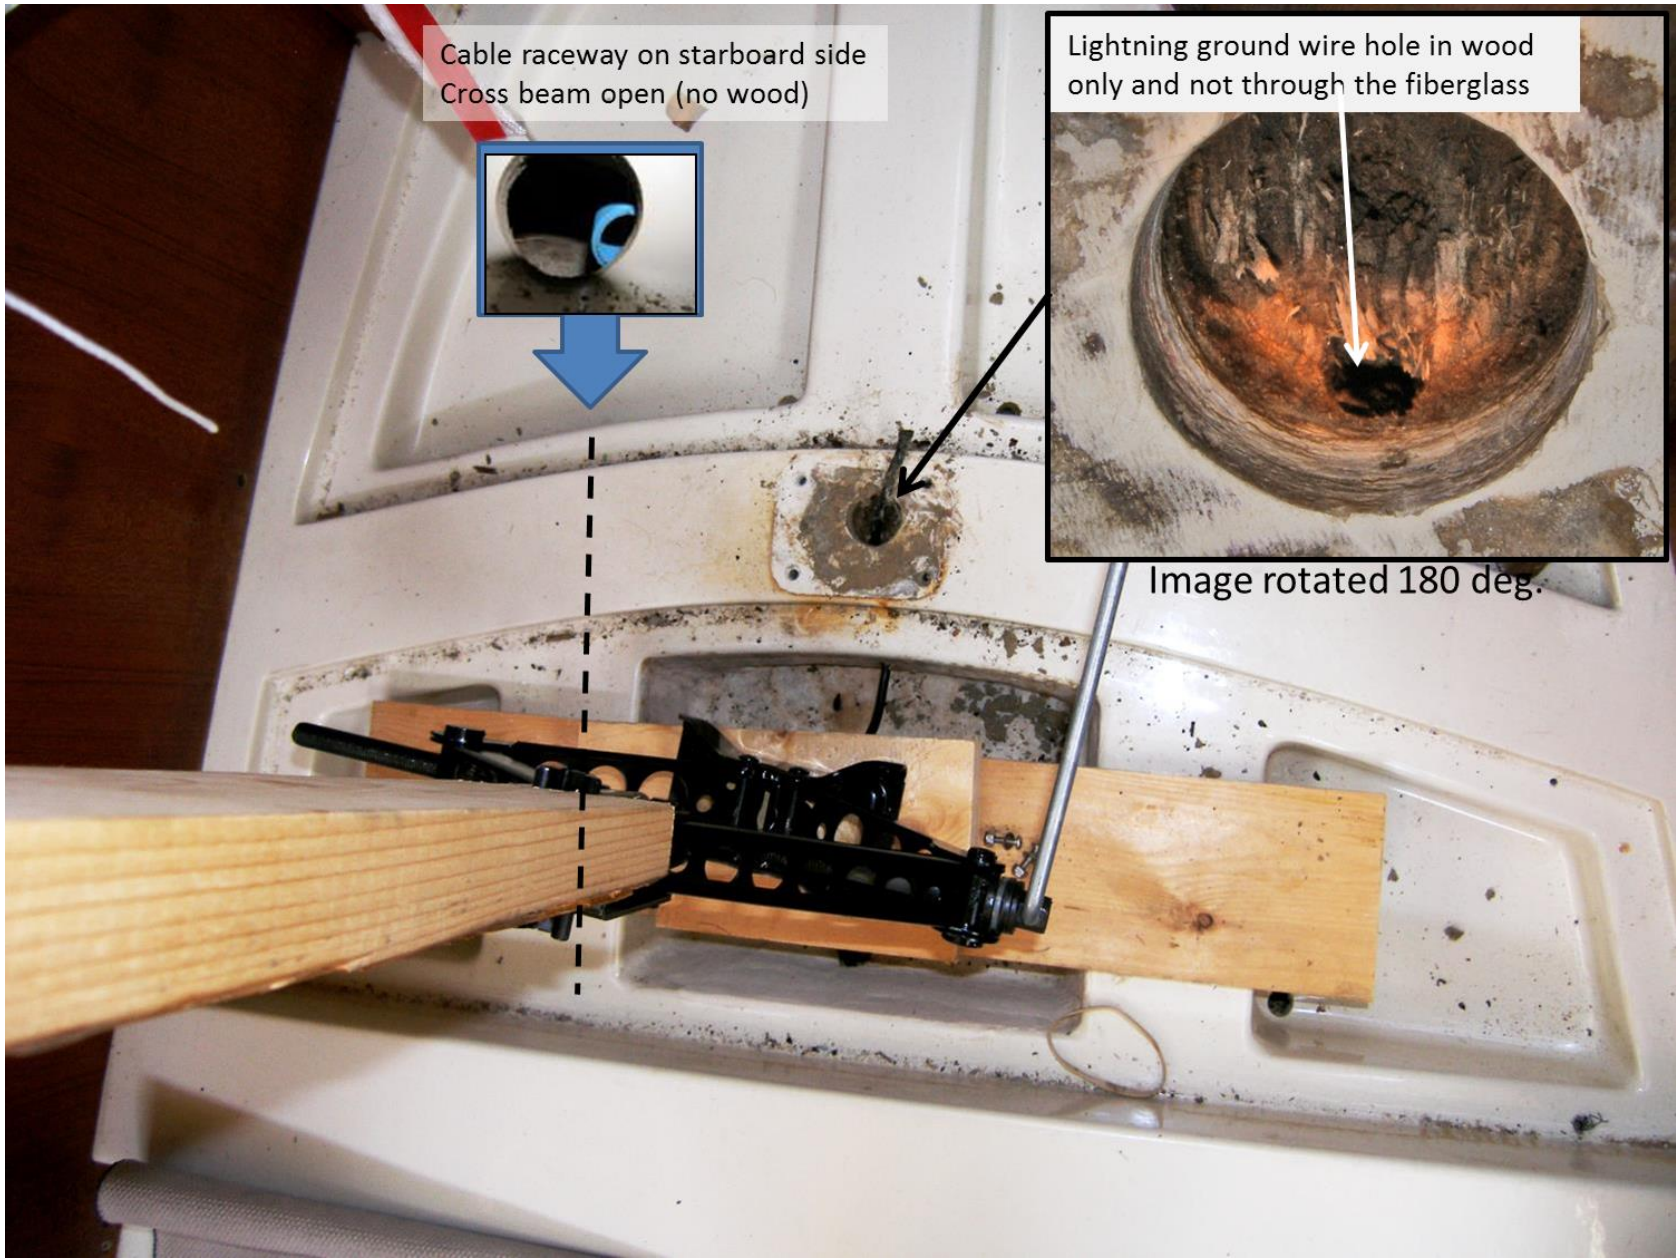
Above - View of cabin floor where compression post foot sets. Water ran down through compression post and sat in the hole and rotted the wood. This wood is not structural, but only to help form the cross member and to anchor the post foot with the four, 2-in, lag bolts. The black wire exiting the cross member is the lightning wire that came up through the hole in the cross member and into the lower post foot. It fastened to the tab in the foot. The hole through the cross member was opened up to either $\frac{3}{4}$ or 1 inch to accommodate the #4 lightning ground wire. The four lag bolt holes were drilled slightly over size and filled with west thickened epoxy and re-drilled to the correct size. The rot in the large hole under the mast foot was cleaned out as much as possible, then soaked in thinned epoxy. Note the tire jack was needed to get enough clearance to remove and replace the post. Don't overjack!

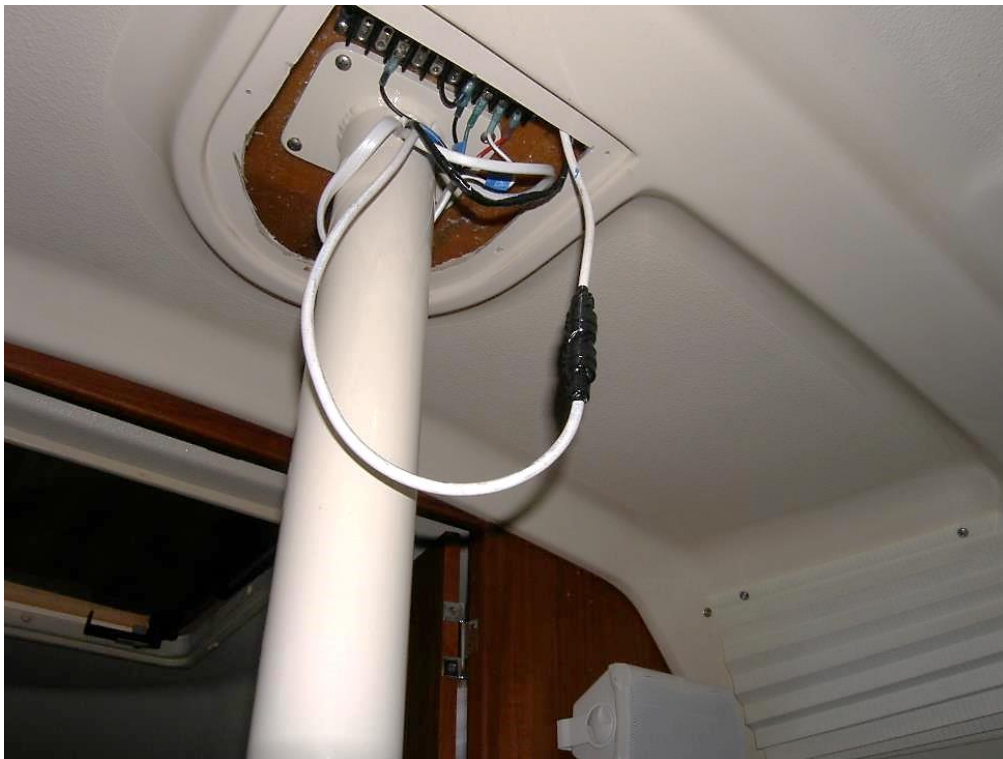
New mast wiring and VHF coax. Lightning ground runs through post down to keel bolt. Mast wires terminated in adhesive-lined shrink ring terminals. New coax connector wrapped in electrical tape. Should have used self-fusing tape.

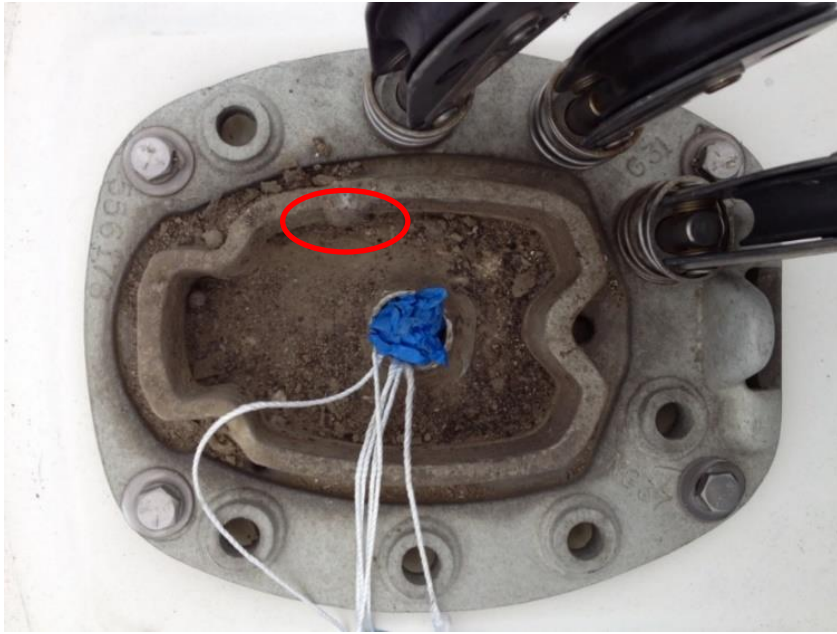
Mast foot on deck. Circle is around where the lightning ground wire used to attach to the mast base. Ground it off, re-drilled and tapped (next photo).

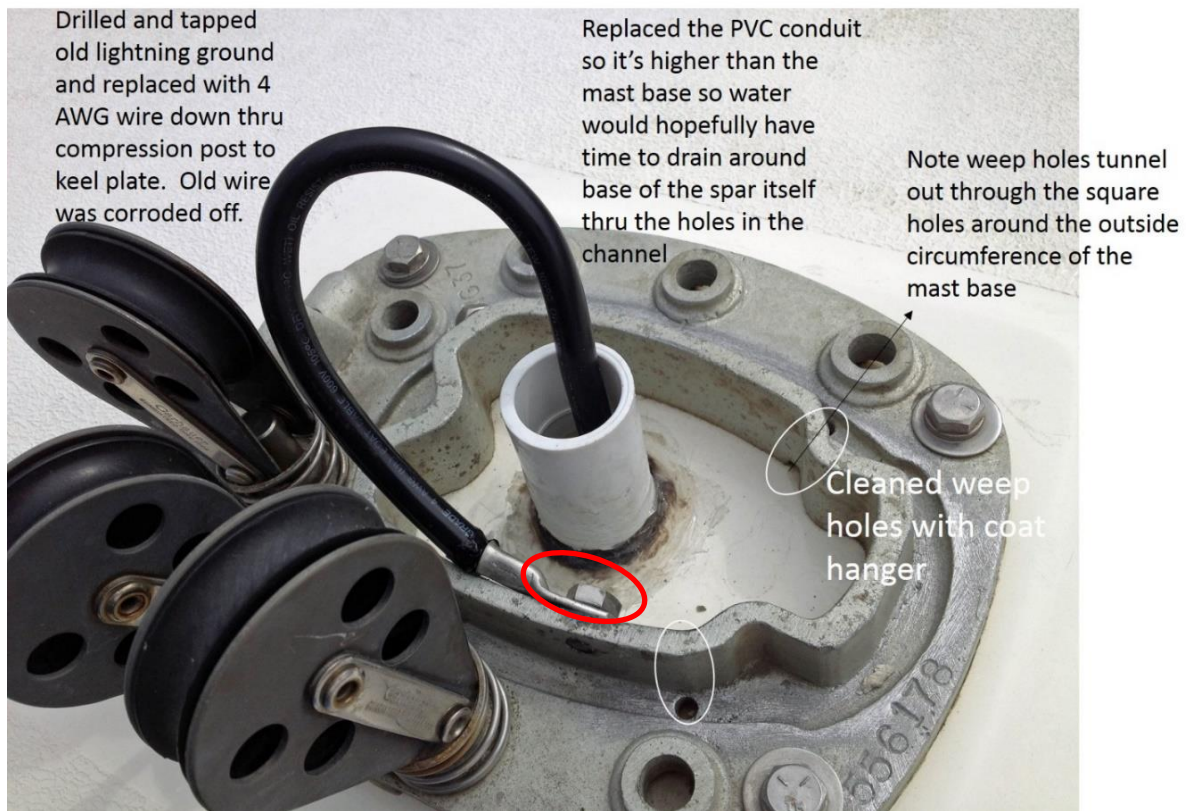
seal the wires and tube, then lowered the mast onto the base. NOTE: KEEP YOUR MAST BASE WEEP HOLES CLEAR if you haven't lengthened the PVC tube to be above the "waterline" (top of mast base). In the "before" photo above, the top of the PVC was < 1/2 inch above the deck surface and water would flow in because the weep holes were plugged. The conduit did not come sealed from Hunter. This entire issue could have been avoided had the conduit been sealed.

Base prior to stepping mast. We stepped the mast and set the end on block about a foot above the base so we could run wires down through conduit, make drip loops, followed by a generous blob of caulk to
