# UNITED STATES COAST GUARD

## **TALL SHIP BOUNTY**

**123 MILES OFF THE COAST OF CAPE  
HATTERAS, NORTH CAROLINA ON OCTOBER  
29, 2012 WITH LOSS OF ONE LIFE AND  
ANOTHER MISSING AND PRESUMED DEAD**

**MISLE ACTIVITY NUMBER: 4474566**

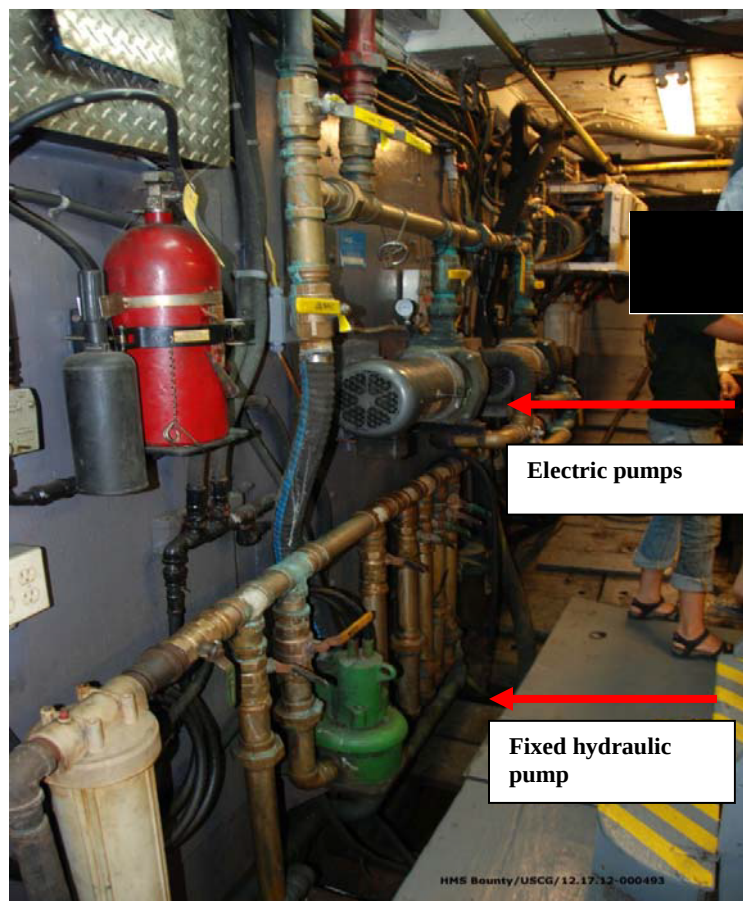
Figure 4 The BOUNTY's bilge system with two electric pumps mounted above the bilge manifold and the green fixed hydraulic is below.

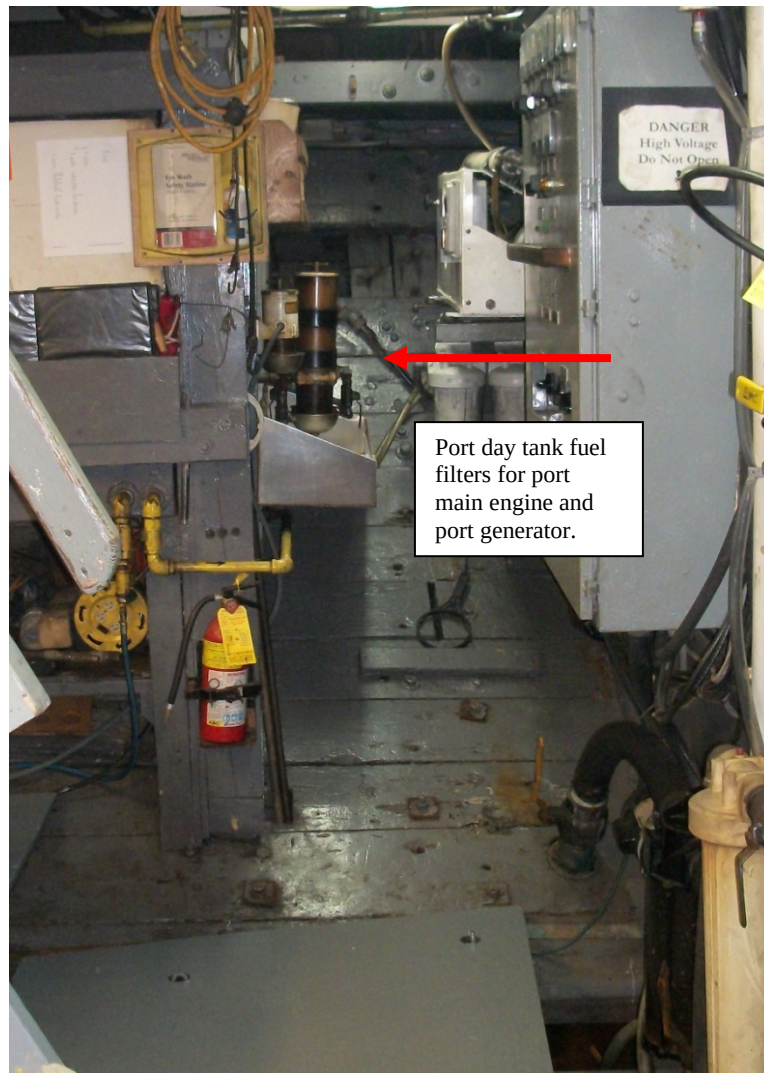
Figure 5 BOUNTY's port day tank and fuel filters.

29. According to crew testimony, on the BOUNTY, it was the job of the engineer to press up the day tanks in the engine room from the main fuel tanks via an electrical transfer pump, although this is not detailed in any written policy. Engineer [REDACTED] reported that he did so each morning. It was the job of the deckhands to check and record the fuel level in the day tanks every half hour while underway. Day tank fuel readings were taken via a sight glass on each tank. While underway, the BOUNTY used approximately 10 – 12 gallons of fuel per hour from each day tank under normal operating conditions.

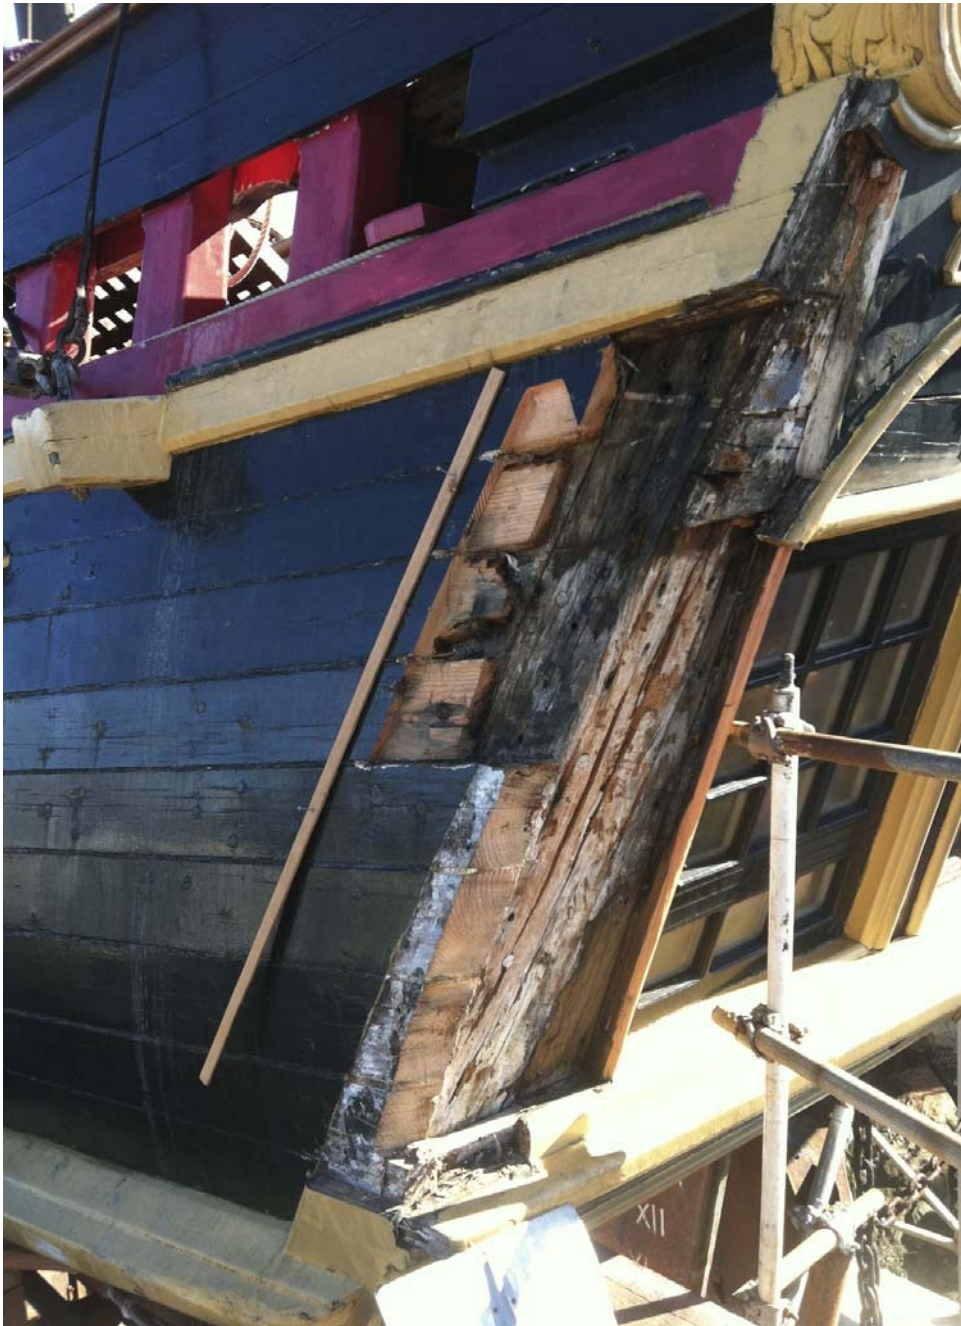
**Figure 6 BOUNTY's Port quarter**

and visible rot was removed from the exposed frames. The oil based primer was once again applied, and the area was closed up.

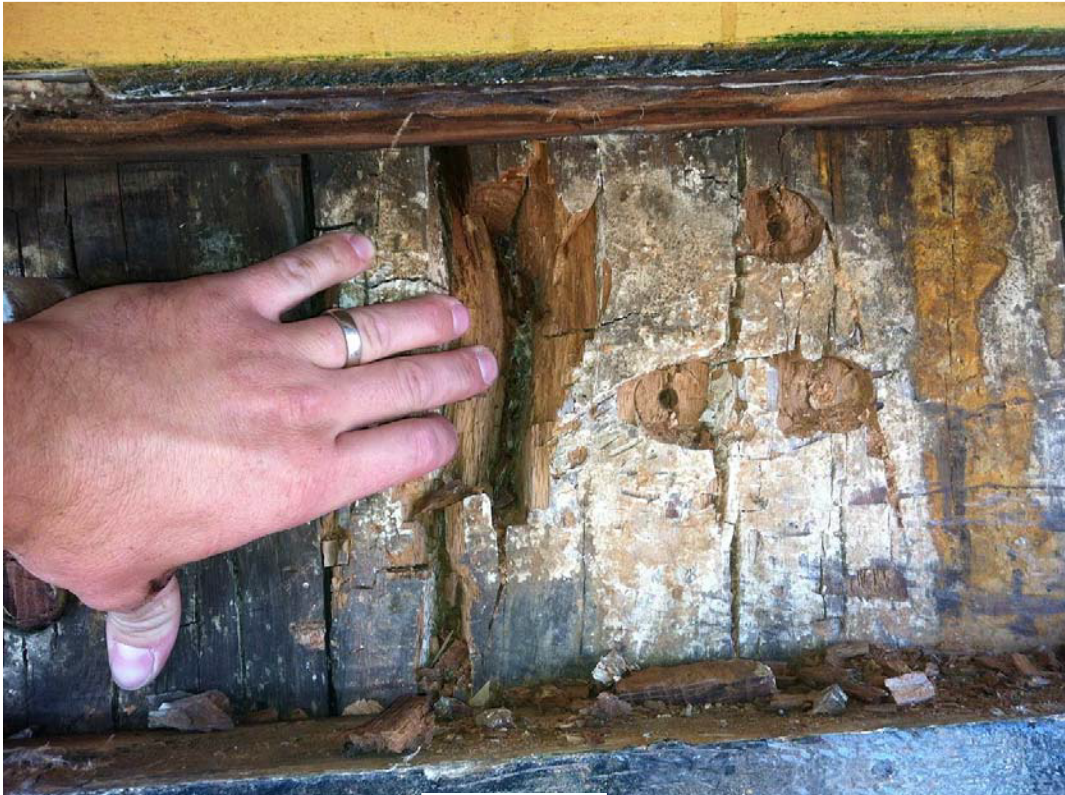
Testimony from Mr. [REDACTED] differed from Mr. [REDACTED], in that Mr. [REDACTED] believed the decay problem was more serious. However, both provided testimony that they believed the vessel was capable of making it to the next haul out, tentatively scheduled for the following year, when the vessel left Boothbay Harbor Shipyard.

Figure 17 Photo of frame decay taken by [REDACTED].

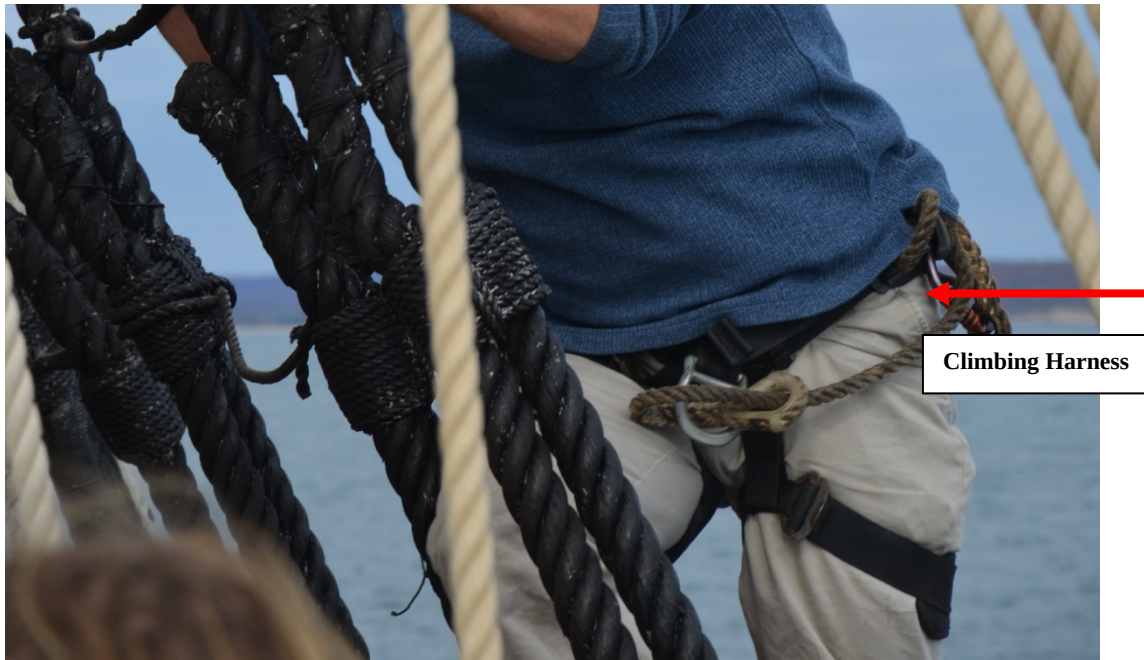
Figure 19 Climbing harness

34. The merits and drawbacks of wearing the climbing harnesses (see Figure 19) or riggers belt with the immersion suit was also discussed. Wearing of the belts almost caused Deckhand [REDACTED] and AB [REDACTED] to be dragged underwater, but some crew said it was easier to pull crew members into the raft because of it. The Stearns model 1590 immersion suits were an older model of immersion suit. Many of the newer model immersion suits come with clips that are built into the suit, and are flush to the chest so they will not get caught up. No one on the BOUNTY crew stated that they ever trained to use their climbing harness over their immersion suit. No one on the crew who had been on other vessels or attended BST ever had this practice taught or recommended. No BST training facility or manufacturer of immersion suits recommends placing any item, including other PFDs, on top of an immersion suit.
