Hunter 34 Compression Post Replacement Project

November 2017 to March 2018

Brian J. Gallagher

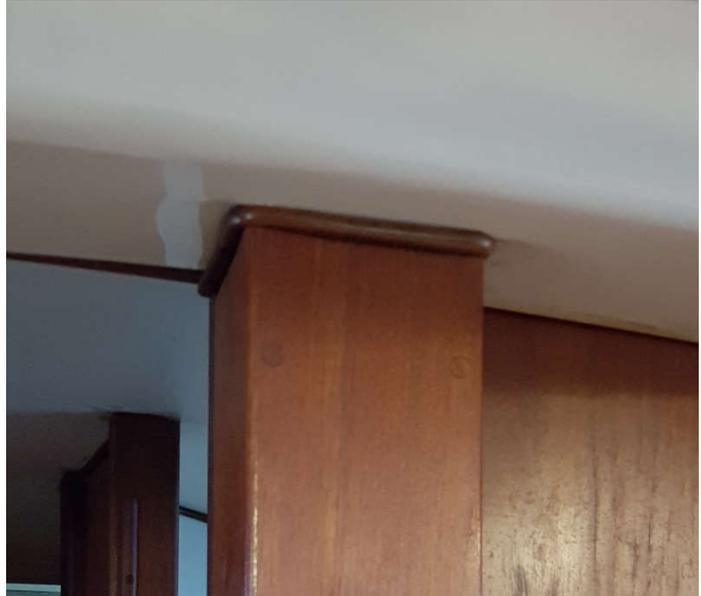
The post didn't look too bad at first. The FRP above it had crushed upwards slightly, but you couldn't really see how much at this point.

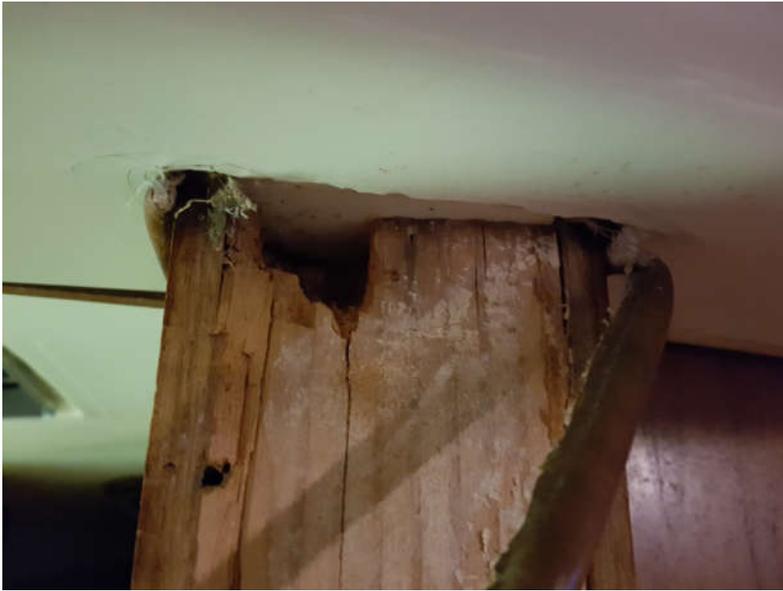
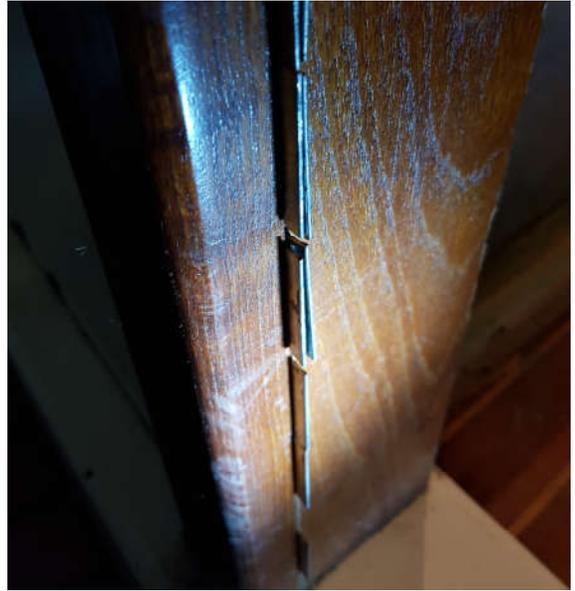
The damage to the beam was now much more visible and quite a bit worse than I thought. Also, there was significant rot of the douglas fir post within the teak.

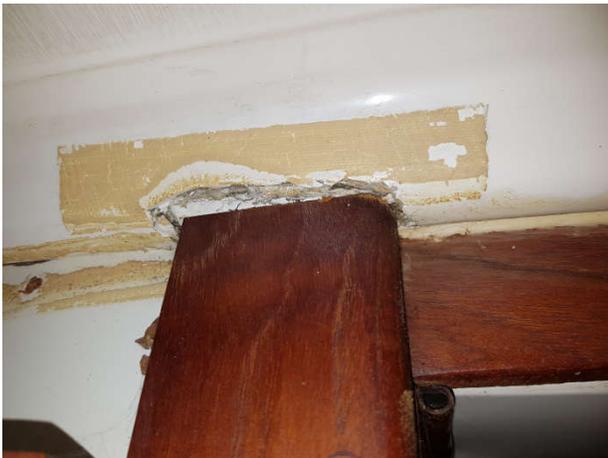
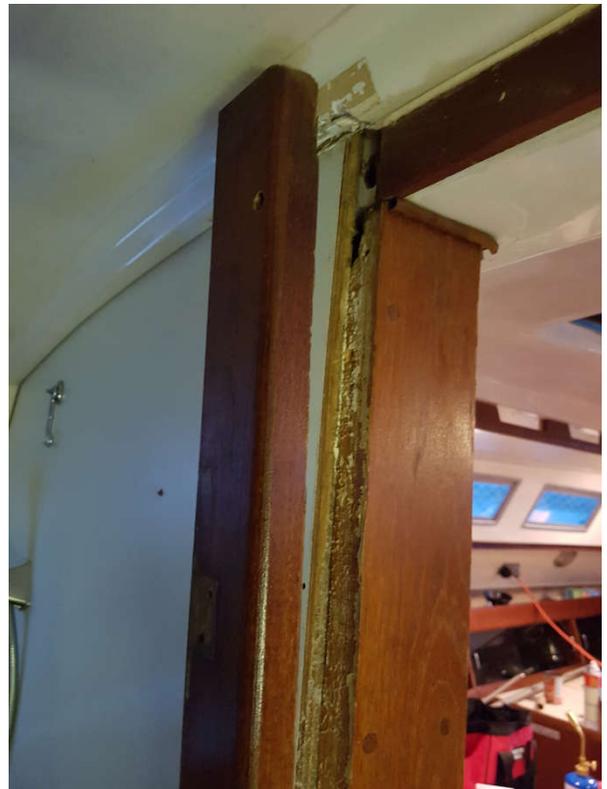
Looking from the head door jamb side(below), the coachroof had compressed downward enough to crush a hole above the jamb. Interestingly, the teak won that battle. Strong stuff, that teak. I later fixed the FRP, which came out beautifully (but forgot to take a picture of it).

What it looked like behind the jamb is to the right.

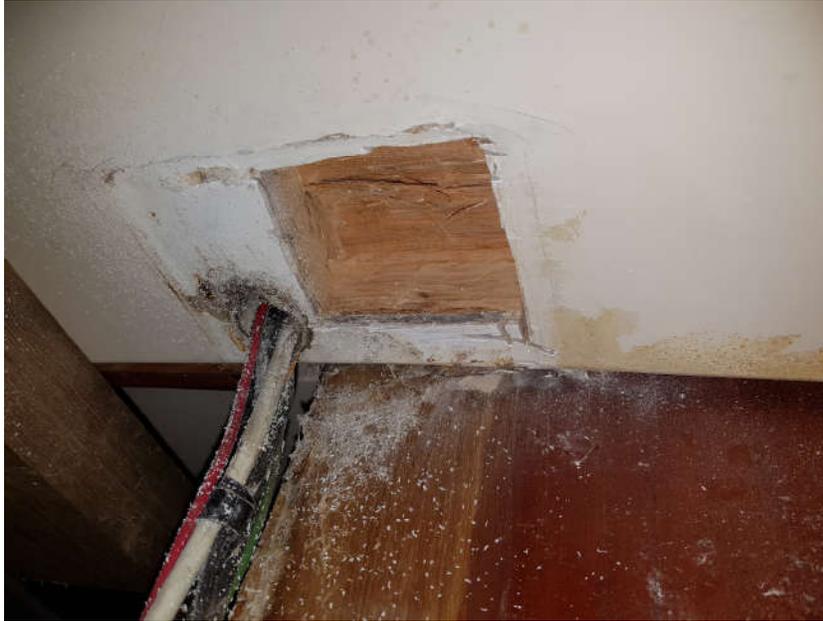
I was quite surprised at how sound the wood was inside. There was no sign of rot. The wood had simply crushed.

I looked at the yield strength of douglas fir perpendicular to the grain, and have seen numbers ranging from 340 psi to 625. The post only bears on $3.5 \times 3.5 = 12.25 \text{ in}^2$, so even at 625 psi the wood will only support about 7,600 lb (and that's to failure, not design). That is not nearly strong enough to take the compressive force of this boat.

I continued to use a chisel, Dremel, oscillating tool, and anything else I could find to dig out enough wood that my planned aluminum header would fit in. This took a really long time, and was the most difficult part of the job. I couldn't finish the design of the post until I had the wood out, because I needed to measure the length the new post would need to be exactly.

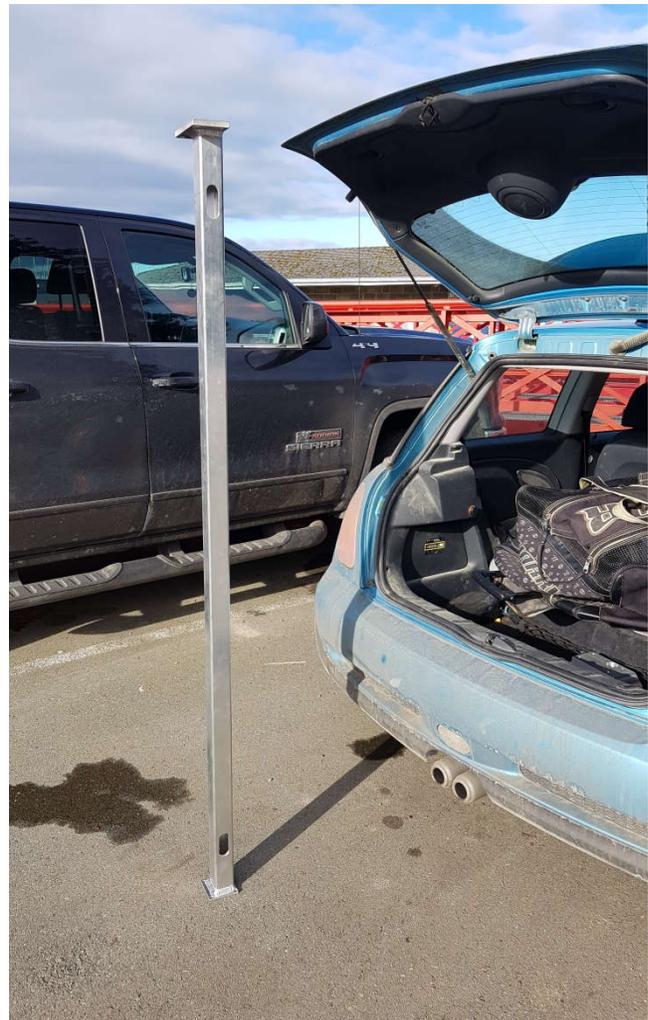
Here is the post newly retrieved from the fab shop. The hole in the side at the bottom is the exit for the masthead wiring; the hole at the top is a screw-up by the shop, because they originally made the hole there instead of the bottom (they misread the drawing). This has minimal effect on the strength, and even with the holes the post can handle just under 35,000 lb before failure, which is more than enough. That's a safety factor of roughly 3, and nearly five times as strong as the wood in the beam was.

After a lot of careful measuring, I finalized the design of a new post and header to go from the floor beam up to directly under the mast step. The post itself is a 2x2x1/4" square 6061 aluminum square tube with plates welded top and bottom. The header is a chunk of aluminum 3" wide by 7-1/2" long by 1-1/2" deep. Fabrication of these two parts cost CAD\$800 at a local shop. I will happily make the fabrication drawings available to anyone who wants them. The header is attached to the post with 3/8" UNC stainless hex head capscrews. When I installed it I used blue threadlocker on the screws so they won't vibrate out.

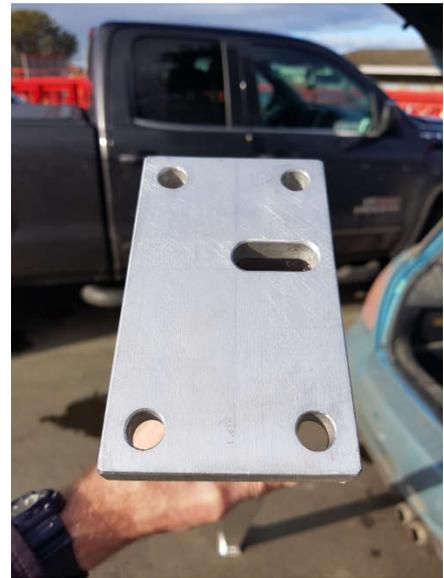
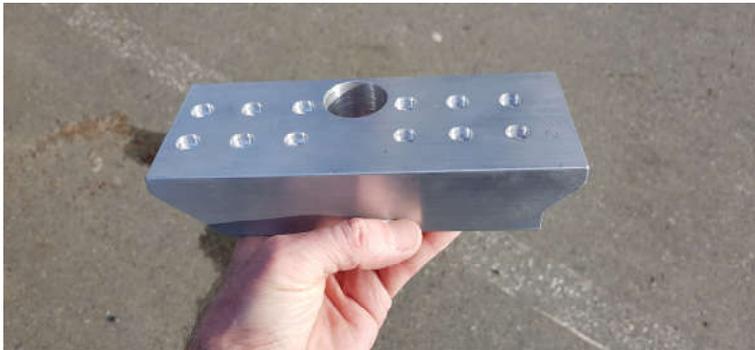
The top of the post is to the right. The oblong hole is the pass-through for the wiring.

The header is below. The big hole is for the wiring. The smaller holes are 1/4" deep blind holes to key the epoxy I mounted it with. The epoxy is partly to secure it in place, and partly to distribute the load evenly. I left a bit of the PVC pipe in place, and it sticks into the hole in the header. Any water that comes through with the mast wiring will now go through the header, down through the inside of the new post, out a drain hole I put in the bottom of the post and into the bilge. It won't touch any wood on the way.
