ELECTROLYSIS IN SMALL YANMAR ENGINES

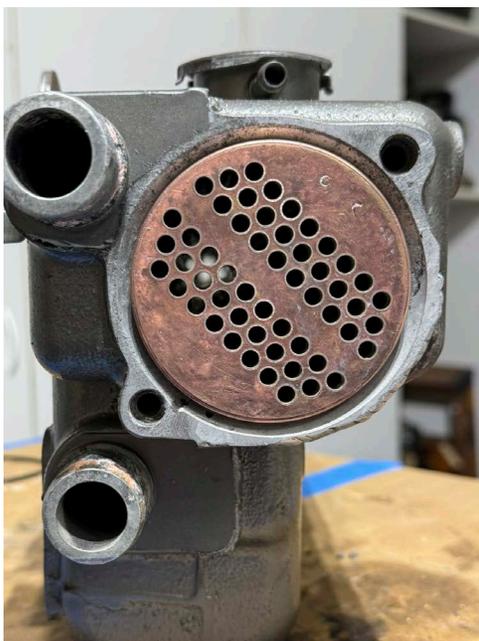
That is when I noticed the telltale accumulation of salt at the 5 o'clock position on the forward end-cap of the Heat Exchanger (p/n 129670-44911); that part of the engine that includes the manifold and Tube Core assembly ("Cooling Pipe" in Yanmar vernacular). Once I got the cap off, the damage was more than apparent.

With a new Heat Exchanger price in the \$1,400 - \$1,500 range, I decided to see if a machine shop could re-weld and resurface the original. Fortunately, there was just enough room to unbolt and remove

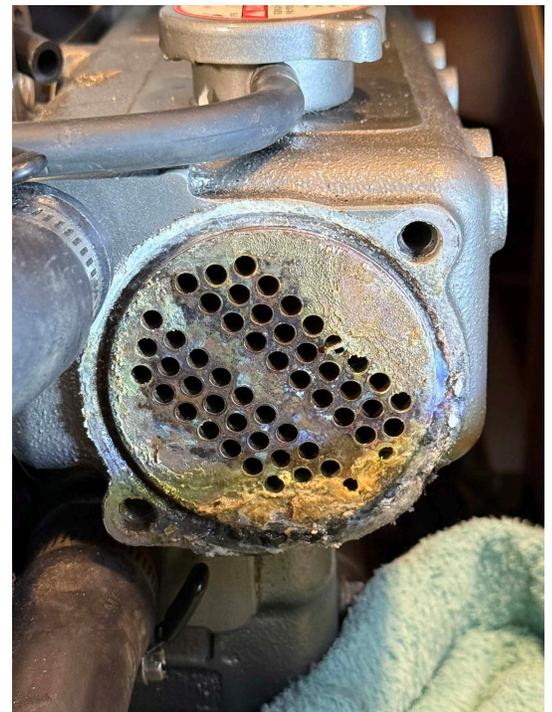
The machine shop did what I thought was a good job. Here is what everything looked like before it went back on the engine.

Thinking I had this problem taken care of, I headed back to the boat, installed the repaired Heat Exchanger, reconnected the hoses and filled the coolant reservoir

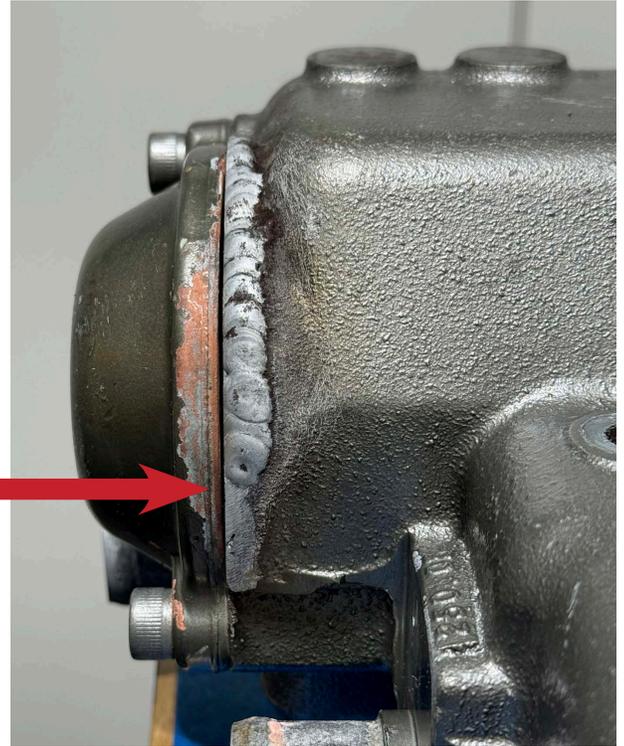
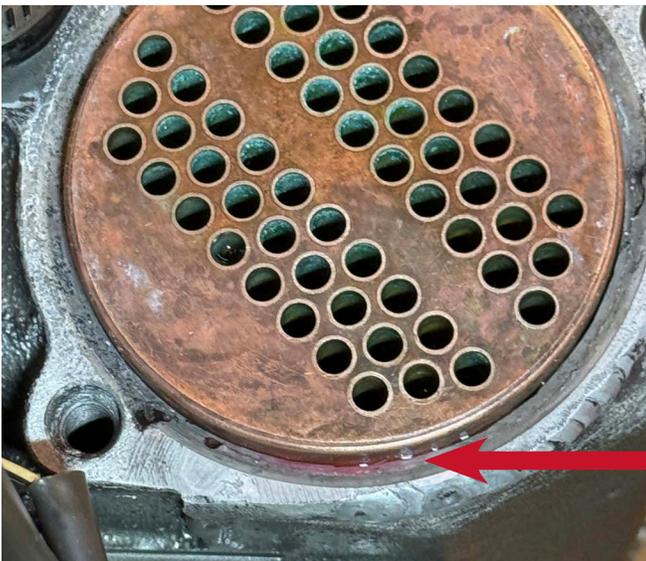
A little while later, antifreeze started dripping out of the forward end-cap. That meant I had two problems: antifreeze was getting by the 'O' ring that surrounded the end of the Tube Core assembly (this is the barrier between the raw water and the antifreeze) and it was leaking from the end-cap. That would result in a raw water leak and eventually a failure of the alternator mounted under it!

You can clearly see that the end of the Heat Exchanger that had been re-welded was not planed properly which left a gap for raw water to escape.

After I removed the end-cap I could clearly see antifreeze seeping out of a small gap in the welded area at the bottom of the Tube Core.

The machine shop approach had not worked. While I could have taken it back for remachining, I decided that would take additional time and money without a guarantee of success. After a hard swallow, I ordered a new Heat Exchanger assembly!

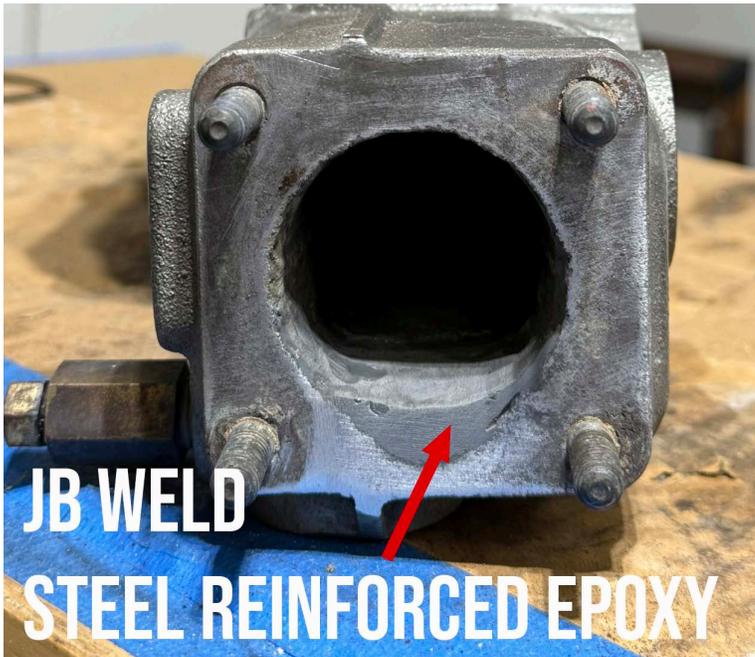
NOTE: I had been so focused on the disintegration of metal at the front of the Heat Exchanger, that I did not examine the dark and sooty exhaust port at the back until my return from the machine shop. This area also had significant metal loss where raw water tended to congregate. Here, I used JB WELD steel reinforced epoxy to fill in the gap.
