## Failure of the Forestay Lower Toggle

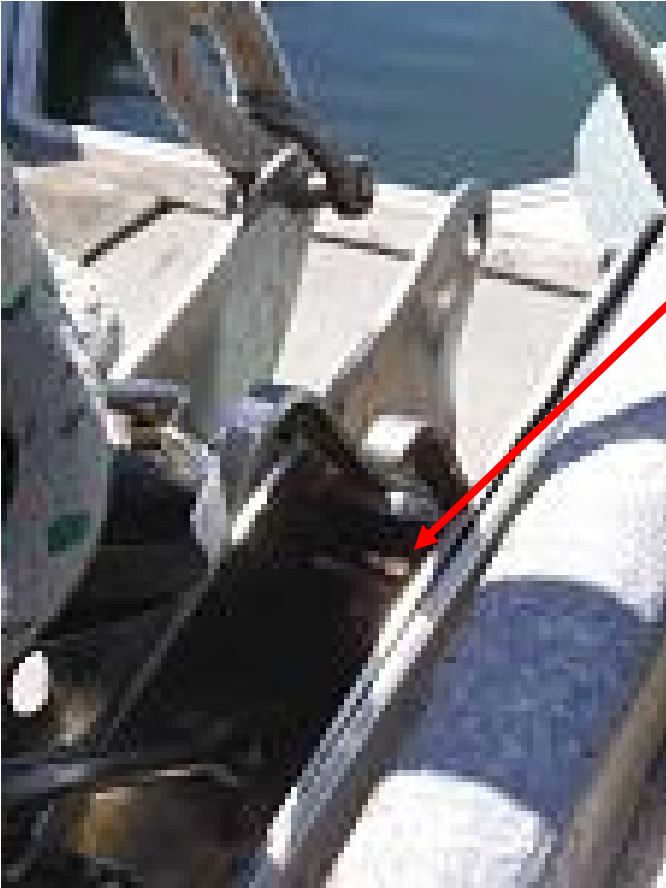
The starboard toggle leg lower fracture surface shows some discoloration indicating fracture face has existed for some time. Also notice that the new metal part of the fracture face is to the port side. So failure progressed starboard to port including final failure.

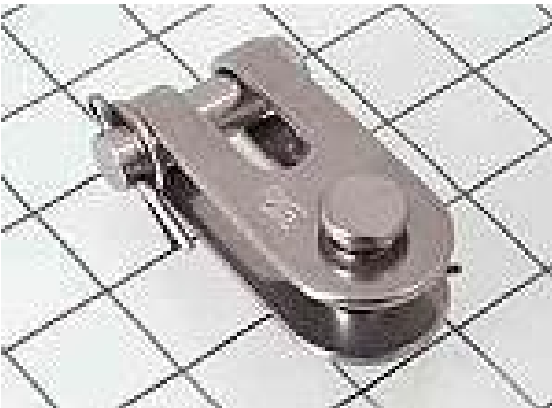
New toggle which tells me that the toggle above was mounted in the upset position or the legs of the "U" were pointed down.

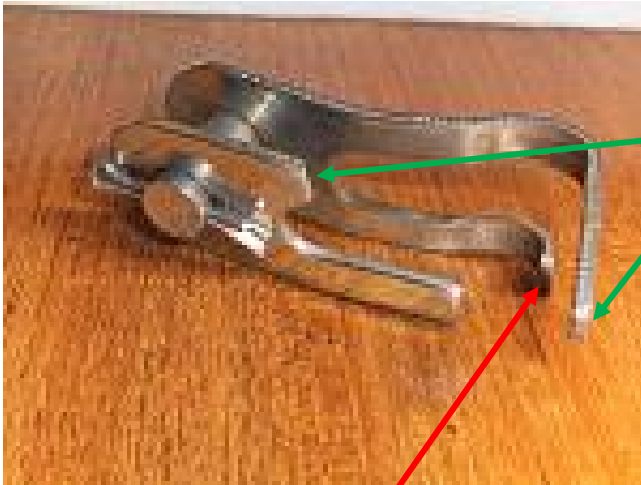
Port side fracture faces look new and not discolored meaning Port side leg fracture was secondary and not primary failure leg.

Starboard leg fracture face is discolored showing it is the primary failure leg.

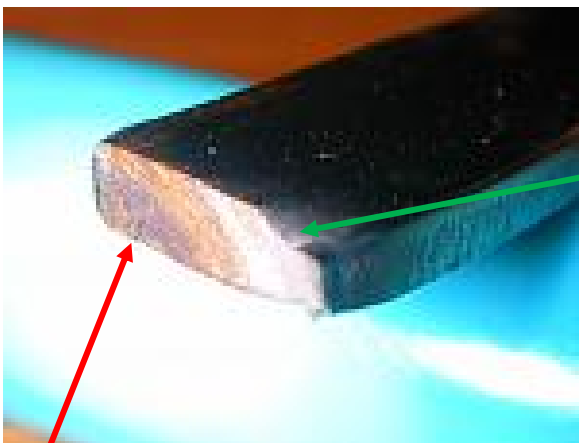
Clean portion of fracture face plus sucking in of the metal in the through thickness direction indicates final fracture overload.

Discolored primary fracture face from Starboard leg showing cracking existed for some time before failure.

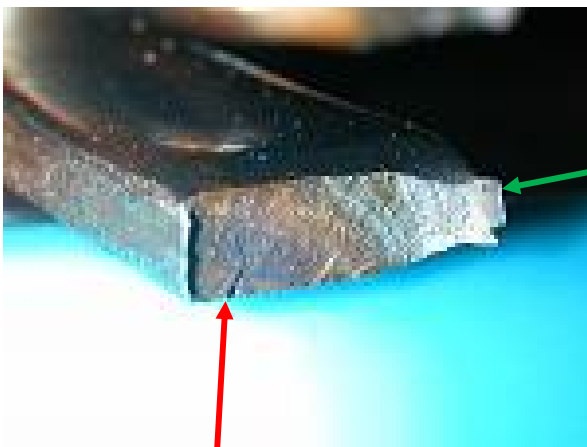
Again clean area with suck-in is indicative of overload final failure of the starboard leg.

Clam shell markings from lower left are indicative of fatigue. Stress corrosion cracking can create this appearance but usually not this definitive. The fracture surface ridge at the tip of the red arrow is usually indicative of boundary that separates two fracture origins. Both in the lower left area of the fracture surface.

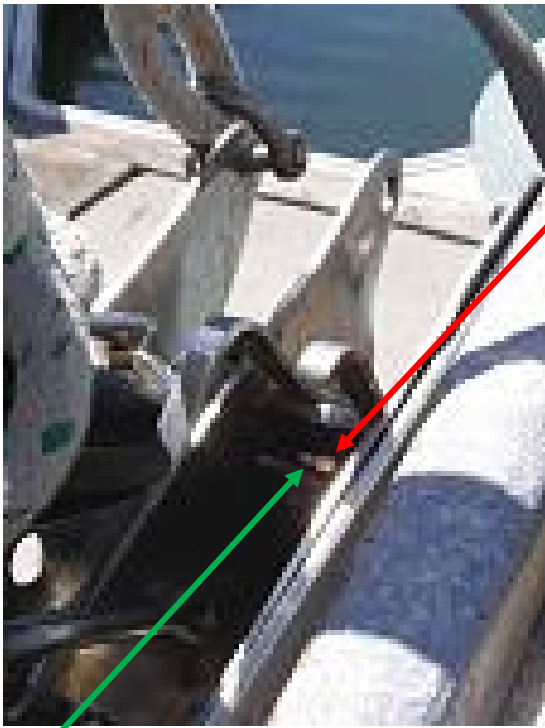
Assuming I have the orientation right the red arrow points to the failure origin and green arrow points to the final fracture part of the starboard leg. That being the case it tells me that the crack started on the inside of the "U" and at a level adjacent to what appears to be a section of a bow roller. I would look for corrosion pits or wear (fretting) near or at the fracture face as the origin on the inside of the "U". In any case the presence of multiple fracture origins indicates a higher than planned load on this leg of the "U". Given that then it looks to me like the toggle is constrained from port to starboard and reverse movement by the side of the bow roller thus loading the starboard leg of the "U" in tension on a port tack.

What I am wondering at this point is that if the "U" legs had been pointing up and rotated 90 degrees. The base of the "U" would have been free to rotate port to starboard and reverse, and a pin at the legs of the "U" through an eye on the base of the turnbuckle would allow rotation fore and aft relieving all constraints on both tacks.

My interest in this failure is would it be easy to inspect without disassembling the toggle. Since I believe it started from the inside of the "U" it looks like I would have the disassembly the toggle to fully inspect it.
