**A MARINE SURVEY**, conducted solely and exclusively for:

**Vessel Surveyed:** "CLOUD NINE," a 1974 Cal 2-29 Sloop rigged Sailboat  
Hull Identification Number: **CAB297230274**

**Date of Survey:** August 7, 2019

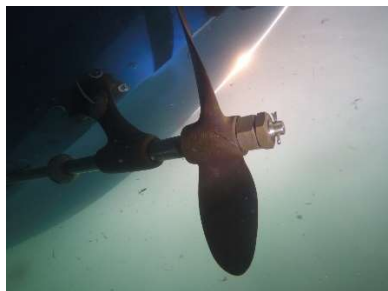
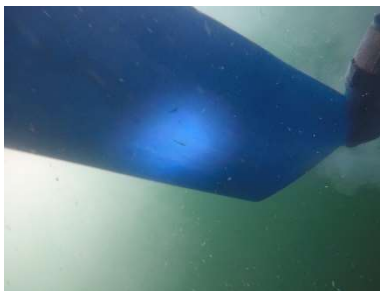
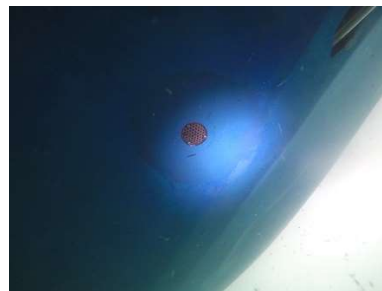
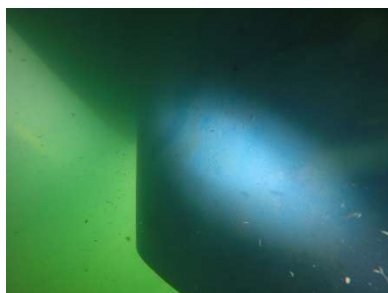
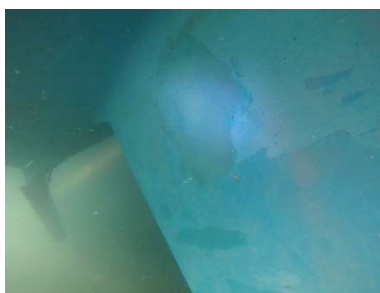
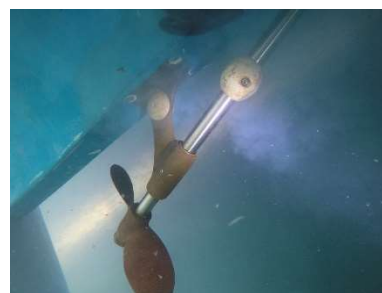
The exterior hull of this boat is made from fiberglass reinforced plastic, and single molded construction. The underwater inspection revealed minimal blisters, and found the hull in overall good condition. Shaft and strut found in good serviceable condition. Sacrificial anodes were in good condition, but should be changed out to ones of Magnesium instead of zinc, for better freshwater protection.

Material Condition:	GOOD
Through-hull Fittings, external:	GOOD
Transducers:	GOOD
Sacrificial anodes:	GOOD, ZINC; SHOULD CHANGE TO MAGNESIUM
Propellers:	2-BLADE SIGHTED, GOOD CONDITION
Propeller clearance:	GOOD
Propeller shafts:	GOOD
Struts:	GOOD
Rudders:	SPADE, GOOD CONDITION
Rudder bearings:	GOOD

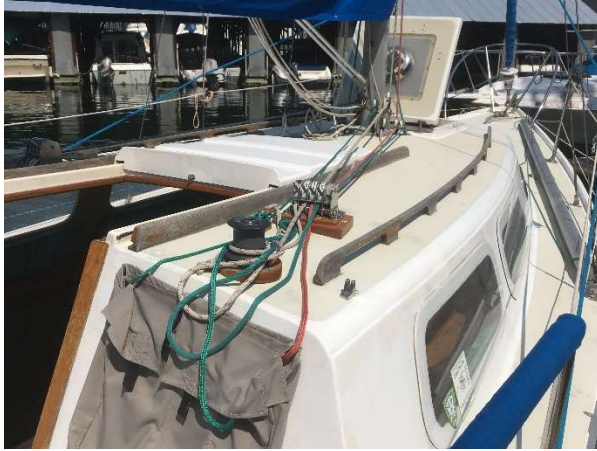
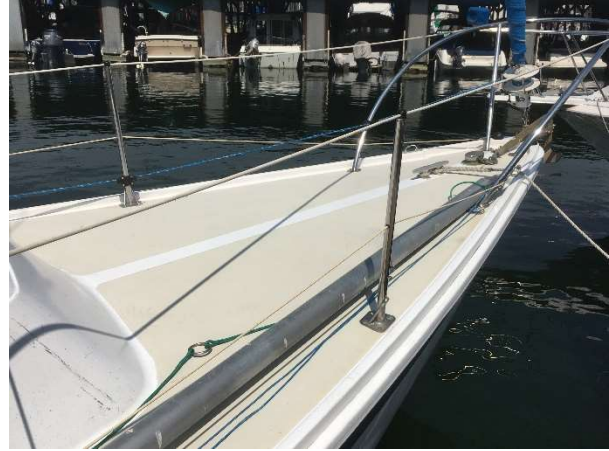
The deck of this boat is also made from FRP, and single molded. The overall condition of the deck is fair, with moderate oxidation, expected on a vessel of this age.

Material Condition:	FAIR
Hull-to-deck Connection:	SHOEBOX
Deck hardware:	STAINLESS STEEL
Grab rails:	TEAK RAILS ON CABIN TOP
Toe rails:	PART OF DECK MOLD
Stanchions:	STAINLESS STEEL, GOOD CONDITION

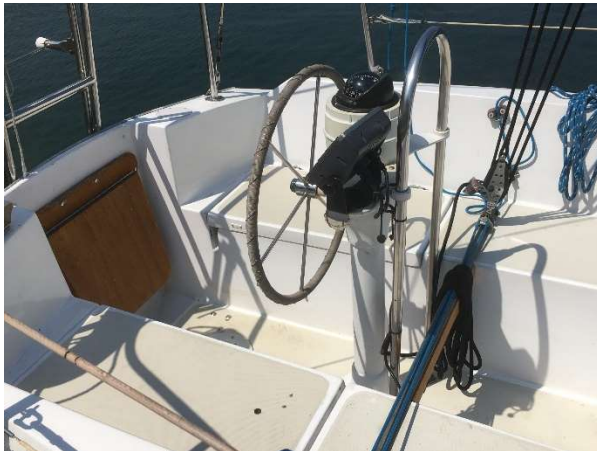
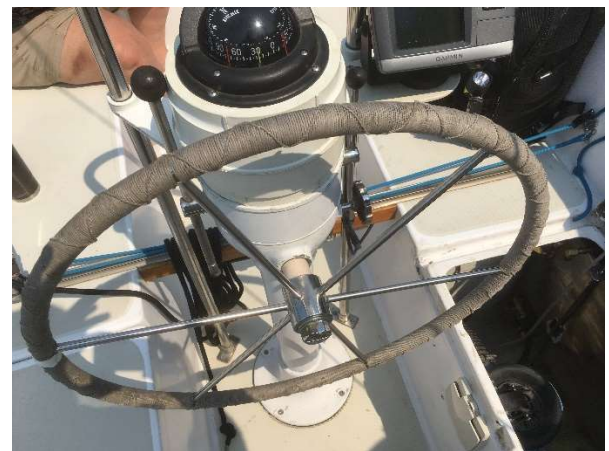
This cockpit on this sailboat is located aft. All control lines, sheets and halyards are “lead aft” to facilitate single handed sailing. Engine controls are mounted on the steering pedestal.

Material Condition:	GOOD
Engine controls:	GOOD
Steering:	PEDESTAL/QUADRANT, GOOD CONDITION
Cables and sheaves/hydraulics:	GOOD
Emergency steering:	YES
Scuppers:	FREEING PORT IN TRANSOM
Antennas:	TRUCK MOUNTED VHF ANTENNA
Winches:	WELL MOUNTED, RECENTLY OVERHAULED

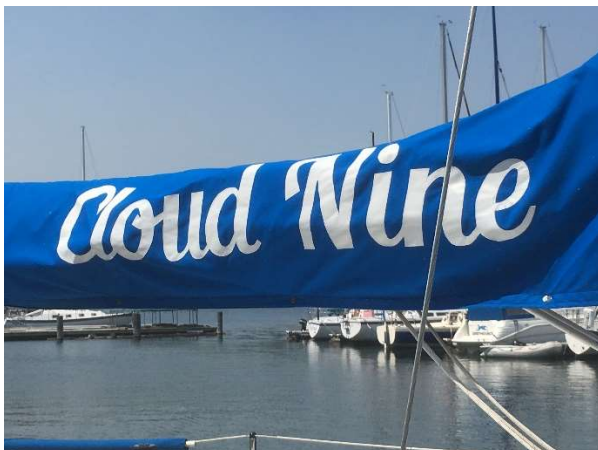
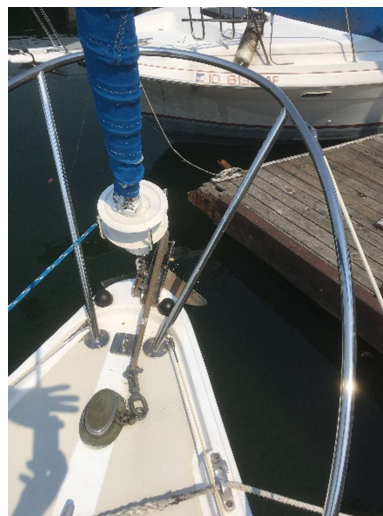
The only canvas products seen were the mainsail cover, and the protective edge of the genoa/headsail. Both were found in good serviceable condition.

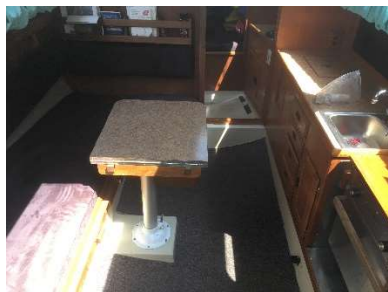
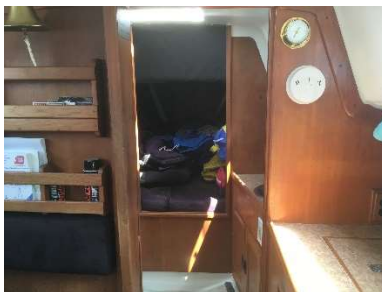
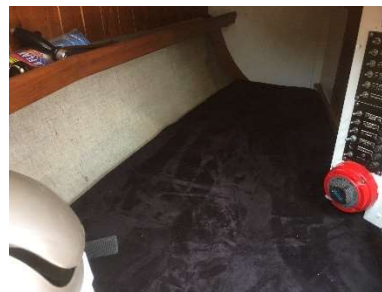
Although an older boat, the interior of this boat was found well maintained, and in good serviceable condition.

Material condition: GOOD  
 General condition (i.e. ventilation, leakage, furnishings, doors, cabinetry): GOOD  
 Bulkheads/Frames: GOOD  
 Bilge: GOOD  
 Sole: GOOD  
 Bilge pumps: YES, w/AUTO FLOAT SWITCH, GOOD CONDITION

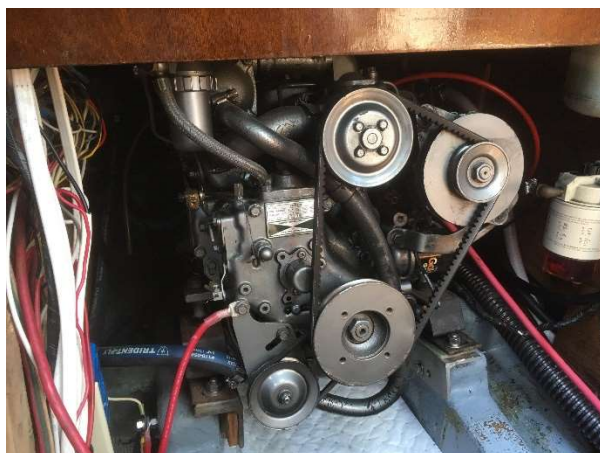
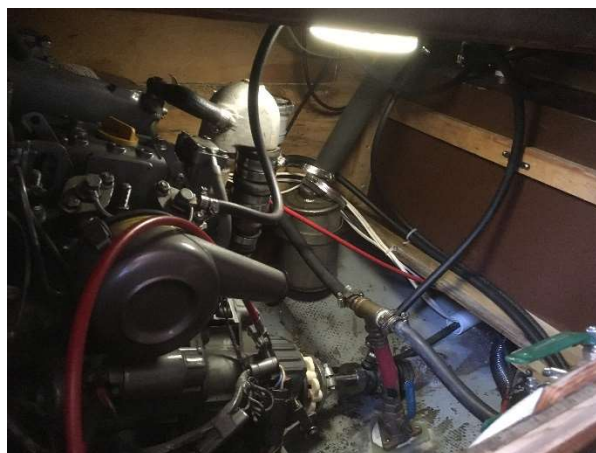
This boat is equipped with an auxiliary diesel engine. The engine was found to be in good serviceable condition.

Installation: GOOD  
 General condition: GOOD  
 Age of Unit: CIRCA 1983  
 Last Overhaul: UNKNOWN

Hours of Operation: NO METER  
 Engine Cooling System: CLOSED COOLED w/HEAT EXCHANGER  
 Engine Exhaust System: WATER COOLED, GOOD CONDITION  
 Engine mounts: GOOD  
 Engine compartment insulation: FAIR  
 Compartment blower: NO, NATURAL VENTILATION  
 Additional ventilation: NATURAL

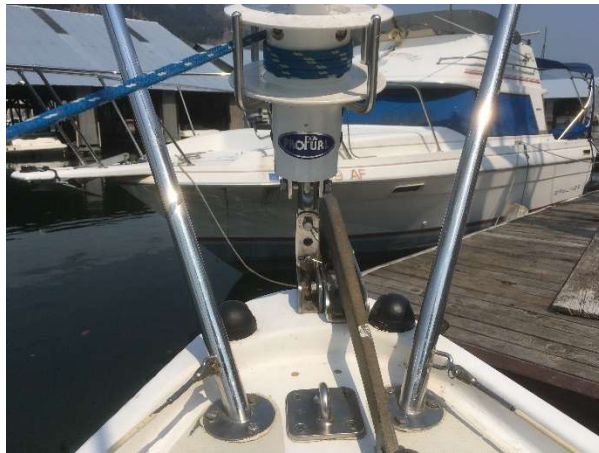
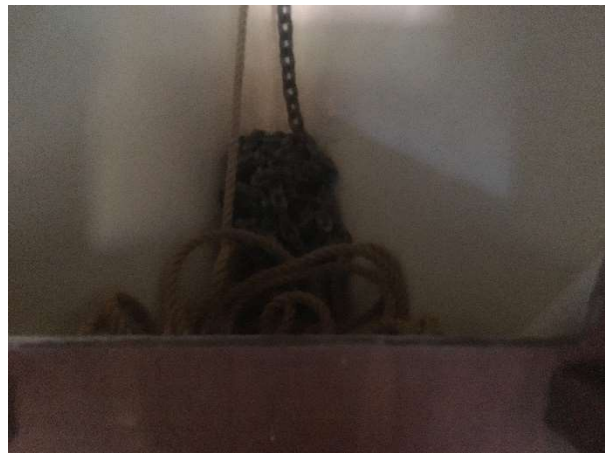
This boat is outfitted with a 7.5 kg Bruce anchor, mounted on the bow. The rode is made up of a combination of 1/4" galvanized chain married to 3-strand nylon line. The rode and anchor were found in good serviceable condition.

Anchors: BRUCE, 7.5 KG  
 Shackles: GOOD, SWIVEL IN GOOD CONDITION  
 Chains: YES, 50 FT 1/4" GALVANIZED, GOOD CONDITION  
 Rodes: CHAIN AND NYLON, GOOD CONDITION, ~200 FEET TOTAL  
 Lines: GOOD  
 Windlass: NO  
 Mooring cleats: YES  
 Backing plates?

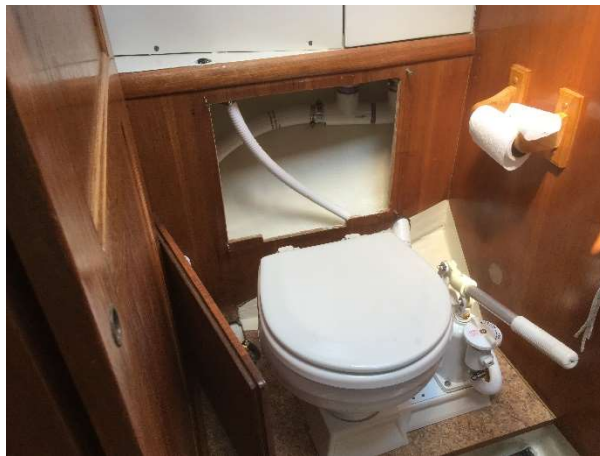
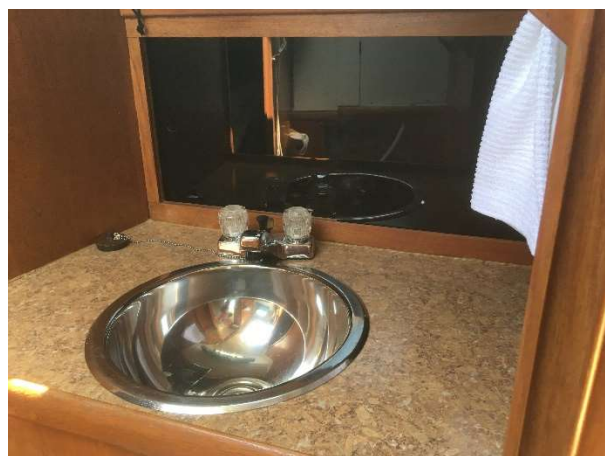
This boat is outfitted with a USCG approved marine sanitation device. The head compartment containing the MSD is located midships, forward of the main salon, and aft of the vee berth. Overboard discharge valve was confirmed secured, as required on inland waters. The head and holding tank installation was found in good serviceable condition.

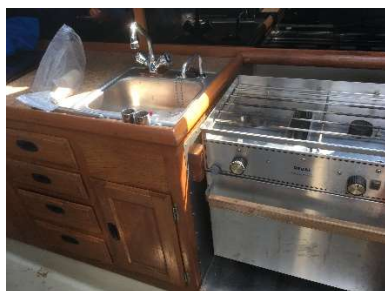
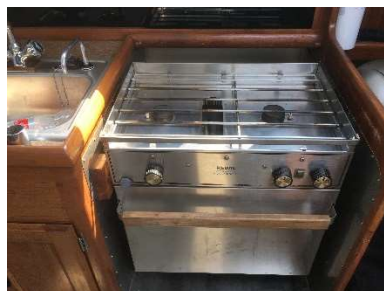
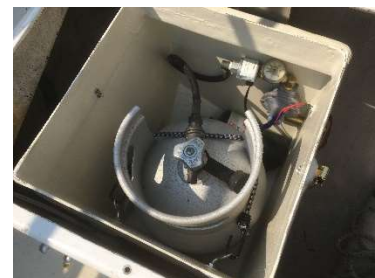
The galley on this sailboat is located on the starboard side of the main salon. The Stove w/oven has LPG for type of fuel. All equipment found in good serviceable condition.

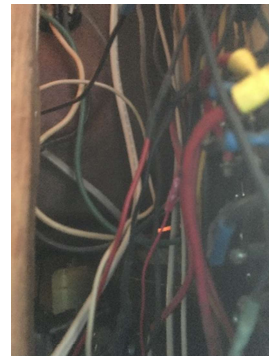
Wiring behind DC panel

The electrical system on this boat is a 12v DC based system, supplied from (4) series 27 12v DC batteries. Batteries were found properly secured and ventilated. Shore power is available, 110v AC. Outlets were found to be GFI protected. Wiring was randomly inspected for condition and support. The wiring behind the DC distribution panel needs to be better supported and sorted to reduce the “congestion” in the small space.

1. **INSTALL ENGINE HOUR METER.**
2. **ORGANIZE AND SUPPORT DC WIRING BEHIND DC PANEL.**
3. **INSTALL CO DETECTORS. (OWNER PURCHASED, BUT STILL IN BOXES)**
4. **INSTALL PROTECTIVE COVER IN ANCHOR LOCKER TO PROTECT BOW LIGHT WIRING.**
5. **REPAIR/REPLACE FORWARD NICO SOLAR VENT.**

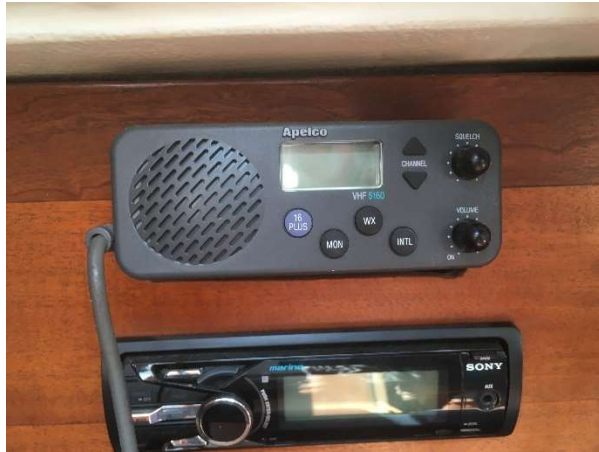
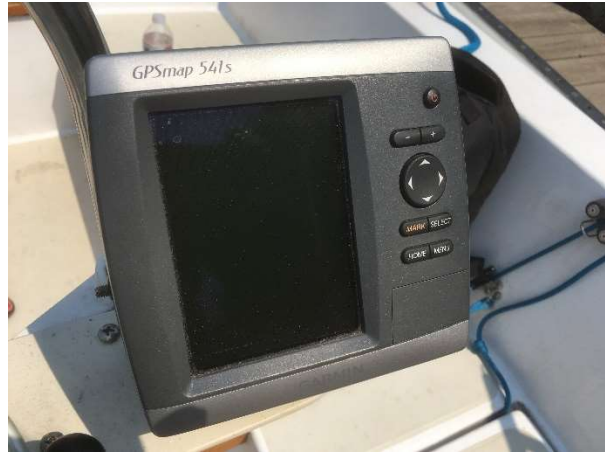
This boat is outfitted with USCG approved navigation light fixtures required on a vessel of this size and type. Additional equipment sighted and tested for “power up” only included an Apelco 5160 VHF radio, and a Garmin GPSMap 541s chartplotter/depthsounder. Both found in good serviceable condition.
