DATE OF SURVEY: June 15th, 2022

TYPE OF SURVEY: Insurance and Pre-

- BUILDER: Beneteau
- MODEL OF VESSEL: *FIRST 375*
- YEAR BUILT: 1985
- HULL CONSTRUCTION MATERIAL: Fiberglass
- HULL/DECK/TOPSIDES MATERIAL USED: Fiberglass

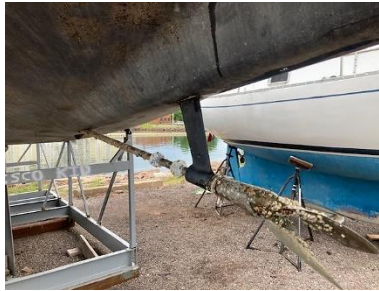
- NUMBER OF BILGE PUMPS: 2 - electric pumps + 1 - manual bilge pump.
- THROUGH HULL FITTINGS: The fittings have ball valves which are stuck/seized.
- UNDERWATER HULL COATING: Fair condition

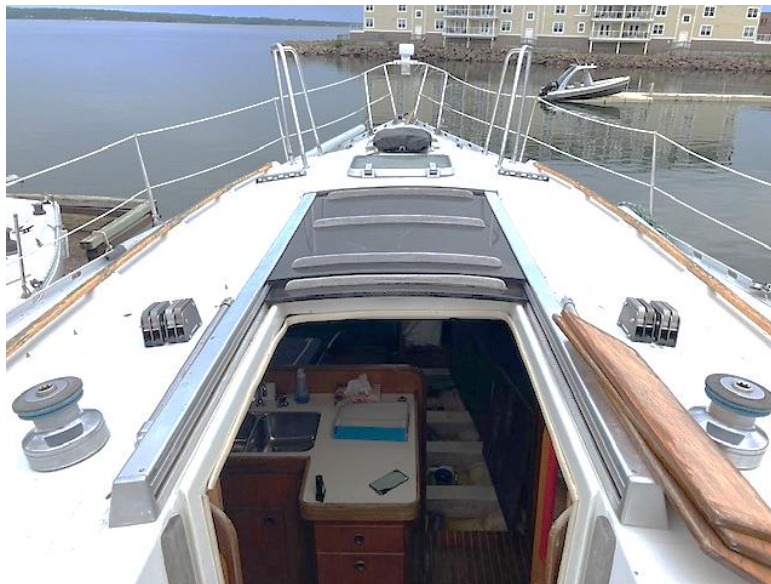
- PORT HOLES/WINDOWS: Fair condition; the windows/skylights are sun crazed.
- DOORS/ENTRANCEWAYS: Fair condition
- STRUCTURAL ANY INDICATION OF JOINT FAILURE CAUSED BY DE-LAMINATION OR COLLISION: No de-lamination or joint failure issues were noted; there's some gel coat cracking along the outside hull and more prevalent on the port side and rudder area.

DEFECTS/RECOMMENDATIONS/FINDINGS: Before purchasing this vessel, I would recommend a fiberglass repair person give an estimate on the gel coat repairs to the outside hull; these cracks in the gel coat are most likely caused by stress or poor gel coating, a mechanical type person should also be called to estimate cost on changing the rudder shaft bearing, the keel bolts are quite rusted and if hit with a hammer a big percentage of the bolt head would likely fall off, so these should be safety checked, also the engine should be started to hear it running. The inside upholstery repair/replacement costs and mold issues could also add up.

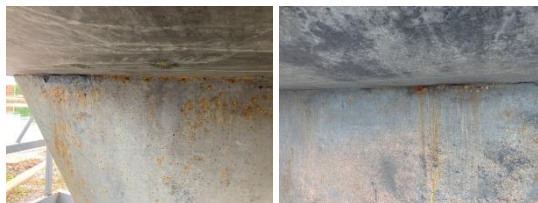
- **KEEL BOLTS:** The keel bolts are rusted and questionable.

- 1- The rudder shaft bearing appears worn and should be replaced.
- 2- The keel bolts should be safety checked.
- 3- A shut off valve should be installed on the propane line behind the stove.
- 4- Oil absorbent pads should be available onboard.
- 5- A Safe-T-Alert alarm or smoke alarm should be installed.
- 6- The two fire extinguishers should be mounted easy and accessible.
