Hull To Deck Re-Sealing

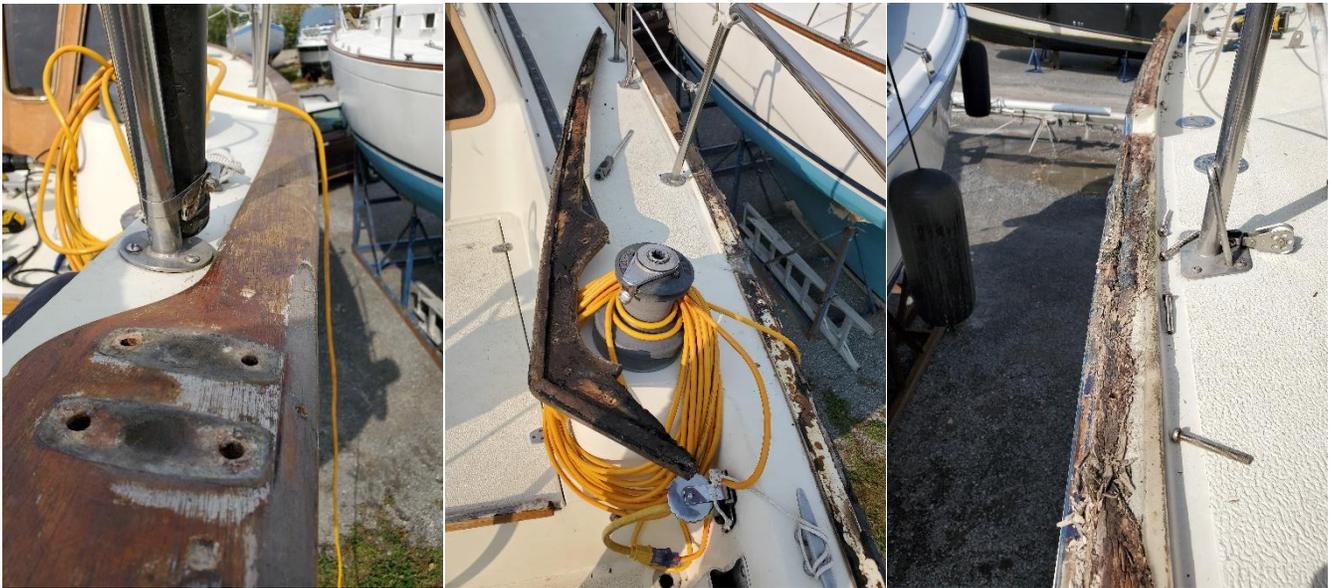
The deck hardware on the teak cap rail came off first then I removed the cap rail. The sealant under the cap rail was really dry. The brown flakey stuff shown here was, at one point, sealant.

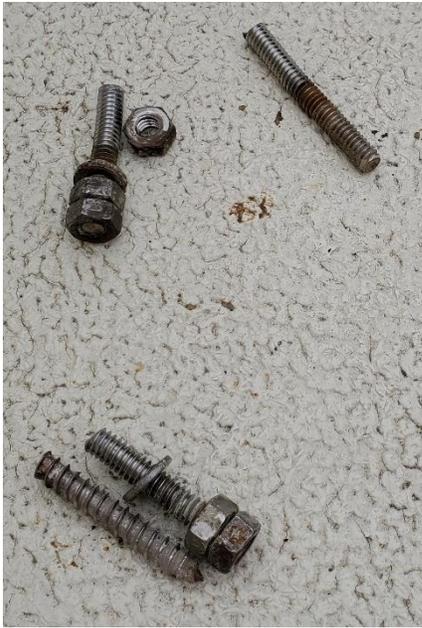
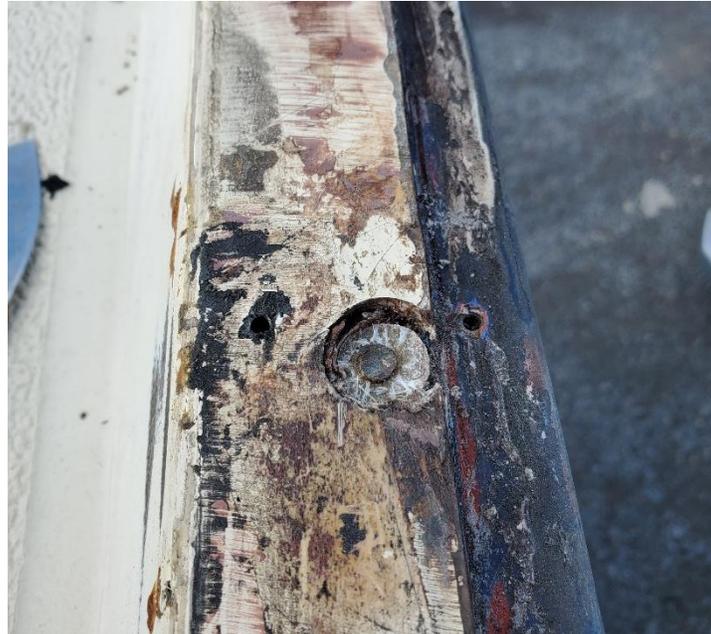
What I found next was more than a little disturbing. The starboard cap rail had been replaced previously, possibly do to a collision although the hull did not have signs of any major repair so it looks like whatever damage there was, was limited to the cap rail. The problem is how the original cap rail was removed. The factory used #14 wood screws to fasten the hull to deck joint but then through bolted the cap rail with 1/4-20 machine screws and nuts through the cap rail, deck and hull which held it all together very securely. The problem is whoever removed the cap rail couldn't figure out how to remove the machine screws so it appears he used a 1" hole saw to just cut the cap rail around the screws then hacksawed through the screws and left the now headless screws in the hull. I actually found one of these headless screws in August and could not figure out where it came from. Turns out they were all along the starboard joint.

The person who worked on this before did a lot of damage with the hole saw that needed to be patched up. Here you can see some of the headless screws (some were wedged in so I needed to use a jam nut to unscrew them from below) and here is one of the holes in the deck he created with the headless screw still in it.
