## Important information concerning forestay fitting 517-914 (2004 – 2008)

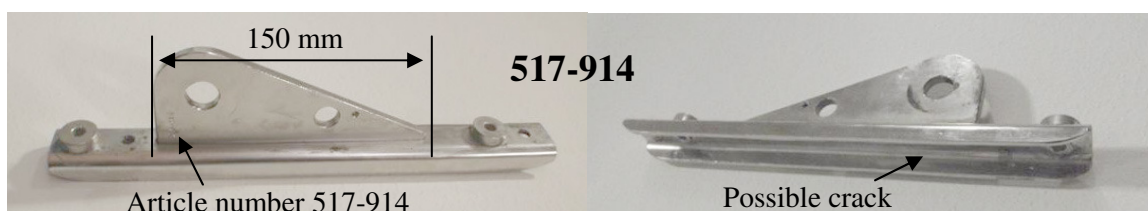
It has been brought to our attention that a few forestay fittings of this design have failed due to a crack in the welding. The crack develops along the weld on the rear side of the fitting inside the mast. It is not visible from the outside. The suspect production batches were used during the period 2004-2008.

All the failed fittings origin from long distance cruising boats with inadequate rig tune and long periods of sailing using only the genoa.

1. Check, before further sailing is done, if your boat is on the list below. If so, please verify that your mast has a forestay fitting marked with the article number 517-914. The number is stamped in the stainless plate and is easy to check from the outside.

2. If that is the case, please fill out and send the [digital form](#) for contacting Seldén.
3. Seldén will immediately deliver a replacement fitting, art no 517-914-90 and decide when and where the replacement will be carried through – naturally in agreement with the owner of the boat.

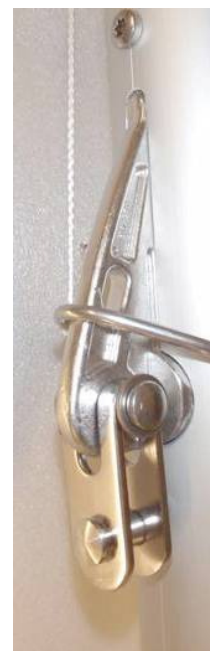
**Forestay fittings marked with article number 517-924, used 2007 and onwards, are not affected by this re call.**
