INTERIOR LIFTING KEEL BOX:

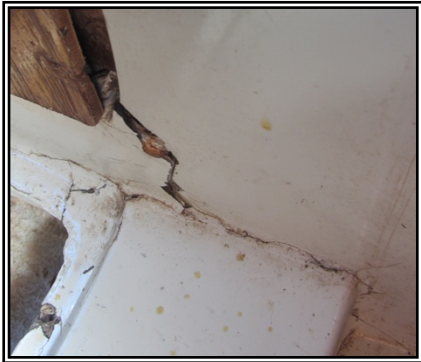
At inspection, the lifting keel housing glassed to hull structure showed signs of movement. Areas of interior (non-structural) hull liner, adjacent, immediately to port side and aft of box were found to have crazing where the floor pan lay hard against a transverse top hat stringer. Inspection of the glass laminate showed no sign of overt movement in hull structure. Similar failure of

and cabin sole had focused stresses in this one area. Though these were considered consistent with even minor fore and aft hull flexing, repairs are highly recommended at this time (ER). Forward and to

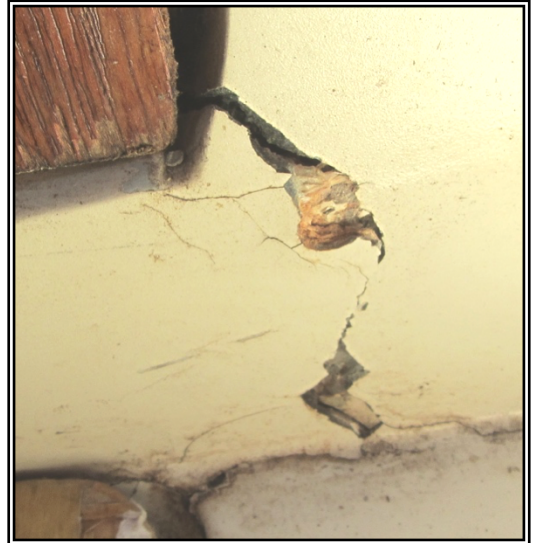
interior glass was noted at aft intersect where a 90° intersection of vertical box aft face

starboard where keel box intersected the structural mast compression post molding, significant athwartship movement (momentary event) had led to fracture of glass laminate compression post support. It appeared that additional glass had been applied to the hull laminate directly adjacent. Though no hull structural damage was noted, repairs to this area should be affected to return the keel box/compression post to its original strength (ER).

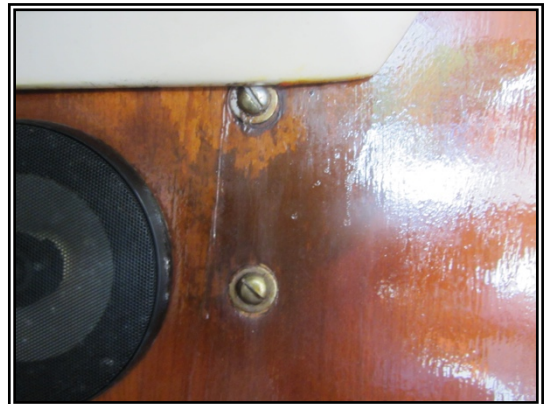
The interior, including joinery, cushions and headliner were in serviceable condition. Soft goods were considered original to manufacture however, no significant rends or wear was noted on fabric. Age and UV fading was noted however. Generally veneers and plywood interior panels were in good condition. Exception to the above was noted at the main structural bulkhead where prolonged moisture intrusion had compromised the wood cellulose structure at the top two (of four) bolt locations (ER).

Additional water damage was found at the base of this bulkhead as viewed from the

head compartment forward (ER). This area was thru bolted to transverse top hat molding feature. These areas should be reconstituted to provide solid bolt attachment to hardware and interior glass structure (ER).
