November/December 2008 --

This will be my last haul out in the SF Bay area, and also my last major project. This time, it's the keel. It's a long story, but my keel has always been a concern. I think that the leading edge was weakened when the [mast step cracked](#), long before I bought the boat. That put an extraordinary load on the smaller leading bolts, which worked a bit and let water into the joint. Then, in 2004 I got seriously stuck in the mud while the tide was going out, and I powered out of it. After that, I had a leak. Three years ago, I did a temporary repair, but knew that the repair trapped salt water around the bolts. Stagnant sea water turns acidic and can cause deep crevice corrosion in stainless steel. I have seen this. So, I need to take it apart and make it right.

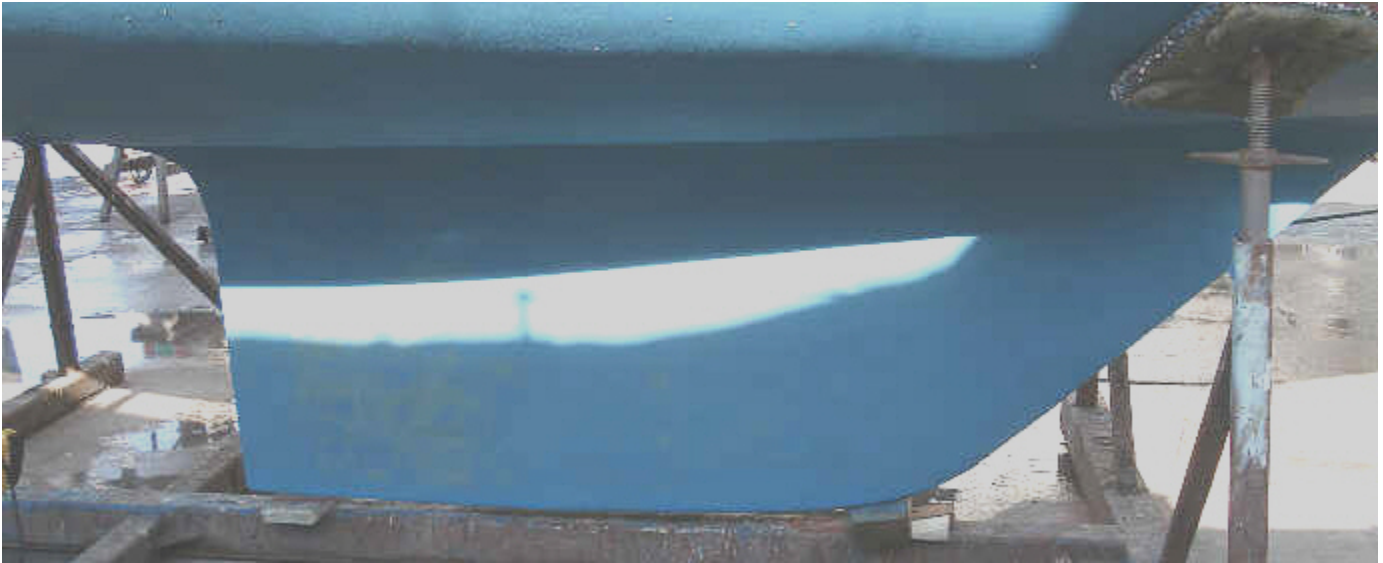
Above, the keel after power washing. I'm really pleased, as [all the work I did three years ago](#) has held up. I really hate to mess with it, but I know it was just a superficial repair. Three years ago, I wrapped the ends of the keel with fiberglass and packed some epoxy in the joint, to provide some support. I also took the keel down to the lead and primed it again, because it was failing all over. That has held up well, and there isn't a single failed spot.

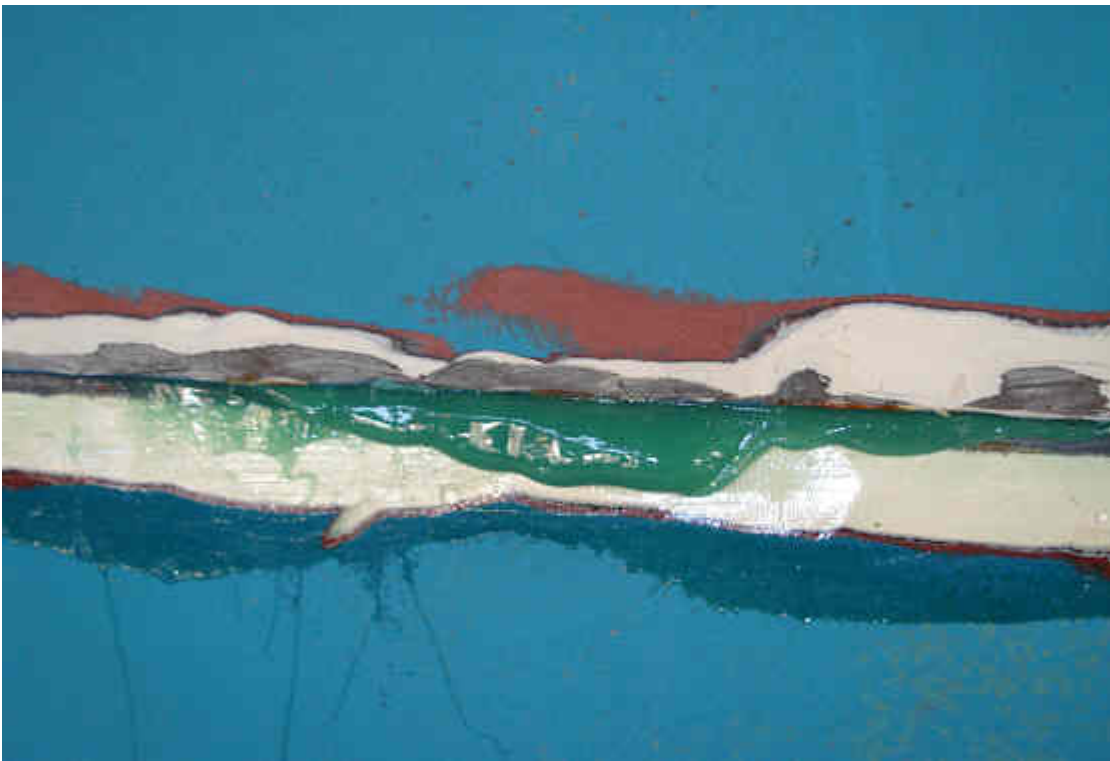
The first three bolts go through a sealed "crash bulkhead" area, so if I hit something and get a hole there, the boat won't sink. For some reason, the area is filled with wood. It's wet, but not rotten. We're going to leave it, and seal the bolts up so that they never get wet again. Removing the wood filler would take a month, and involve

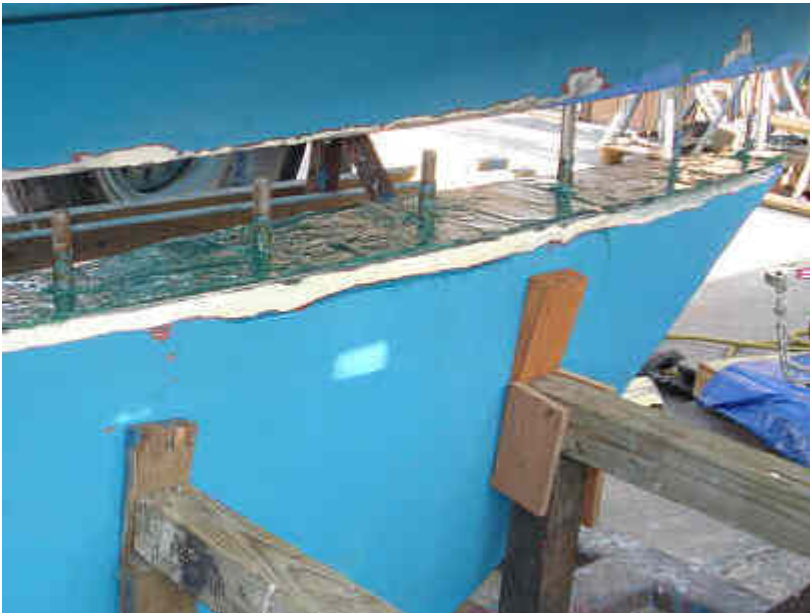
The lead wasn't quite as wide as the fiberglass stub, so I laid a couple of one inch strips of X Cloth with Mat along the lead. To get a good bond, I dry sanded the lead, wet it out with epoxy, and then sanded the epoxy into the lead with 60 grit paper. This made sure that the epoxy was well bonded with new lead that had never been exposed to air. That's important, since lead oxidizes really quickly, and nothing sticks to it once it oxidizes. I sanded until the epoxy was dark gray mud.

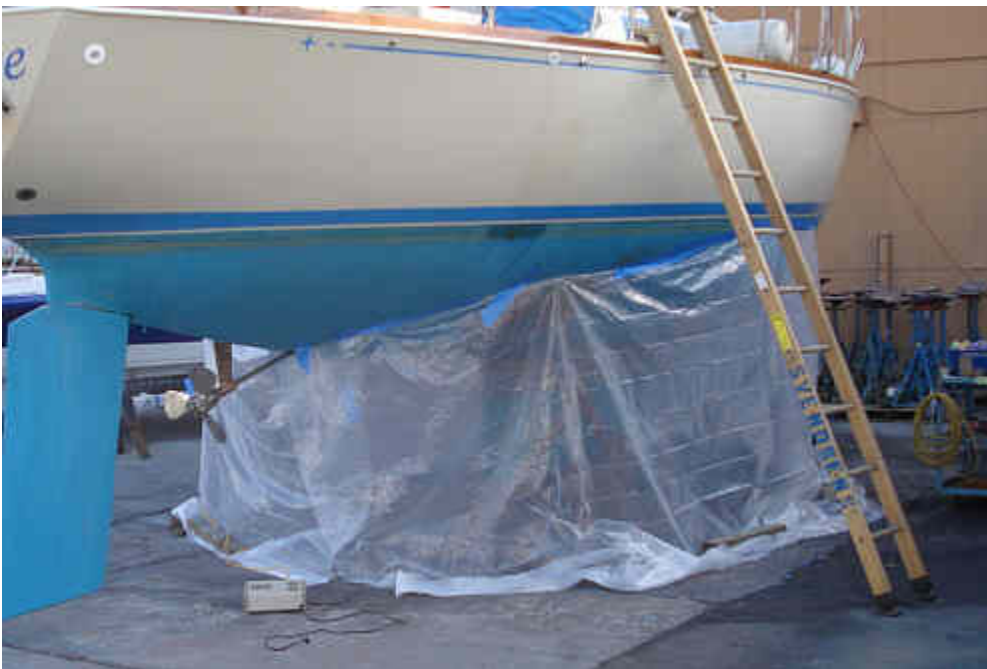
While the boat was hanging, I got out the hose and my right angle die grinder, and cleaned the joint back three inches on either side.

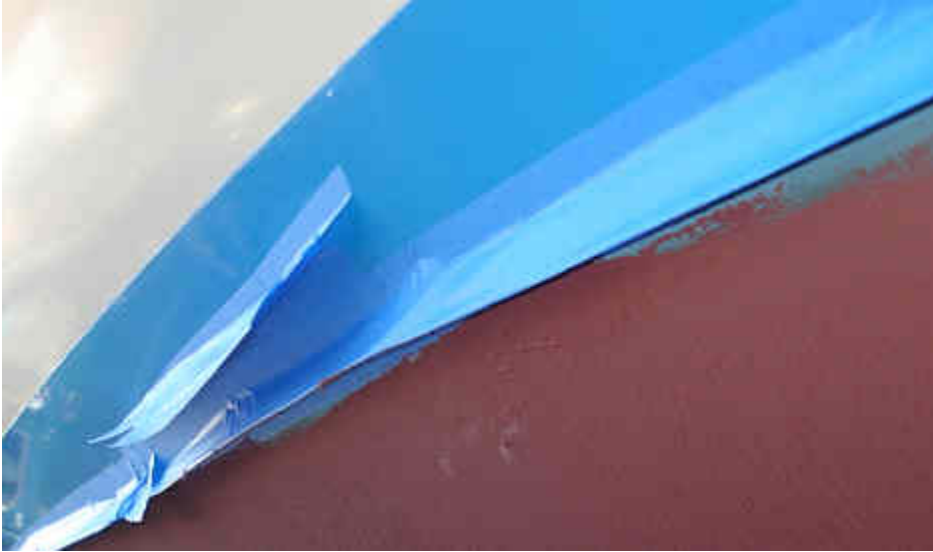
I need to cut off the excess caulk, clean everything and paint.

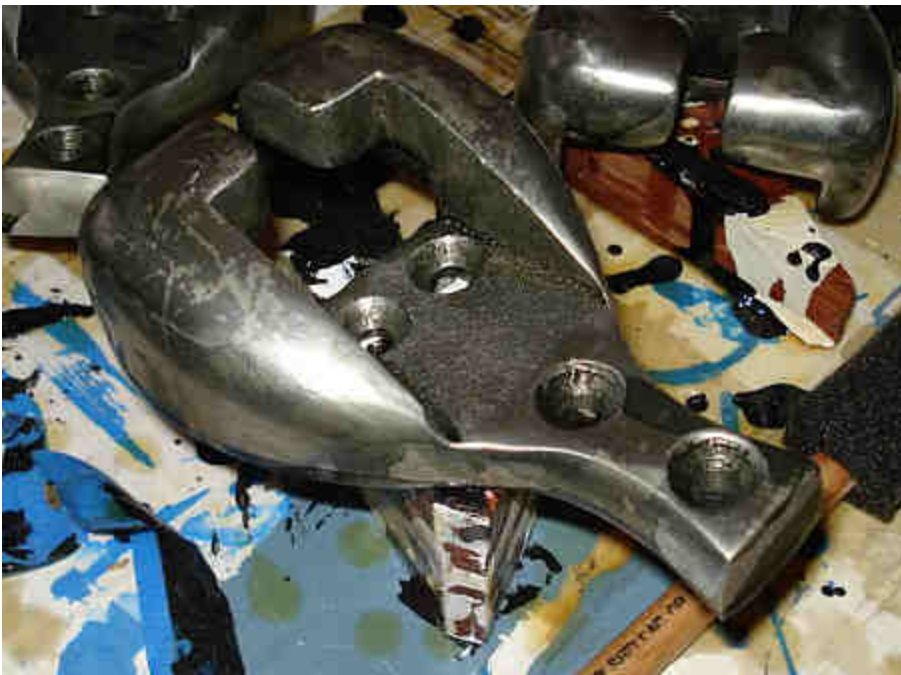
I'd like to hard coat anodize them, but that would cost hundreds of dollars for all these pieces. So I'm painting them. First, I etched them with **Alumiprep**(phosphoric acid.) You can see how previously clean looking aluminum suddenly turned white as the acid worked on invisible oxidation. Then, I painted them with **Alodyne**, which is a chromic acid solution. Then they were all primed with this Petit two part metal primer. It's really nasty toxic stuff, but I like it.

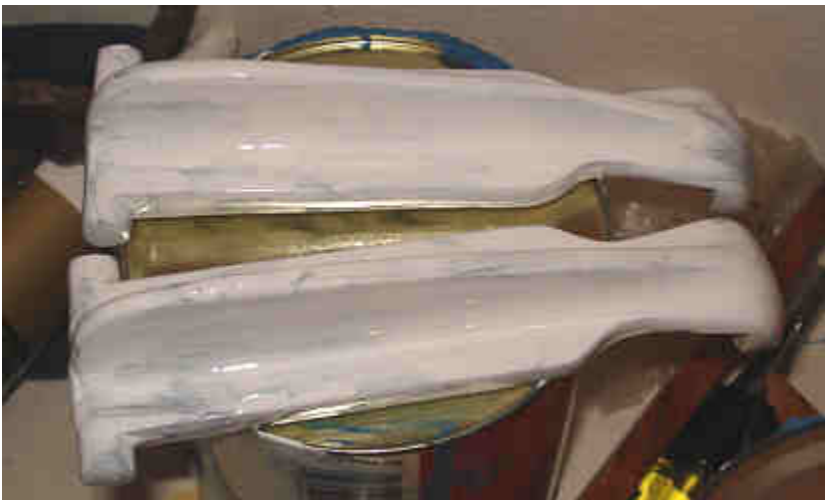
Here's what they look like after priming.

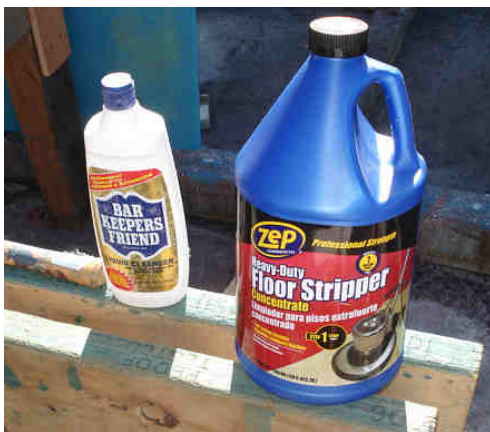
In May 2007, I was waxing my topsides on a weekend when the phone rang. It was an important work call, and I had to take it. I sat there for two hours being polite, while a newbie manufacturer's rep gave me a lecture about my own business. And I watched the wax bake onto my topsides.

It left a horrible buildup, that I'd tried to remove for the last two years. A wonderful woman on the next dock over suggested that I use Zep Floor Wax stripper, following the directions and using really hot water. It worked incredibly well, and also chemically removed all the gelcoat oxidation. It took two iterations of stripper, scrubbing with a soft abrasive and a white 3M scrub pad. But it worked really well, and my topsides look great gain.
