## Replacing the fresh water cooling pump on a 2008 Yanmar 3YM30

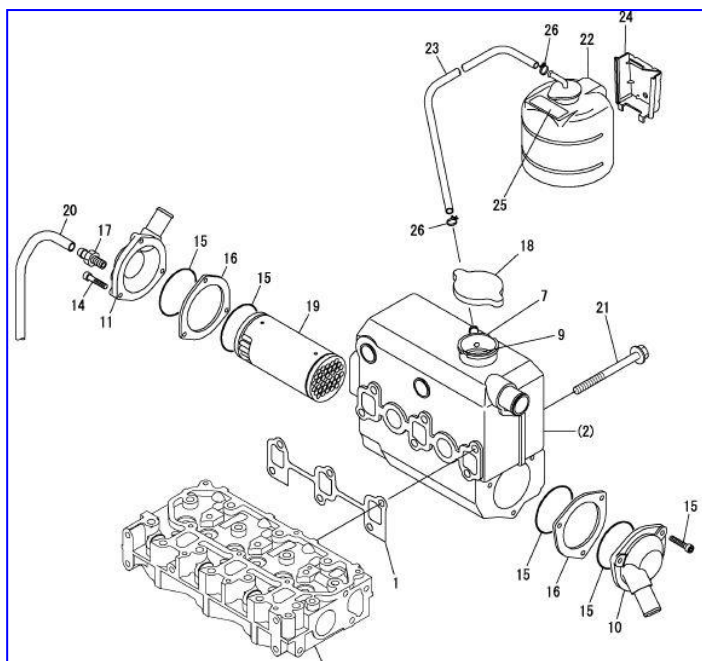
The first leak was in the rear O-rings (#15/16) on the heat exchanger (#2) in the figure (right). The heat exchanger assembly was removed, rebuilt, and tested by a radiator shop. A new steel gasket (#1) was used when replacing the heat exchanger. A torque wrench and medium thread locker were used on the six bolts (#21) during reassembly.

The coolant loss persisted after the heat exchanger rebuild, but at a lesser rate. Diapers were also used to find the leaking fresh water pump shaft behind the V-Pulley, and a leak from the filler neck. The engine only had 770 hours. It is unknown if the alternator belt had been overtightened at some earlier point and rapidly wore out the shaft bearing/bushing seal. The shaft felt snug with no end play.

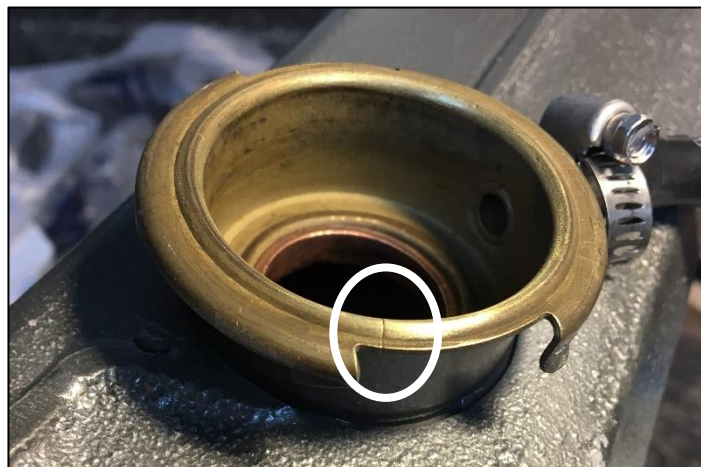
A new radiator cap did not stop the leak around the filler neck. Upon removing the heat exchanger again to replace the filler neck, a crack was discovered on the upper sealing surface (photo at right). There was very little residual antifreeze on the tank around the filler neck because it evaporates off so quickly. The crack is obvious in the photo at right, but was probably there before we bought the boat.

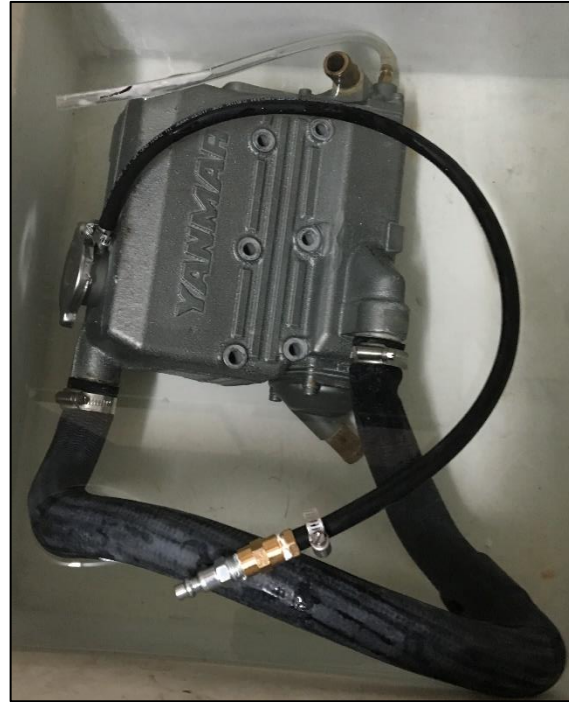
The crack was accidentally found during pressure testing as shown at right. A stream of small bubbles developing at the crack area when bubbles were expected at the seal between the neck and tank. The crack may just have been a lucky find because the bubbles leak out from the cap when the pressure is too great for both seals to hold (a little above 15 psi) in this test configuration. This is a cool test because leaks around the 4 bundle O-rings would show up as either exterior leaks or as bubbles rising from the raw water ports. This test is in the shop manual. The yard pressed in a new filler neck – leak fixed.

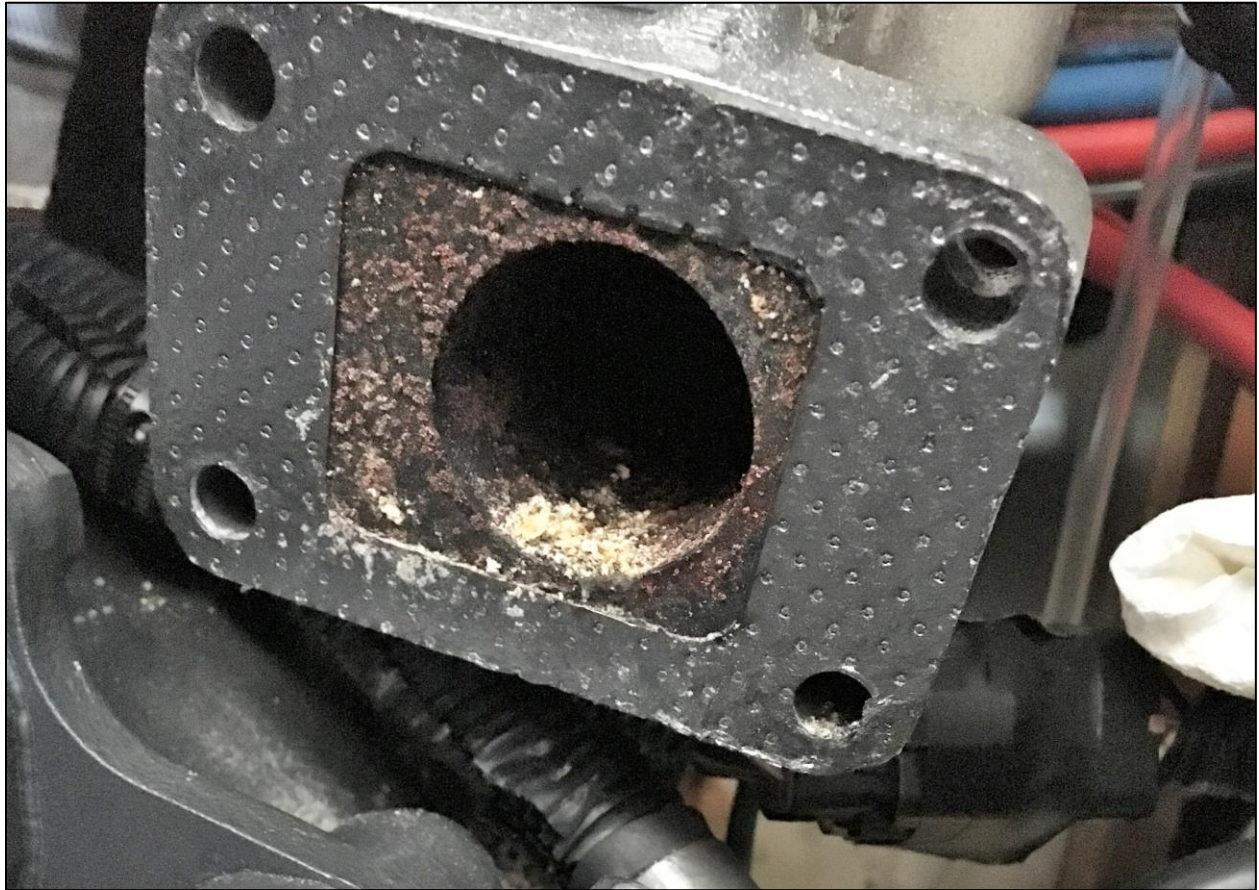
To complete this note, the photo on the next page shows a small amount of what looked like sand in the exhaust manifold opening. There were also small amounts in each of the exhaust ports on the engine block. I am hoping that is NOT what burnt Yanmar coolant looks like. It was loose, so it may be something that condensed over the layup period because I would think it would be blown out of the exhaust system otherwise.
