So the job is finally done. New transmission, damper plate and engine mounts. Not a job for the faint of heart. Here is assembled engine front and rear: (my son's foot at the left)

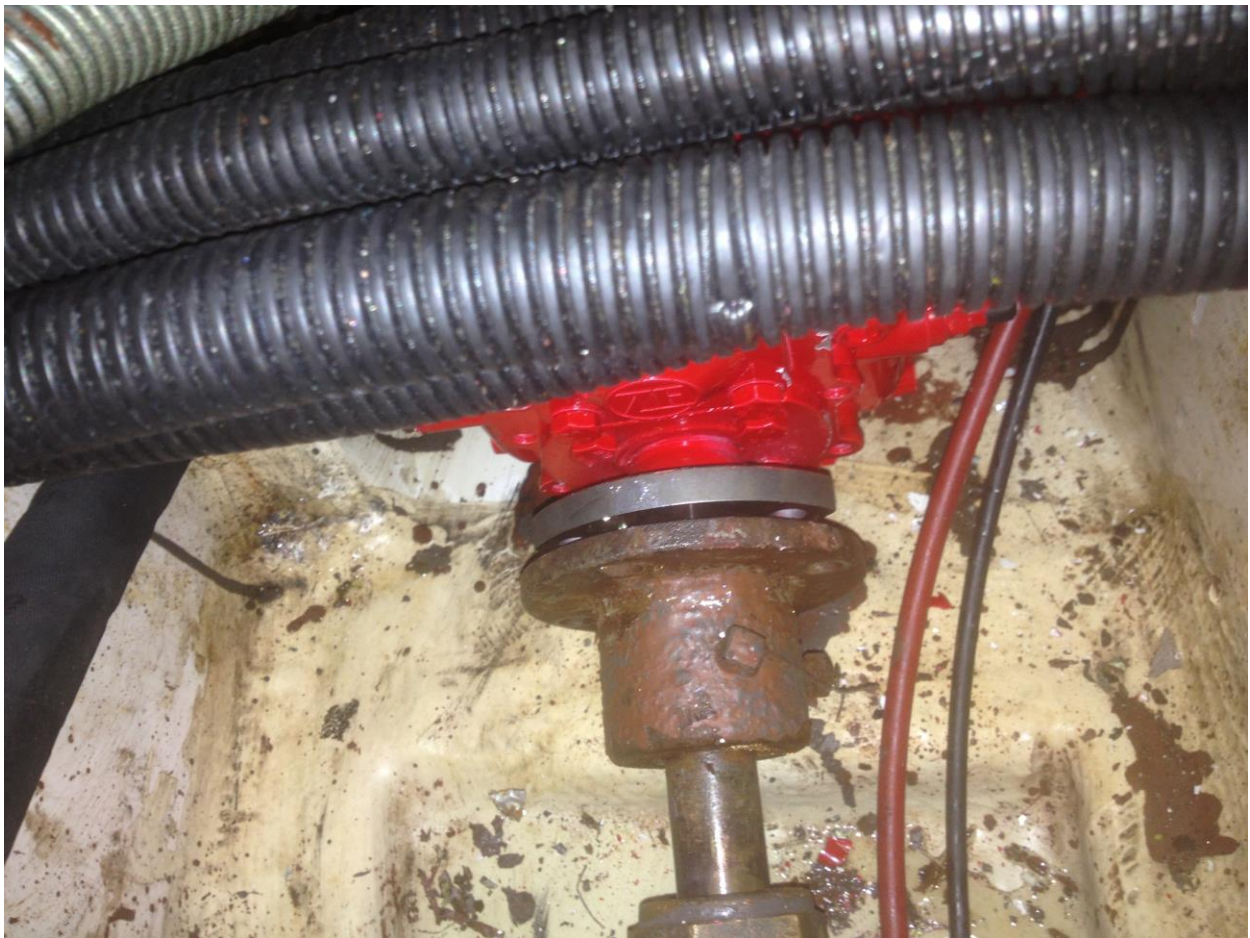
Here is the transmission/shaft coupler before re-attach. It isn't quite adjusted here. The outside edges of the flanges need to be coincident with each other. Horizontal corrections are done by moving the engine laterally on its mounts (not easy) and vertical corrections are done by moving all four leveling screws on the engine mounts (not too difficult). The flange faces need to be parallel to each other. This is done by differential adjustments (twisting the engine and rotating the engine leveling screws). The spec is $<.003$ " difference spacing around the flange face. If the engine mounts are not changed, the process is simpler, involving only the leveling screws.

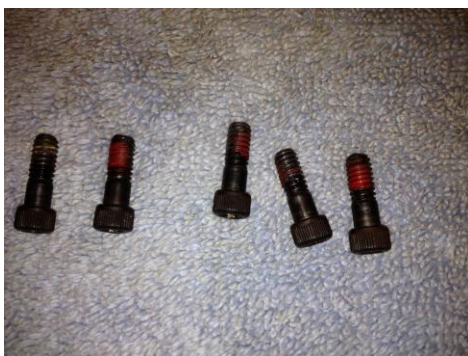
A close second were the $\frac{1}{4}$ " cap screws holding the damper plate. They are held in with Loctite (the red variety, which is high strength) and it takes a lot of torque to break the Loctite. Here are the screws after removal and you can see the Loctite.

Be sure to use the red Loctite on reassembly. You can buy this stuff at Home Depot.

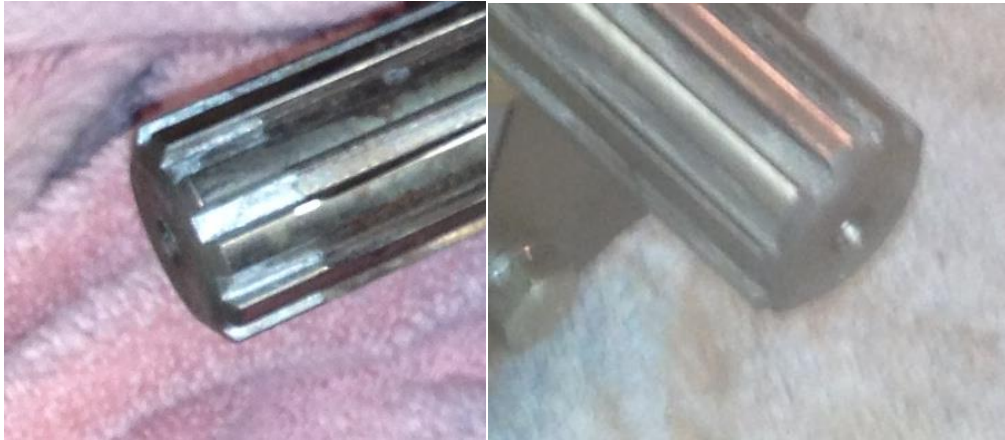
Here is the old and new spline shafts on the transmissions:

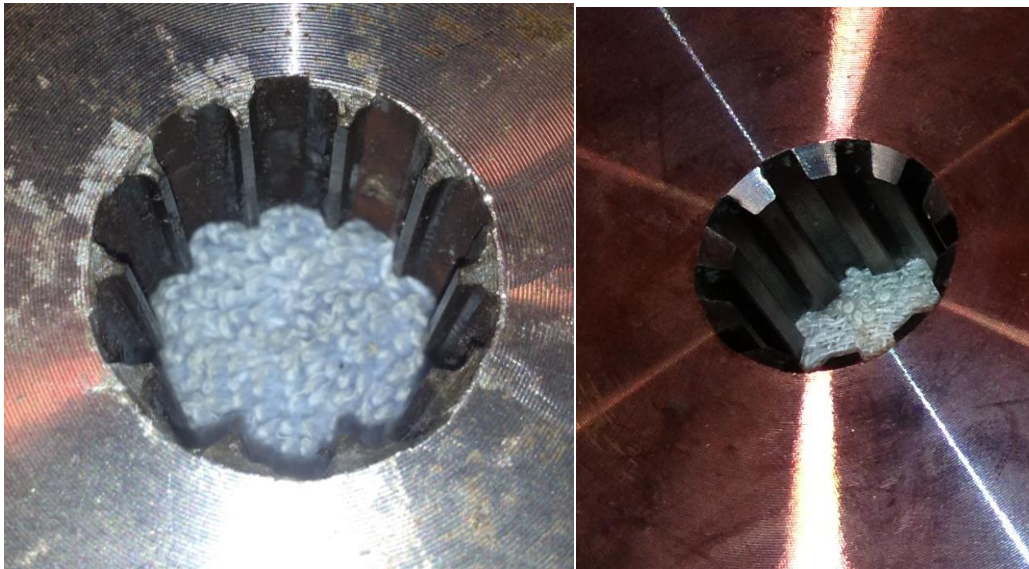
Here are the old and new spline collars on the dampers;

The old spline collar has lost about 70% of its metal. It was all in the bottom of the bell housing as powdered steel.

As you can see there are 10 teeth and ten slots in the spline, so each tooth is $1/20^{\text{th}}$ of a circle or 18 degrees of rotation. The worn spline collar shows at least $\frac{1}{2}$ worn away, which would introduce about 9 degrees of backlash (the transmission should have virtually no backlash). This can be felt as torsional

The wear at the spline interface is caused by a "hammering" or "chatter" motion that they tell me occurs when the engine has no load (idling in neutral). You can see from the wear pattern on the spline collar that the wear is not symmetrical. It is all in the direction of the powered damper hitting on the spline in the counterclockwise direction as viewed from the flywheel end, which is the rotation direction of the Westerbeke crankshaft. This is consistent with the hammering of the spline collar on the tranny with the impulsive motion of the piston firing. With no load on the transmission spline, the spline shaft "bounces" on every impulse, which creates the hammering effect that wears the collar (and the shaft, to a lesser extent). If there is any load on the transmission (i.e. in gear) the shaft won't bounce but will stay in contact on the pressure side (the side that wears). So there won't really be any significant wear under that condition. That's the theory.

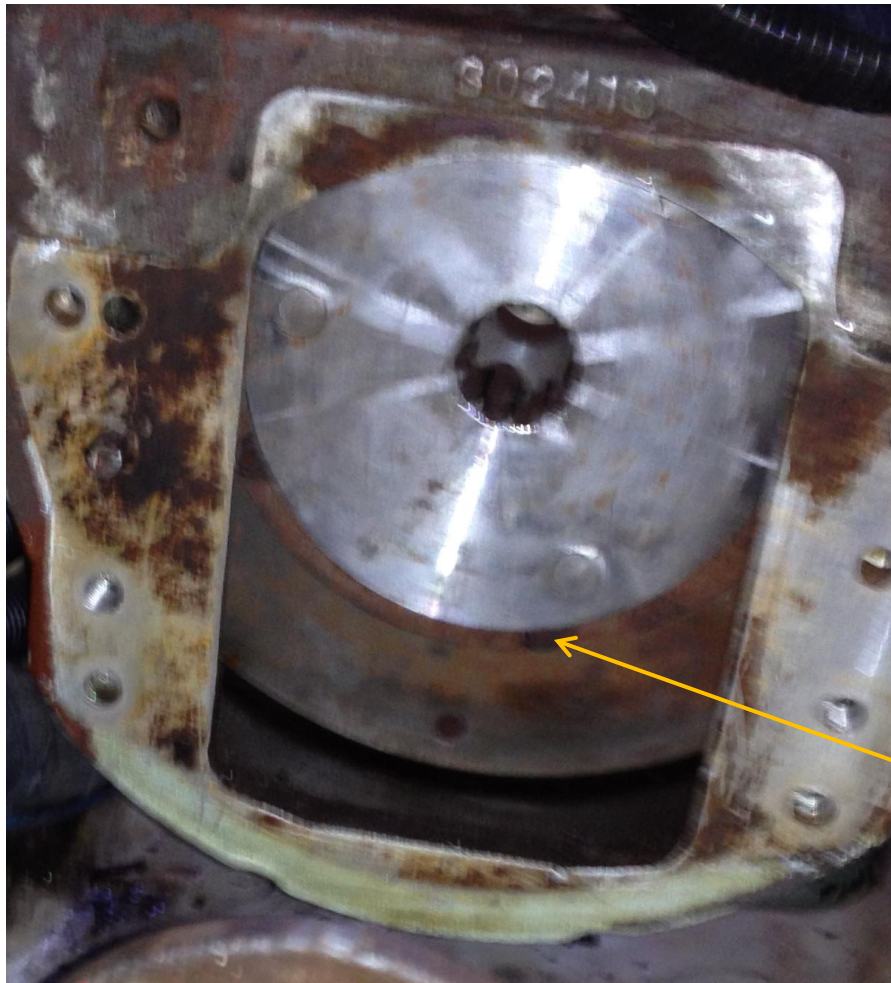
They tell me it is theoretically possible to remove the damper plate without removing the bell housing. The arrow below indicates one of the five cap screws holding the damper plate to the engine flywheel. So I suppose you could remove the cap screw with a 3/16" Allen head and then progressively rotate the crankshaft to get the other cap screws and then maneuver the damper out the opening in the bell housing.

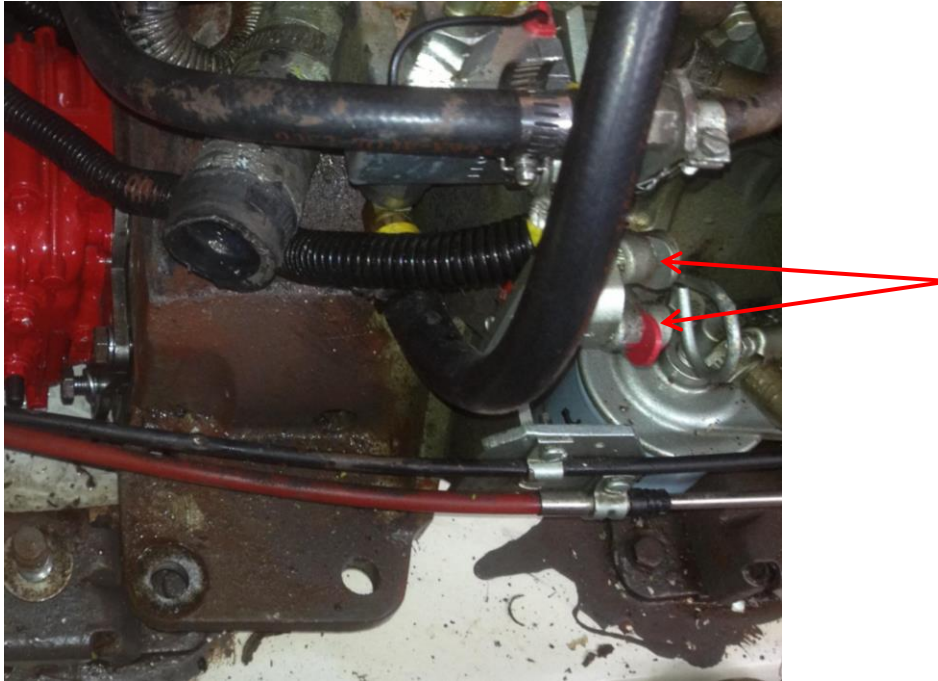
sketches or take pictures. Almost all the wires are just grounds that need to be bolted back to the engine chassis. Two exceptions are the lift pump connection, which is a spade that has 12 v for the lift pump and the small grommet that connects 12 v to the glow plug strip. One thing to be careful of is a circuit breaker that has two 12 v wires that could be hot (maybe not if the battery switch is off but I'm not sure). These wire connections are covered with red plastic boots but are painted over with grey paint and are indicated by the red arrows below.

I recommend peeling off the grey paint to expose the red plastic as a visual warning. Shorting these connection points to ground will make a very large spark in a very dangerous location. I taped them over with electrical tape before removing the mounting plate from the bell. In fact it might not be a bad idea to simply disconnect the battery leads at the batteries before fooling with the electrical connections

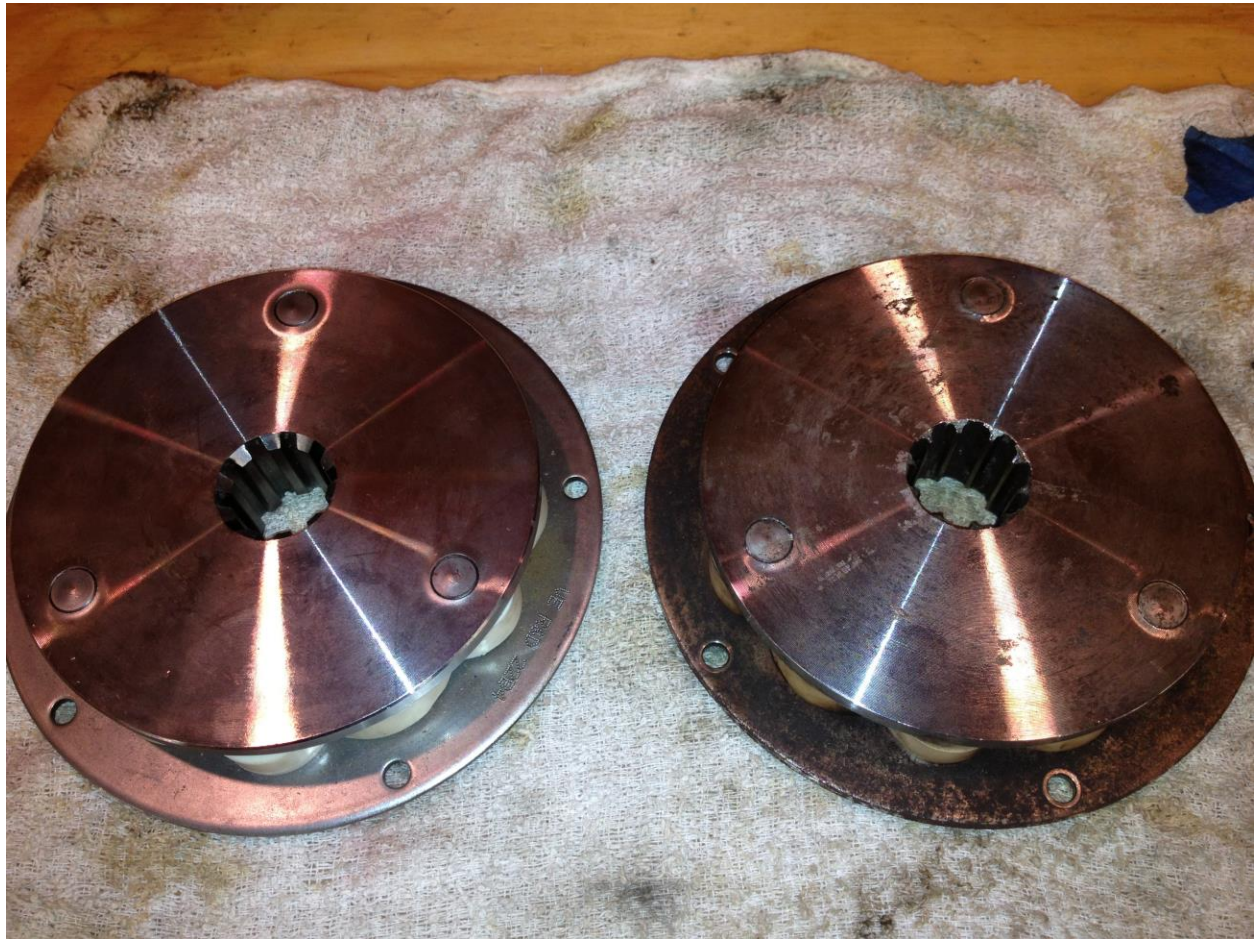
Here is side by side of the new and old damper plate:

Call me crazy, but I went with John the Westerbeke mechanic's recommendation to replace with the identical R&D part. My reasoning went as follows:

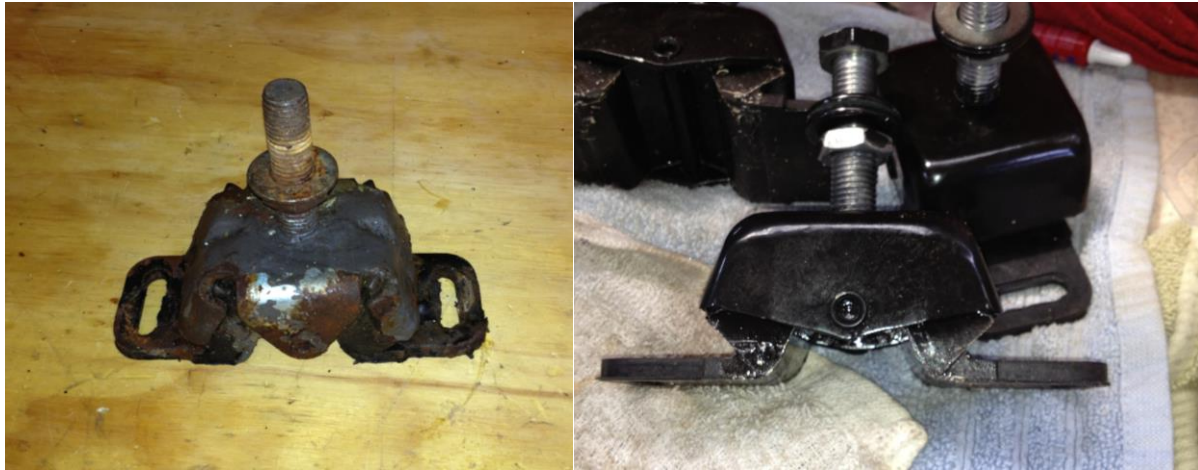
I was advised that as long as I had the engine up I might as well change the engine mounts, so I did. The new design is slightly different. Here is the old and new mounts:

The new ones certainly look better but I'm not sure they were worth the price (\$185.10 ea). I noticed no difference in the 800-900 rpm resonance. I like to think that the old mounts were ready to fail in some way.
