Subject: Speedseal Life - Strange wear problem

I purchased a Speedseal Life from you for my Westerbeke 5.0 BCD generator on 17/11/15 on receipt # 1056. I installed this on my pump and used it for 100 hours this summer season.

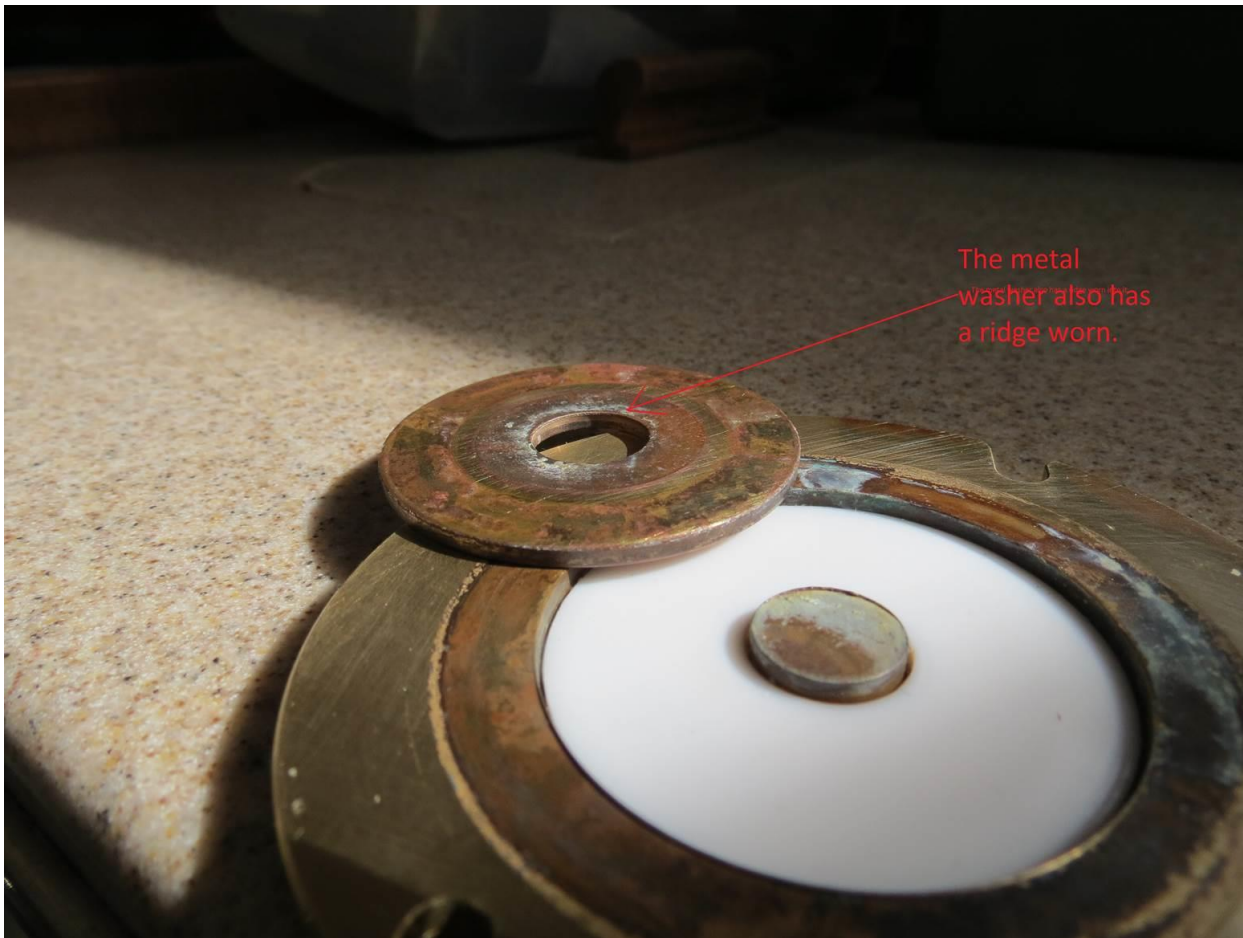
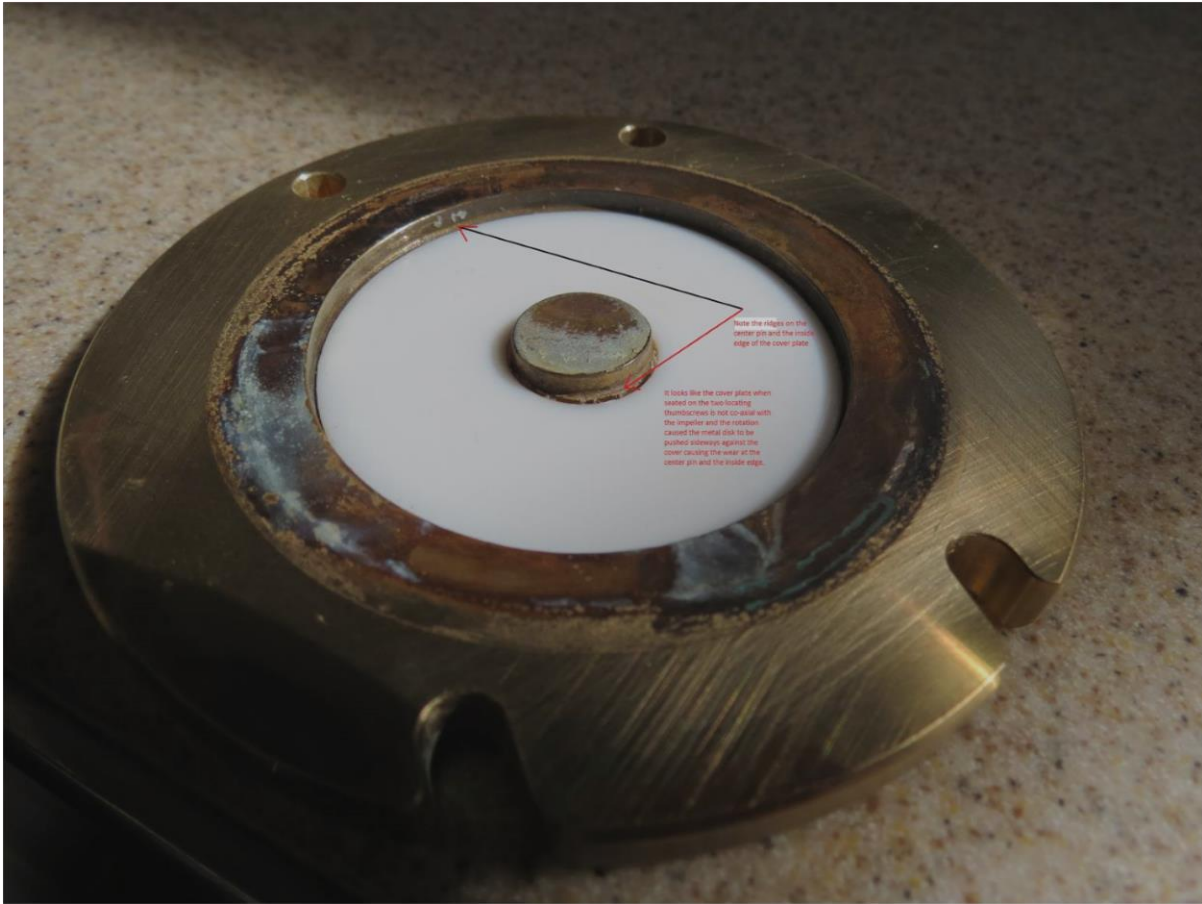
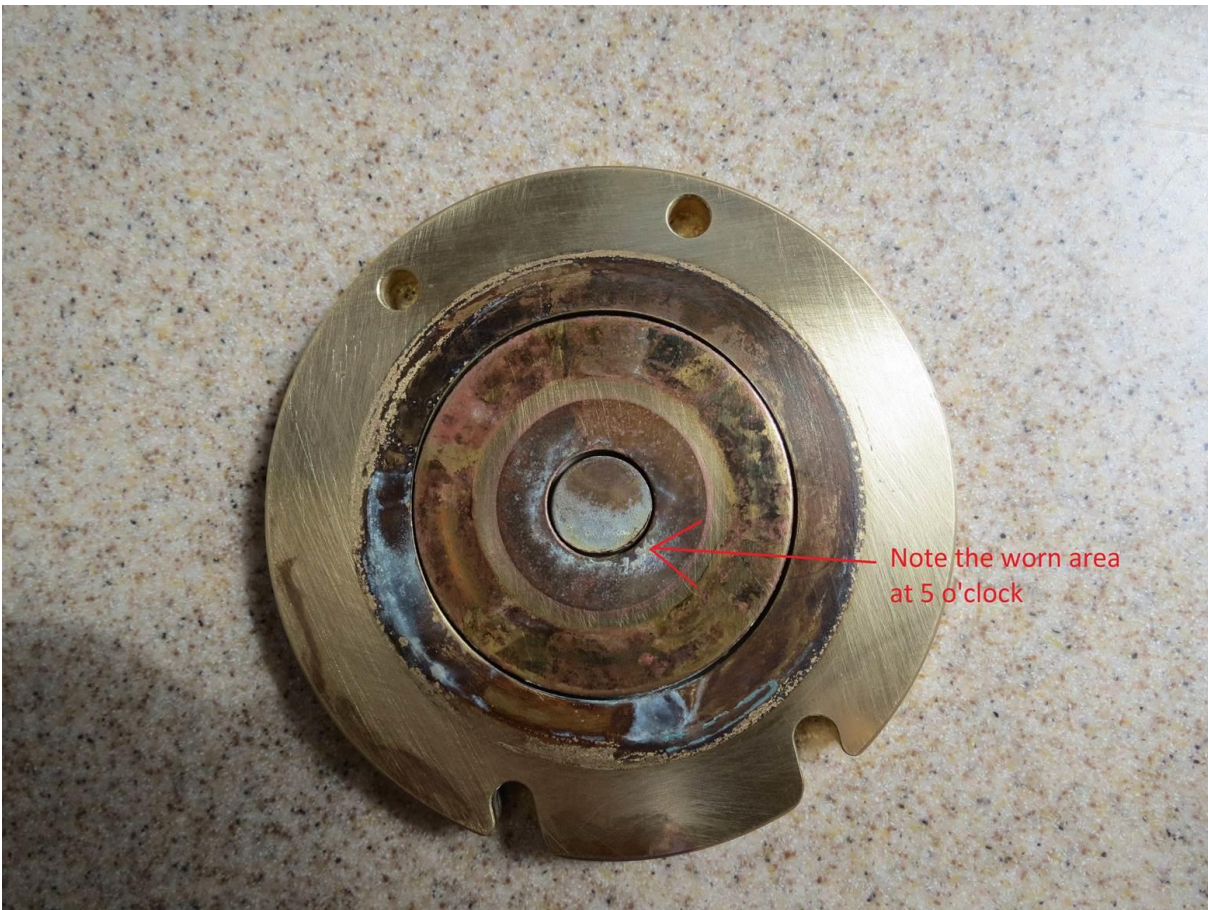
However, I noticed some unusual wear on the cover itself and on the metal disk. See the pictures below. I have placed some annotations on the pictures to explain the wear that I observed.

The characteristic that bothers me is the wear on the cover itself. I would not expect that the cover would wear in addition to the metal disk.

It appears that when the cover is slid onto the two thumbscrews at the slots, the **cover is not co-axial with the impeller** and as the impeller rotates, it causes a lateral movement of the metal disk and results in the wear shown above on both the disk and the cover plate.

Your installation instructions don't say to do any kind of alignment of the outside of the plate with the pump flange, but close examination of the pump with your cover does indicate that the depth of the slots allow the cover to rest too far onto the fixed locating screws.

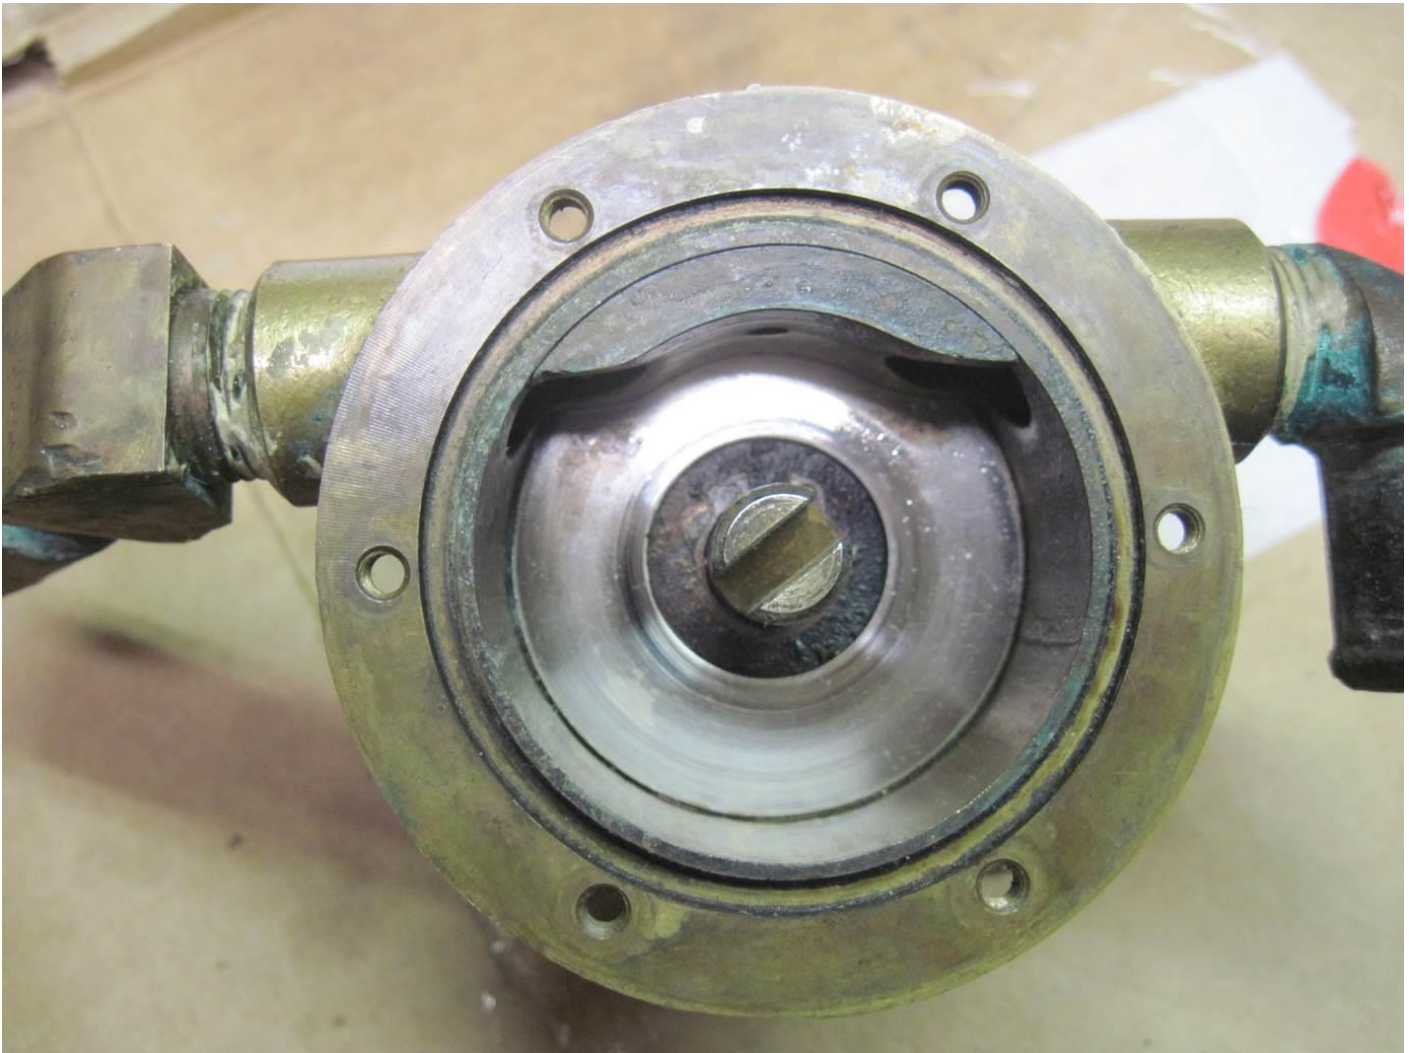
This first picture shows a straight-on view of the pump cavity.

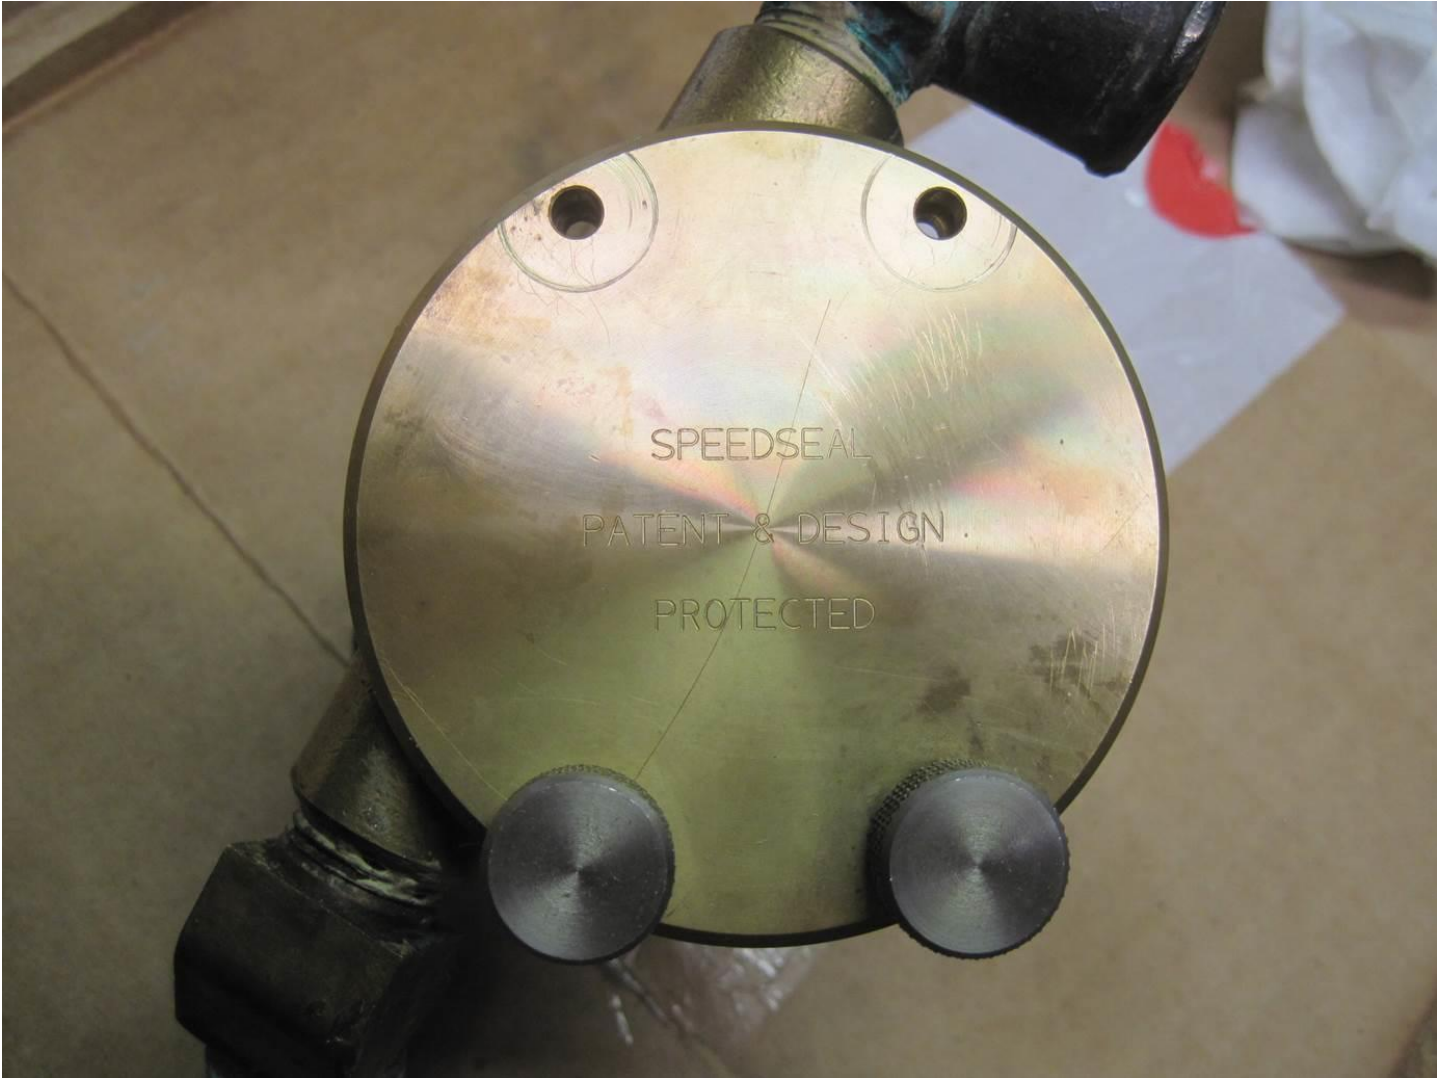
This picture shows the two thumb screws installed with the cover plate dropped in place and resting on the edges of the screw threads.

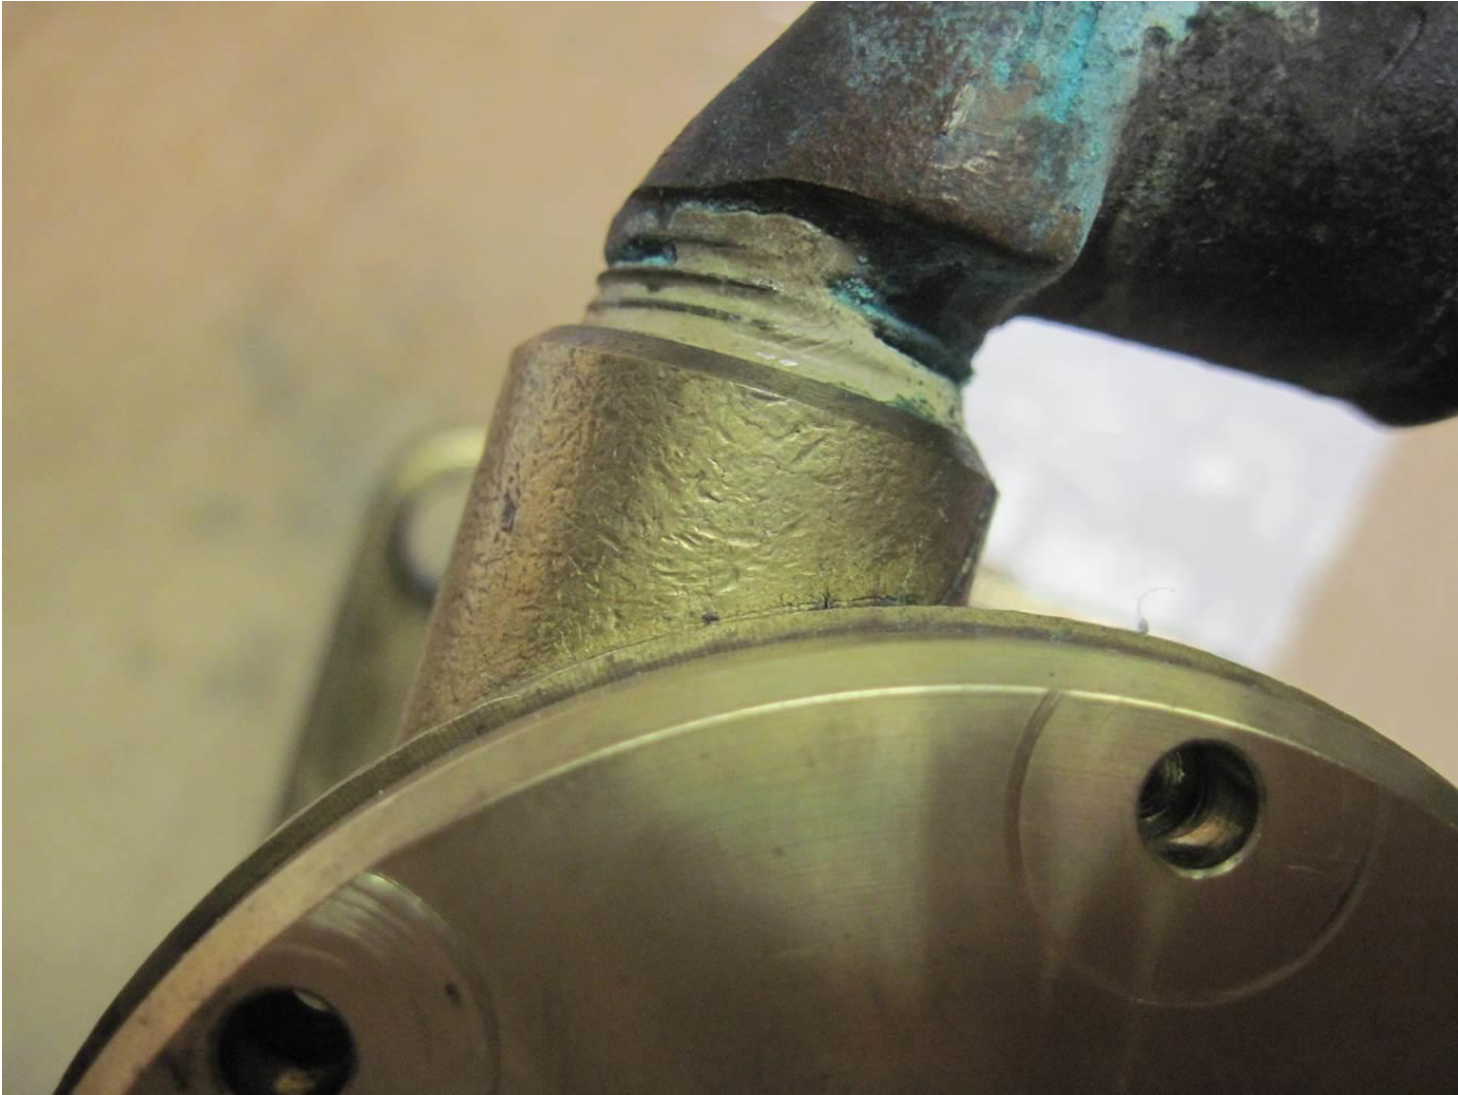
This picture shows the spacing of the cover edge to the pump body edge at the hole side of the plate.

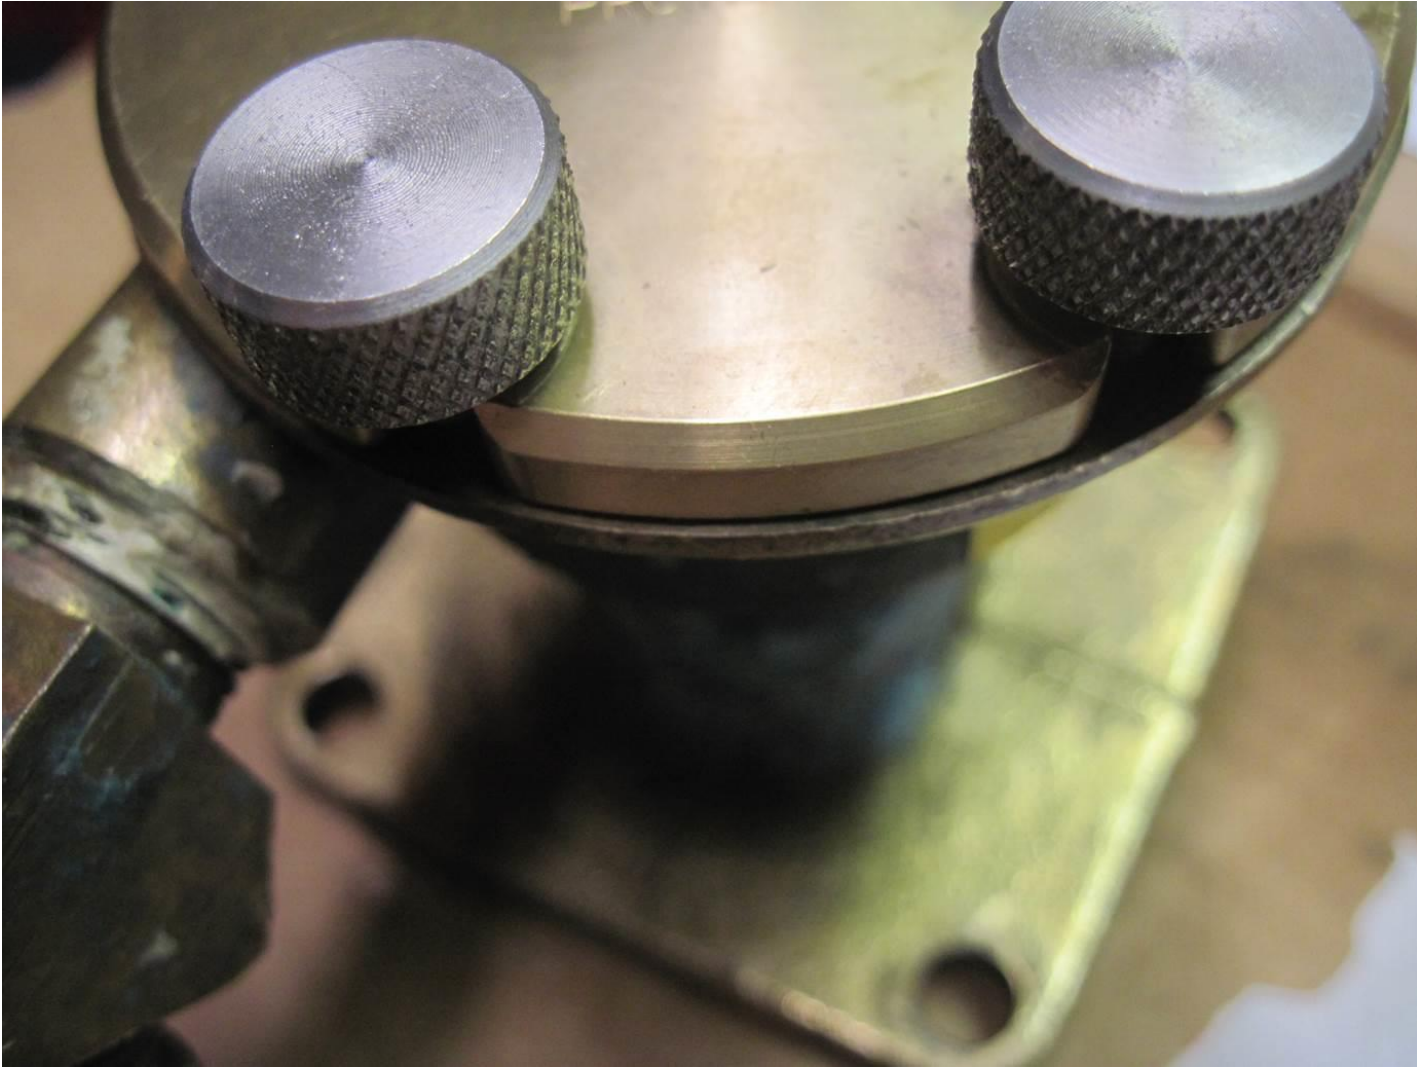
This picture shows the spacing of the cover edge to the pump body edge at the slotted side of the plate. Note that it is less than at the hole side.

I think that this is compelling evidence that the plate is off-center or not co-axial with the impeller when it uses the screws at the slot to locate itself. I believe that this mis-alignment is the cause of the wear to the side of the cover and the outer and inner edges of the metal washer as the impeller pushes the washer to one side as it rotates.

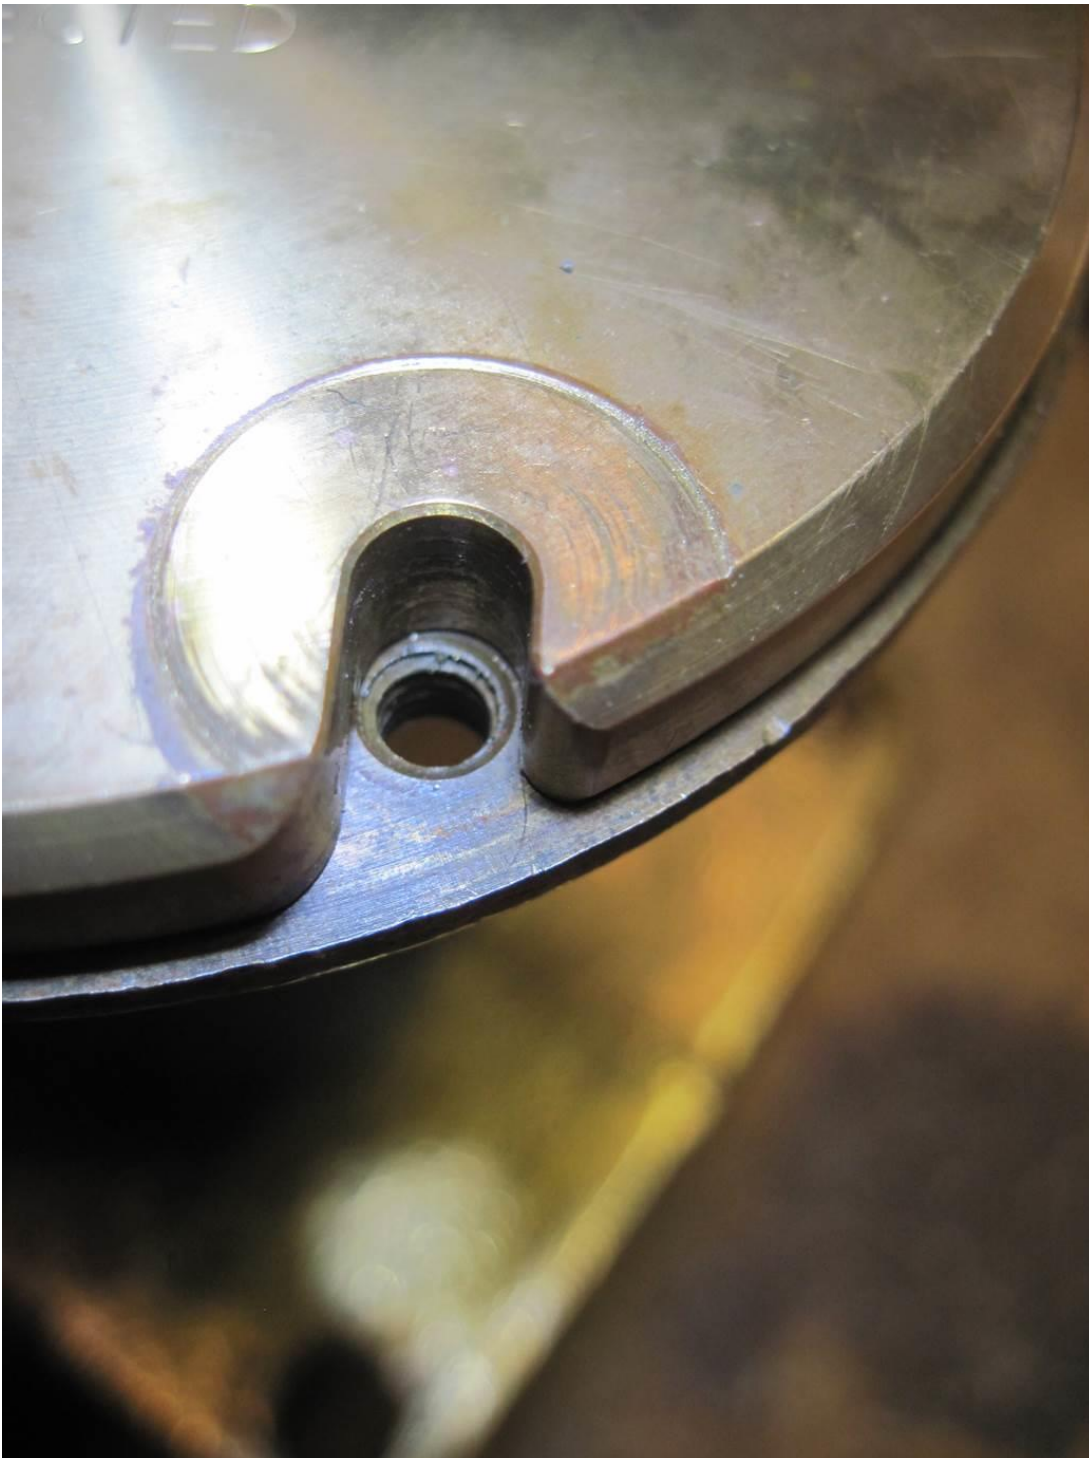
I now removed the screws at the slots, and centered the cover plate on the pump body with my fingers. The clearance of the plate to the pump body is now equal around the entire diameter. This photograph shows the distance that the plate would move to come up against the edge of the threads of the thumbscrews. This equated to the uneven spacing of the outside edge of the plate with respect to the pump body as seen in the above photos.

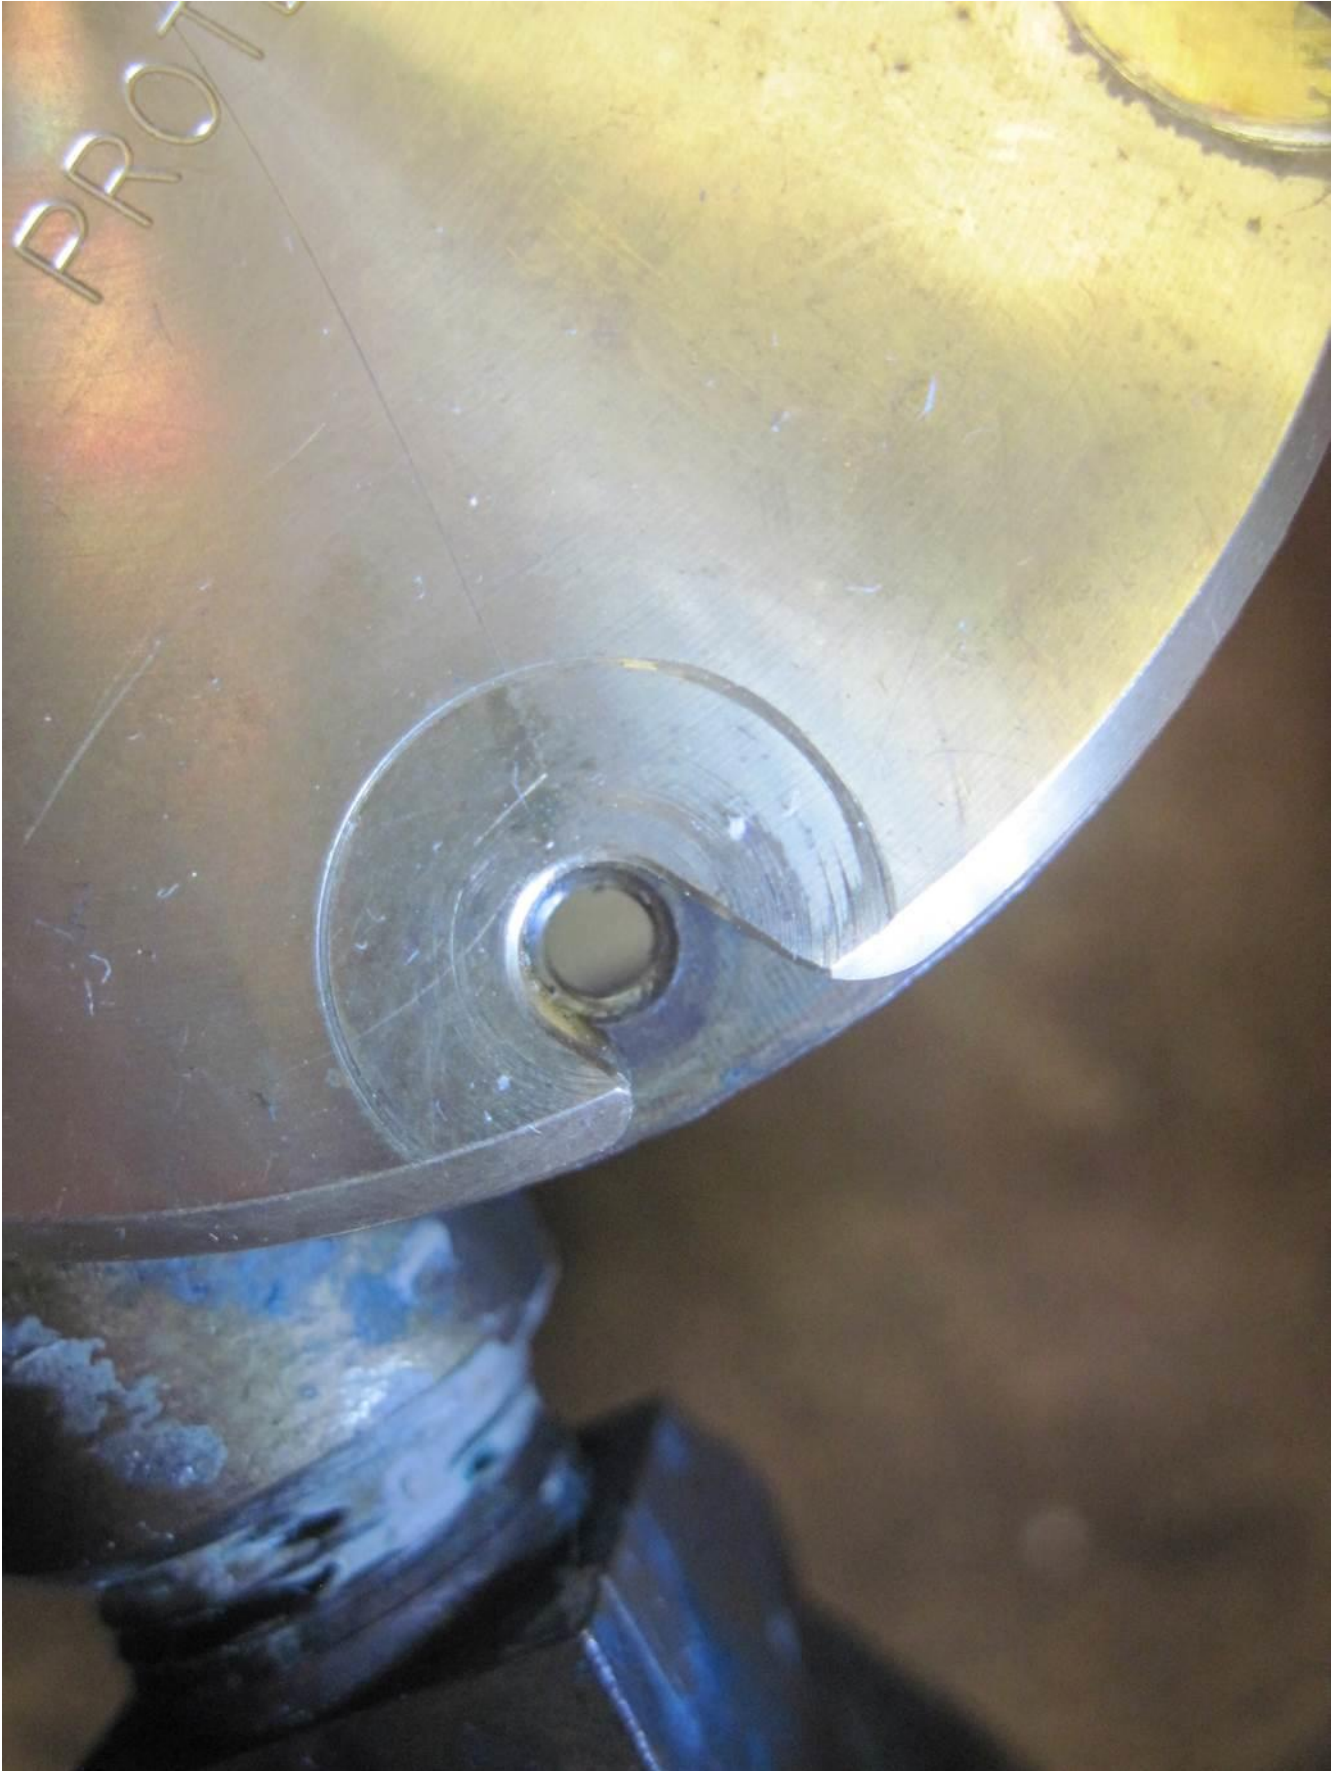
Here is a shot of the other slot, again showing that the plate would move closer to the screws when simply dropped in place.

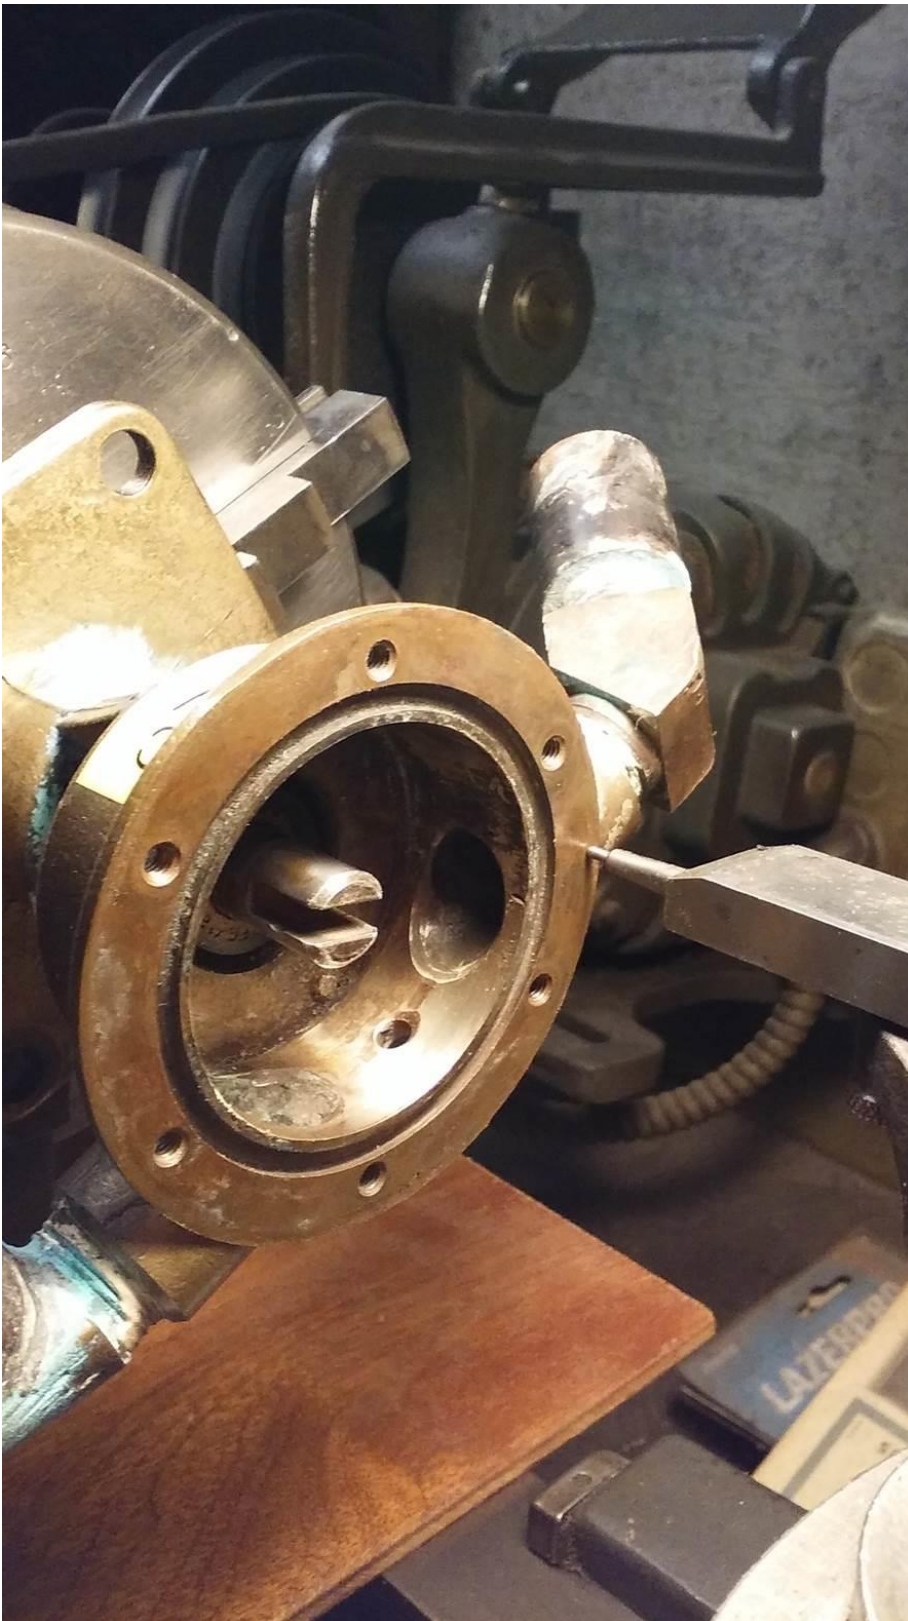
First we measured to be sure that the pump was perfectly centered. We did this by checking the flat surface of the flange where the cover plate attaches. Using an indicator we rotated the pump and checked that the flange was in a perfect vertical plane- that is that measurements at 3, 6, 9 and 12 o'clock were all the same. The pump body was tapped into alignment so that the measurements were all within 0.002" of each other.

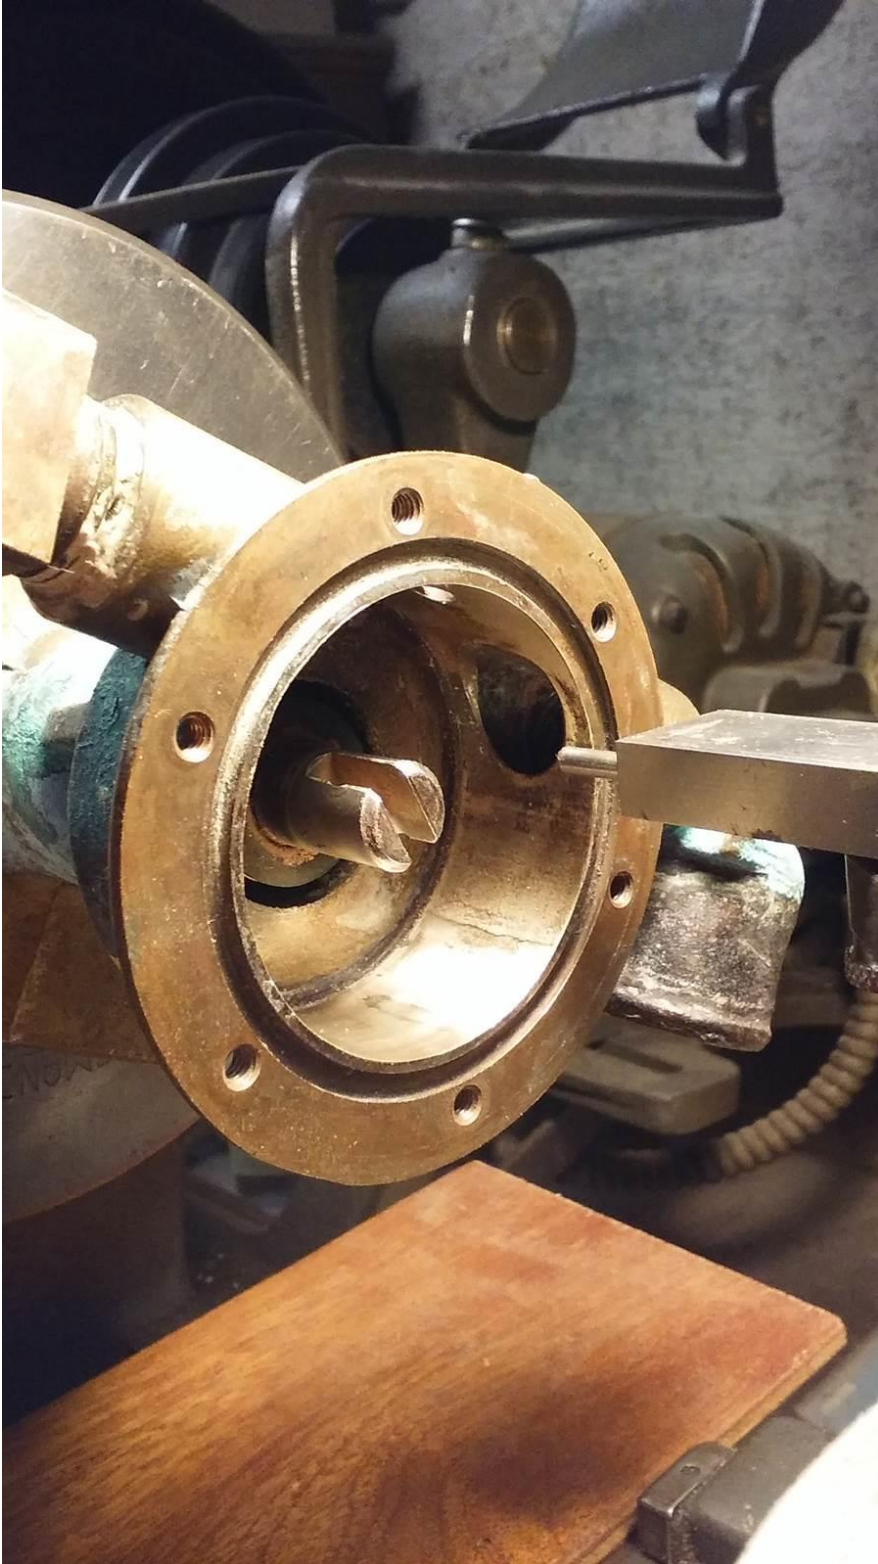
The next step was to measure the roundness of the pump cavity. We moved the indicator to measure the inside surface of the pump cavity and rotated the pump as we watched the indicator. We positioned the indicator about $\frac{1}{4}$ " into the cavity. From the arbitrary "zero" position on the indicator, we observed readings from -0.001 to +0.002. These measurements prove that the cavity of the pump is round to within ± 0.0015 .

These more precise measurements agree with the quick measurements that I made last week with my vernier caliper. So in the case of this pump, the cavity is not worn by the impeller as you suggested could be the case.
