DRIVE MOTOR

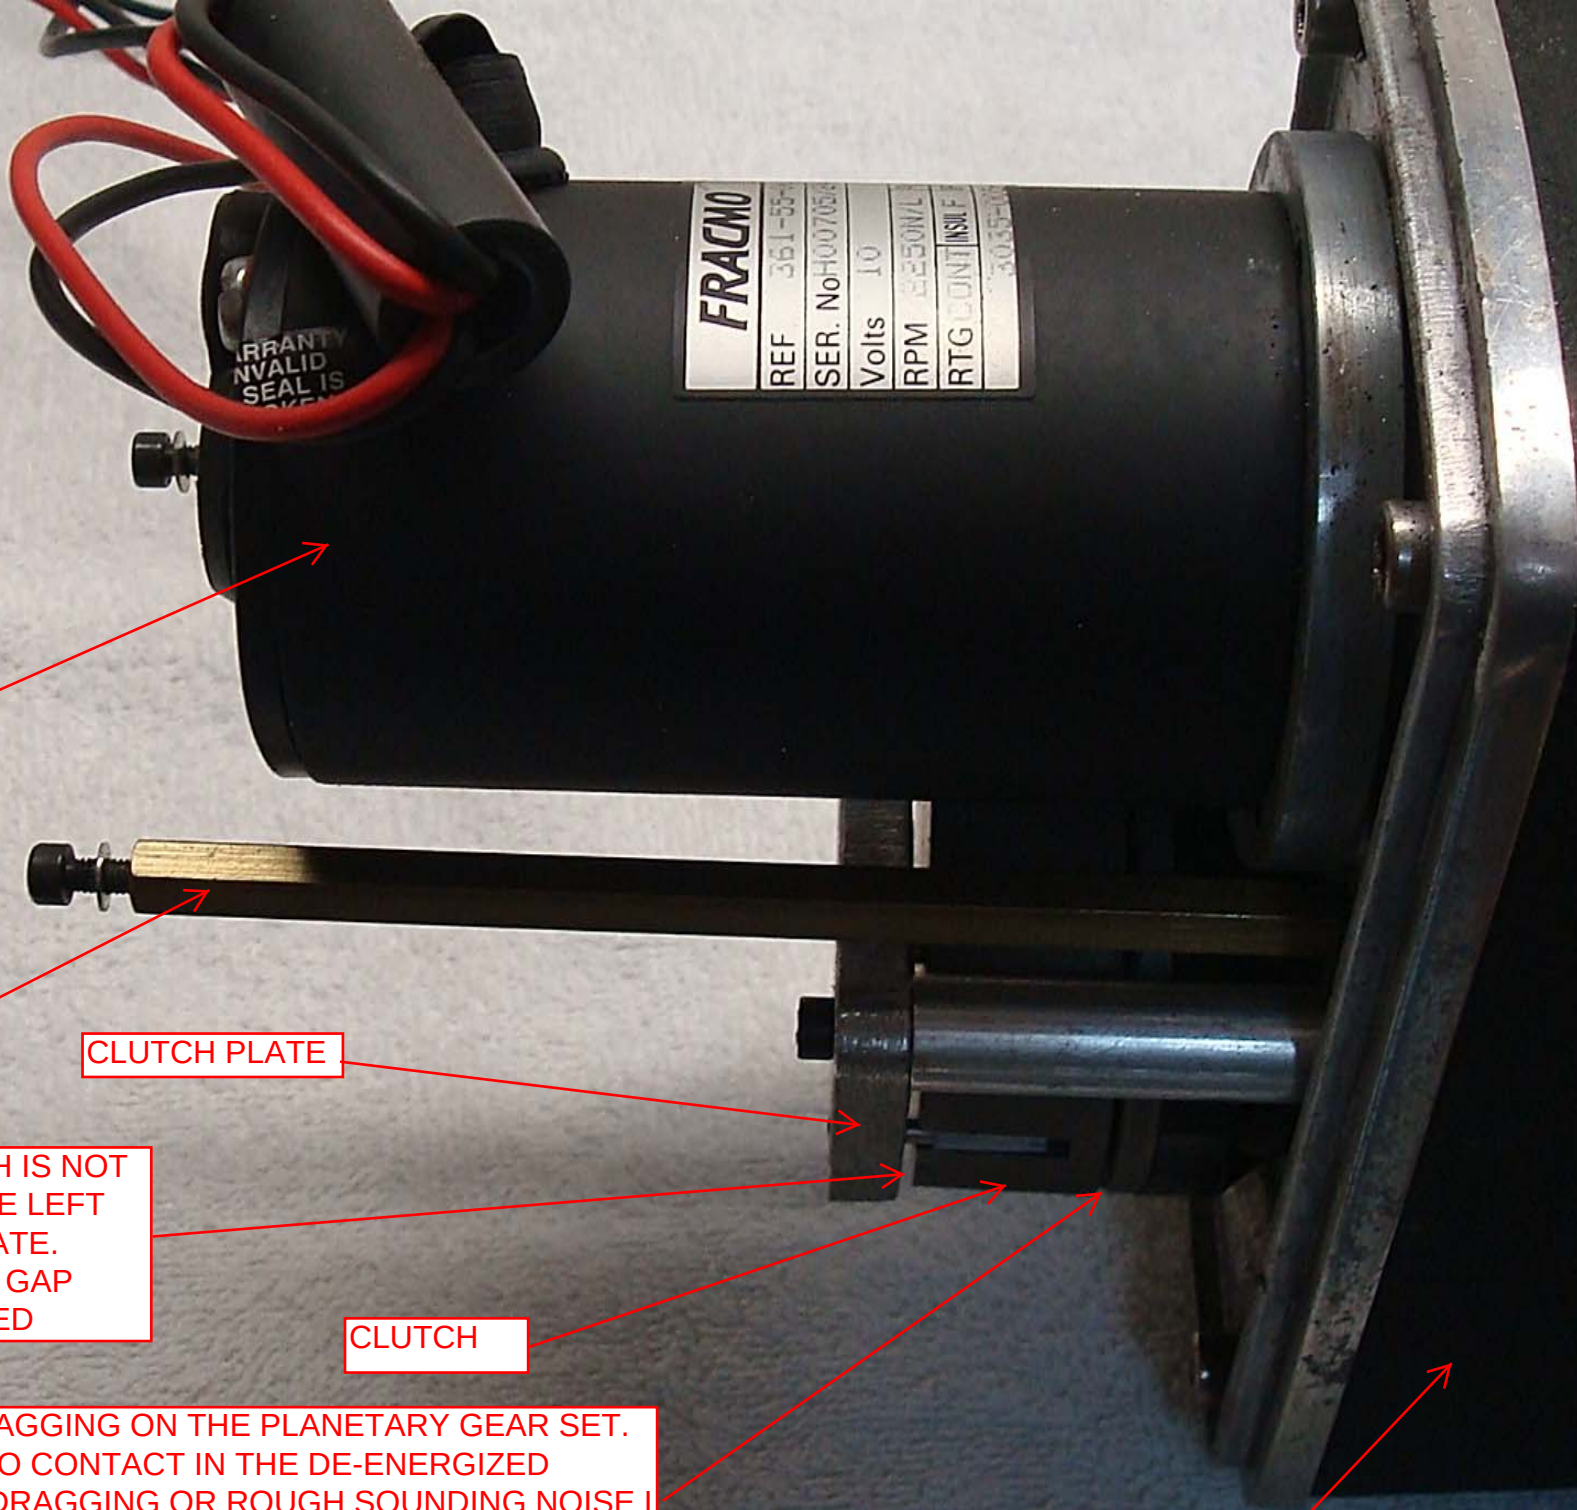
NOTICE THAT THE CLUTCH IS NOT FULLY RETRACTED TO THE LEFT AGAINST THE CLUTCH PLATE. THERE SHOULD NOT BE A GAP HERE WHEN DE-ENERGIZED

NOTE, CLUTCH IS DRAGGING ON THE PLANETARY GEAR SET. THERE SHOULD BE NO CONTACT IN THE DE-ENERGIZED STATE. THIS IS THE DRAGGING OR ROUGH SOUNDING NOISE I HEARD WHEN I INITIALLY ROTATED THE OUTPUT SHAFT THINKING IT WAS WORN OR DAMAGED BRUSHES.

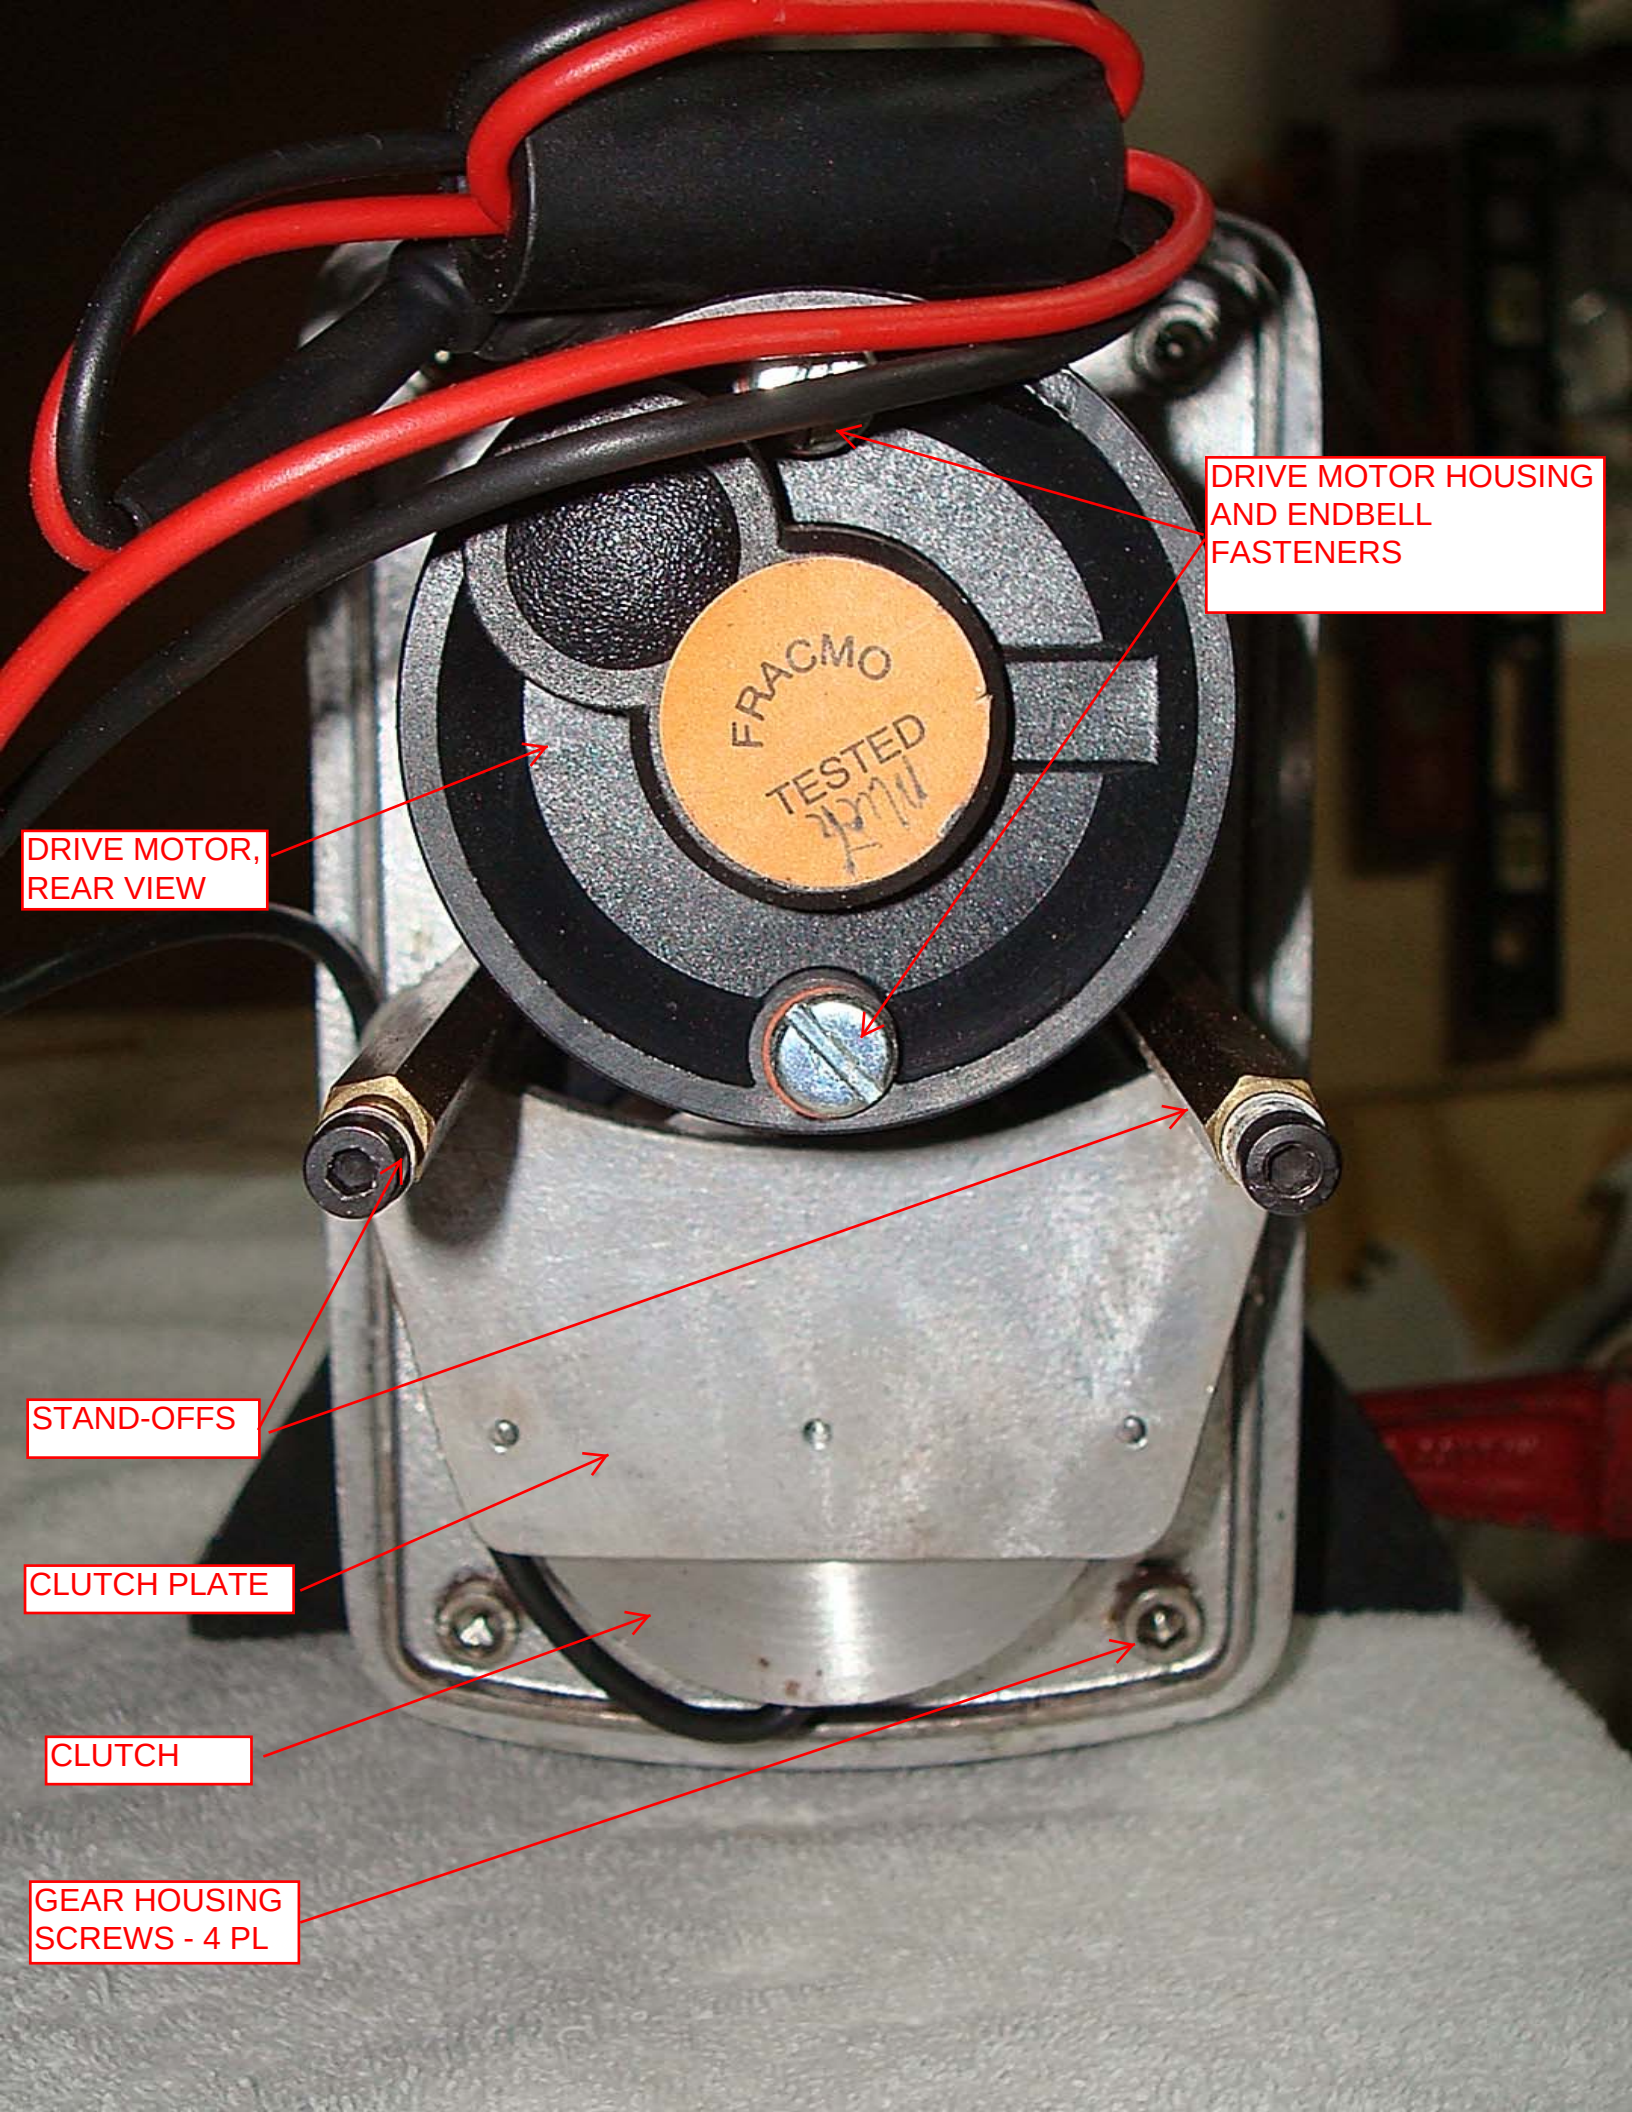
DRIVE MOTOR HOUSING  
AND ENDBELL  
FASTENERS

GEAR HOUSING  
SCREWS - 4 PL

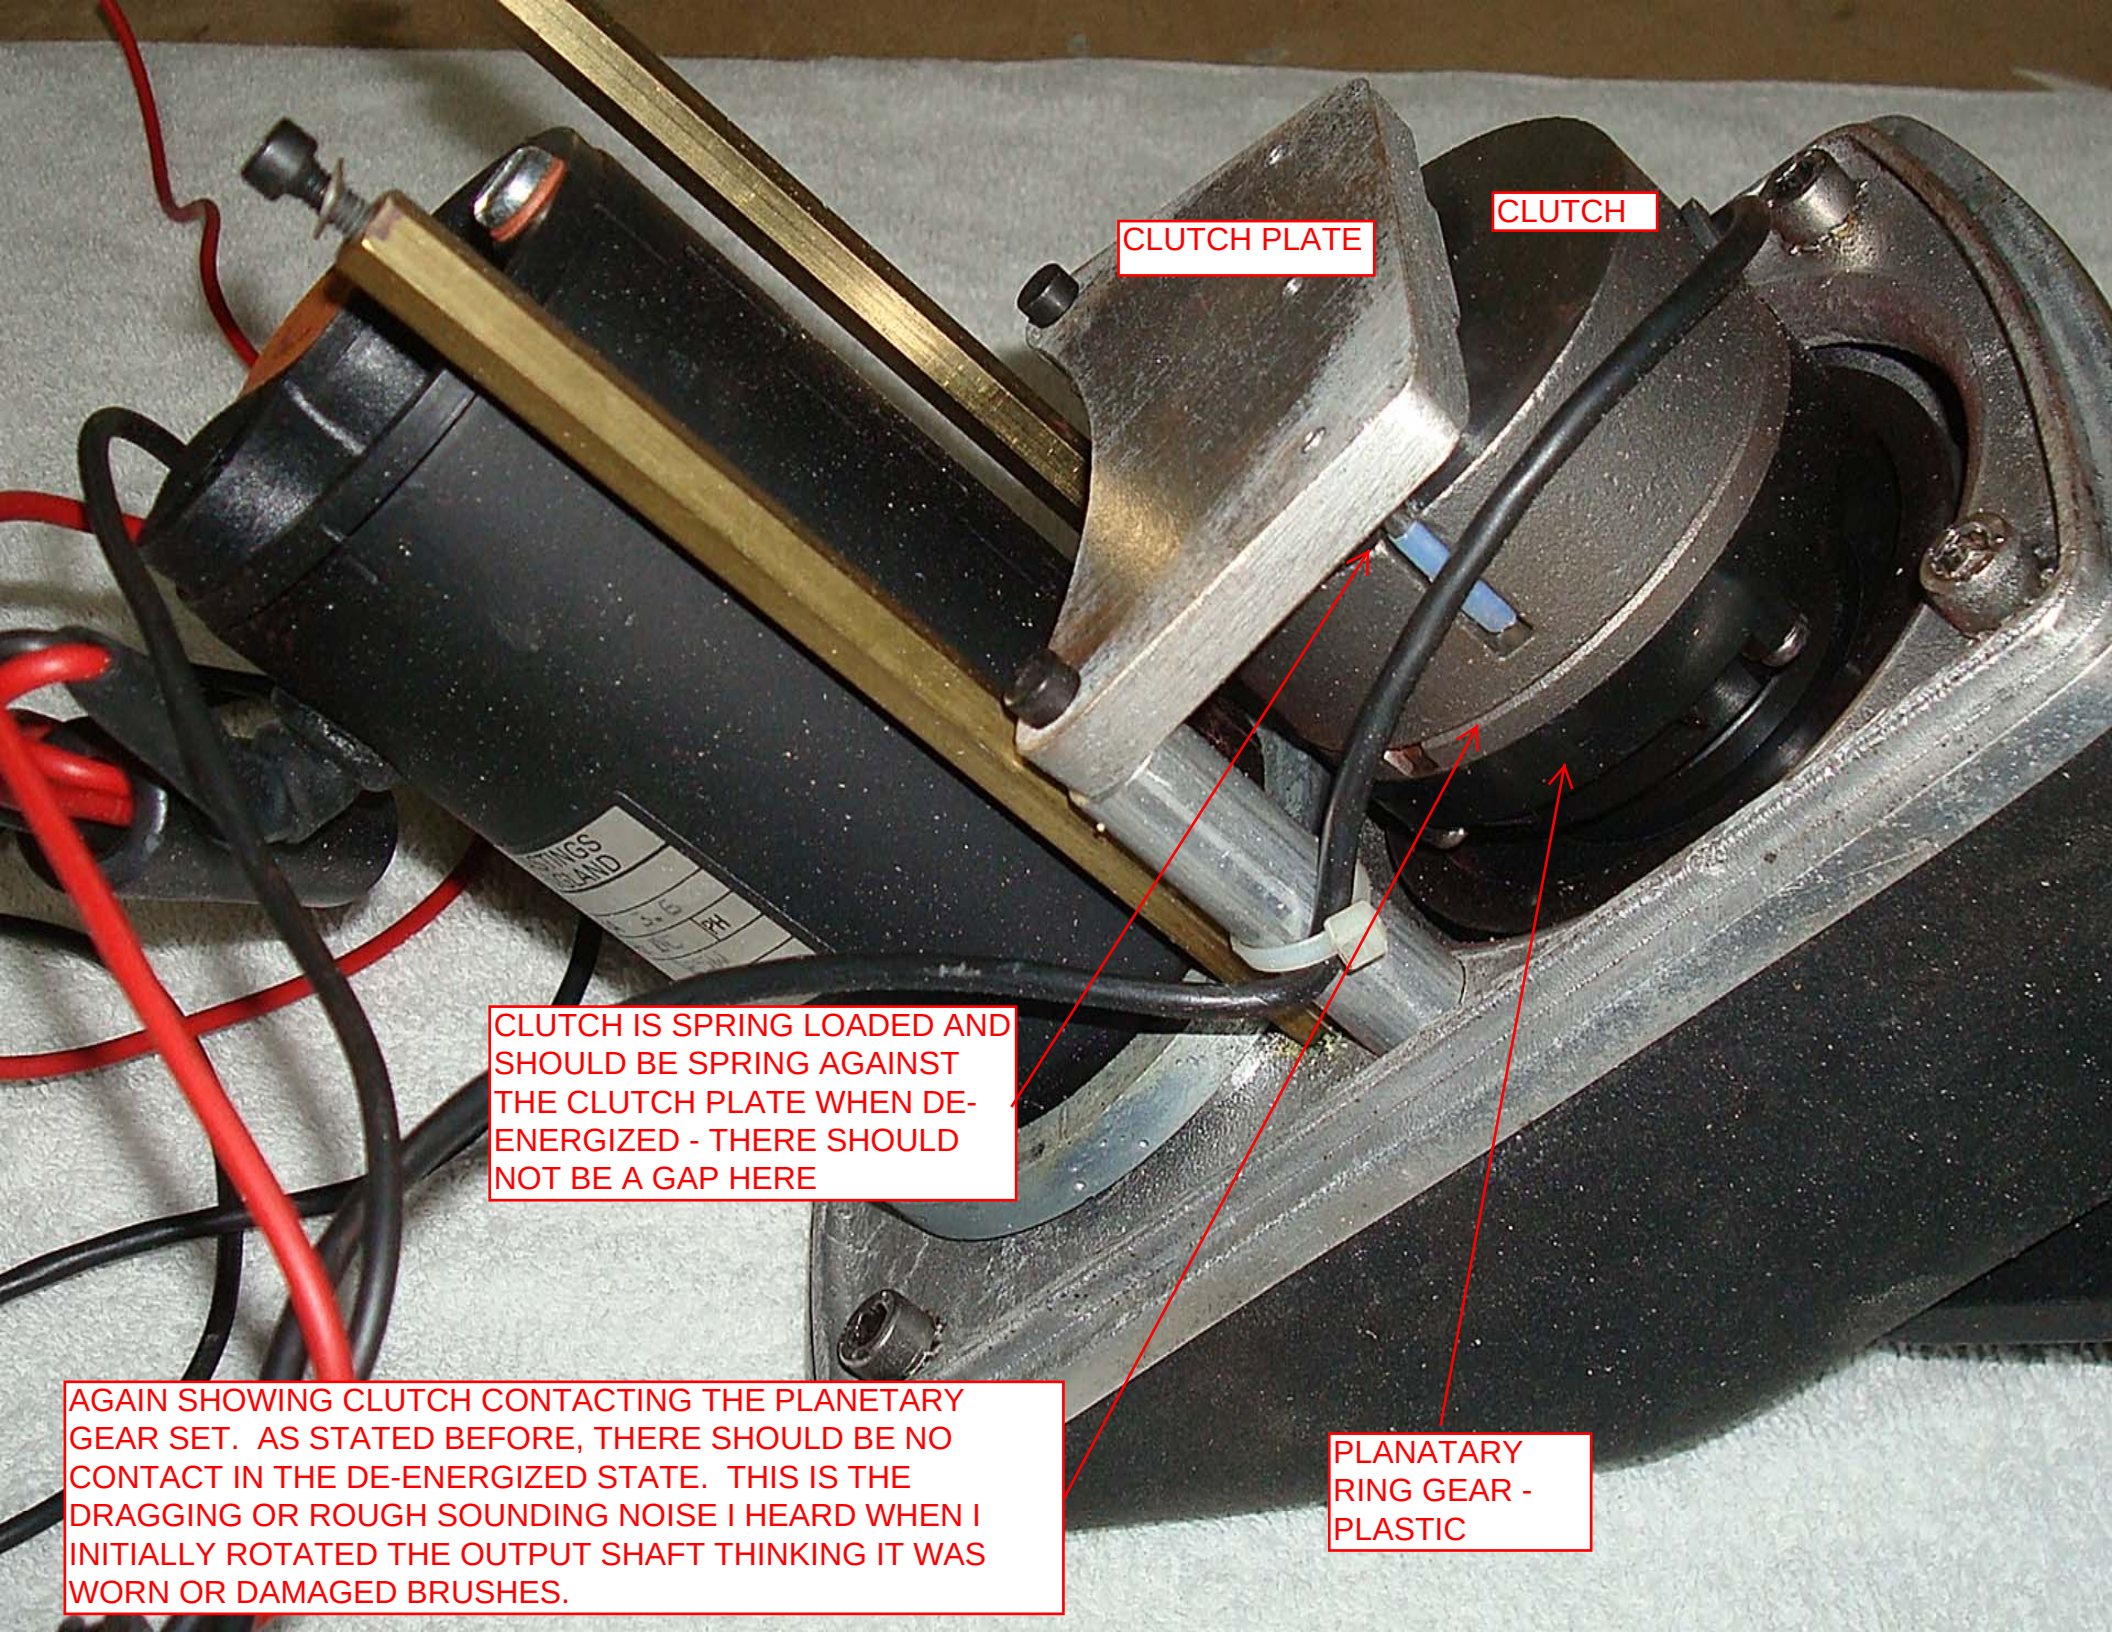
CLUTCH IS SPRING LOADED AND SHOULD BE SPRING AGAINST THE CLUTCH PLATE WHEN DE-ENERGIZED - THERE SHOULD NOT BE A GAP HERE

AGAIN SHOWING CLUTCH CONTACTING THE PLANETARY GEAR SET. AS STATED BEFORE, THERE SHOULD BE NO CONTACT IN THE DE-ENERGIZED STATE. THIS IS THE DRAGGING OR ROUGH SOUNDING NOISE I HEARD WHEN I INITIALLY ROTATED THE OUTPUT SHAFT THINKING IT WAS WORN OR DAMAGED BRUSHES.

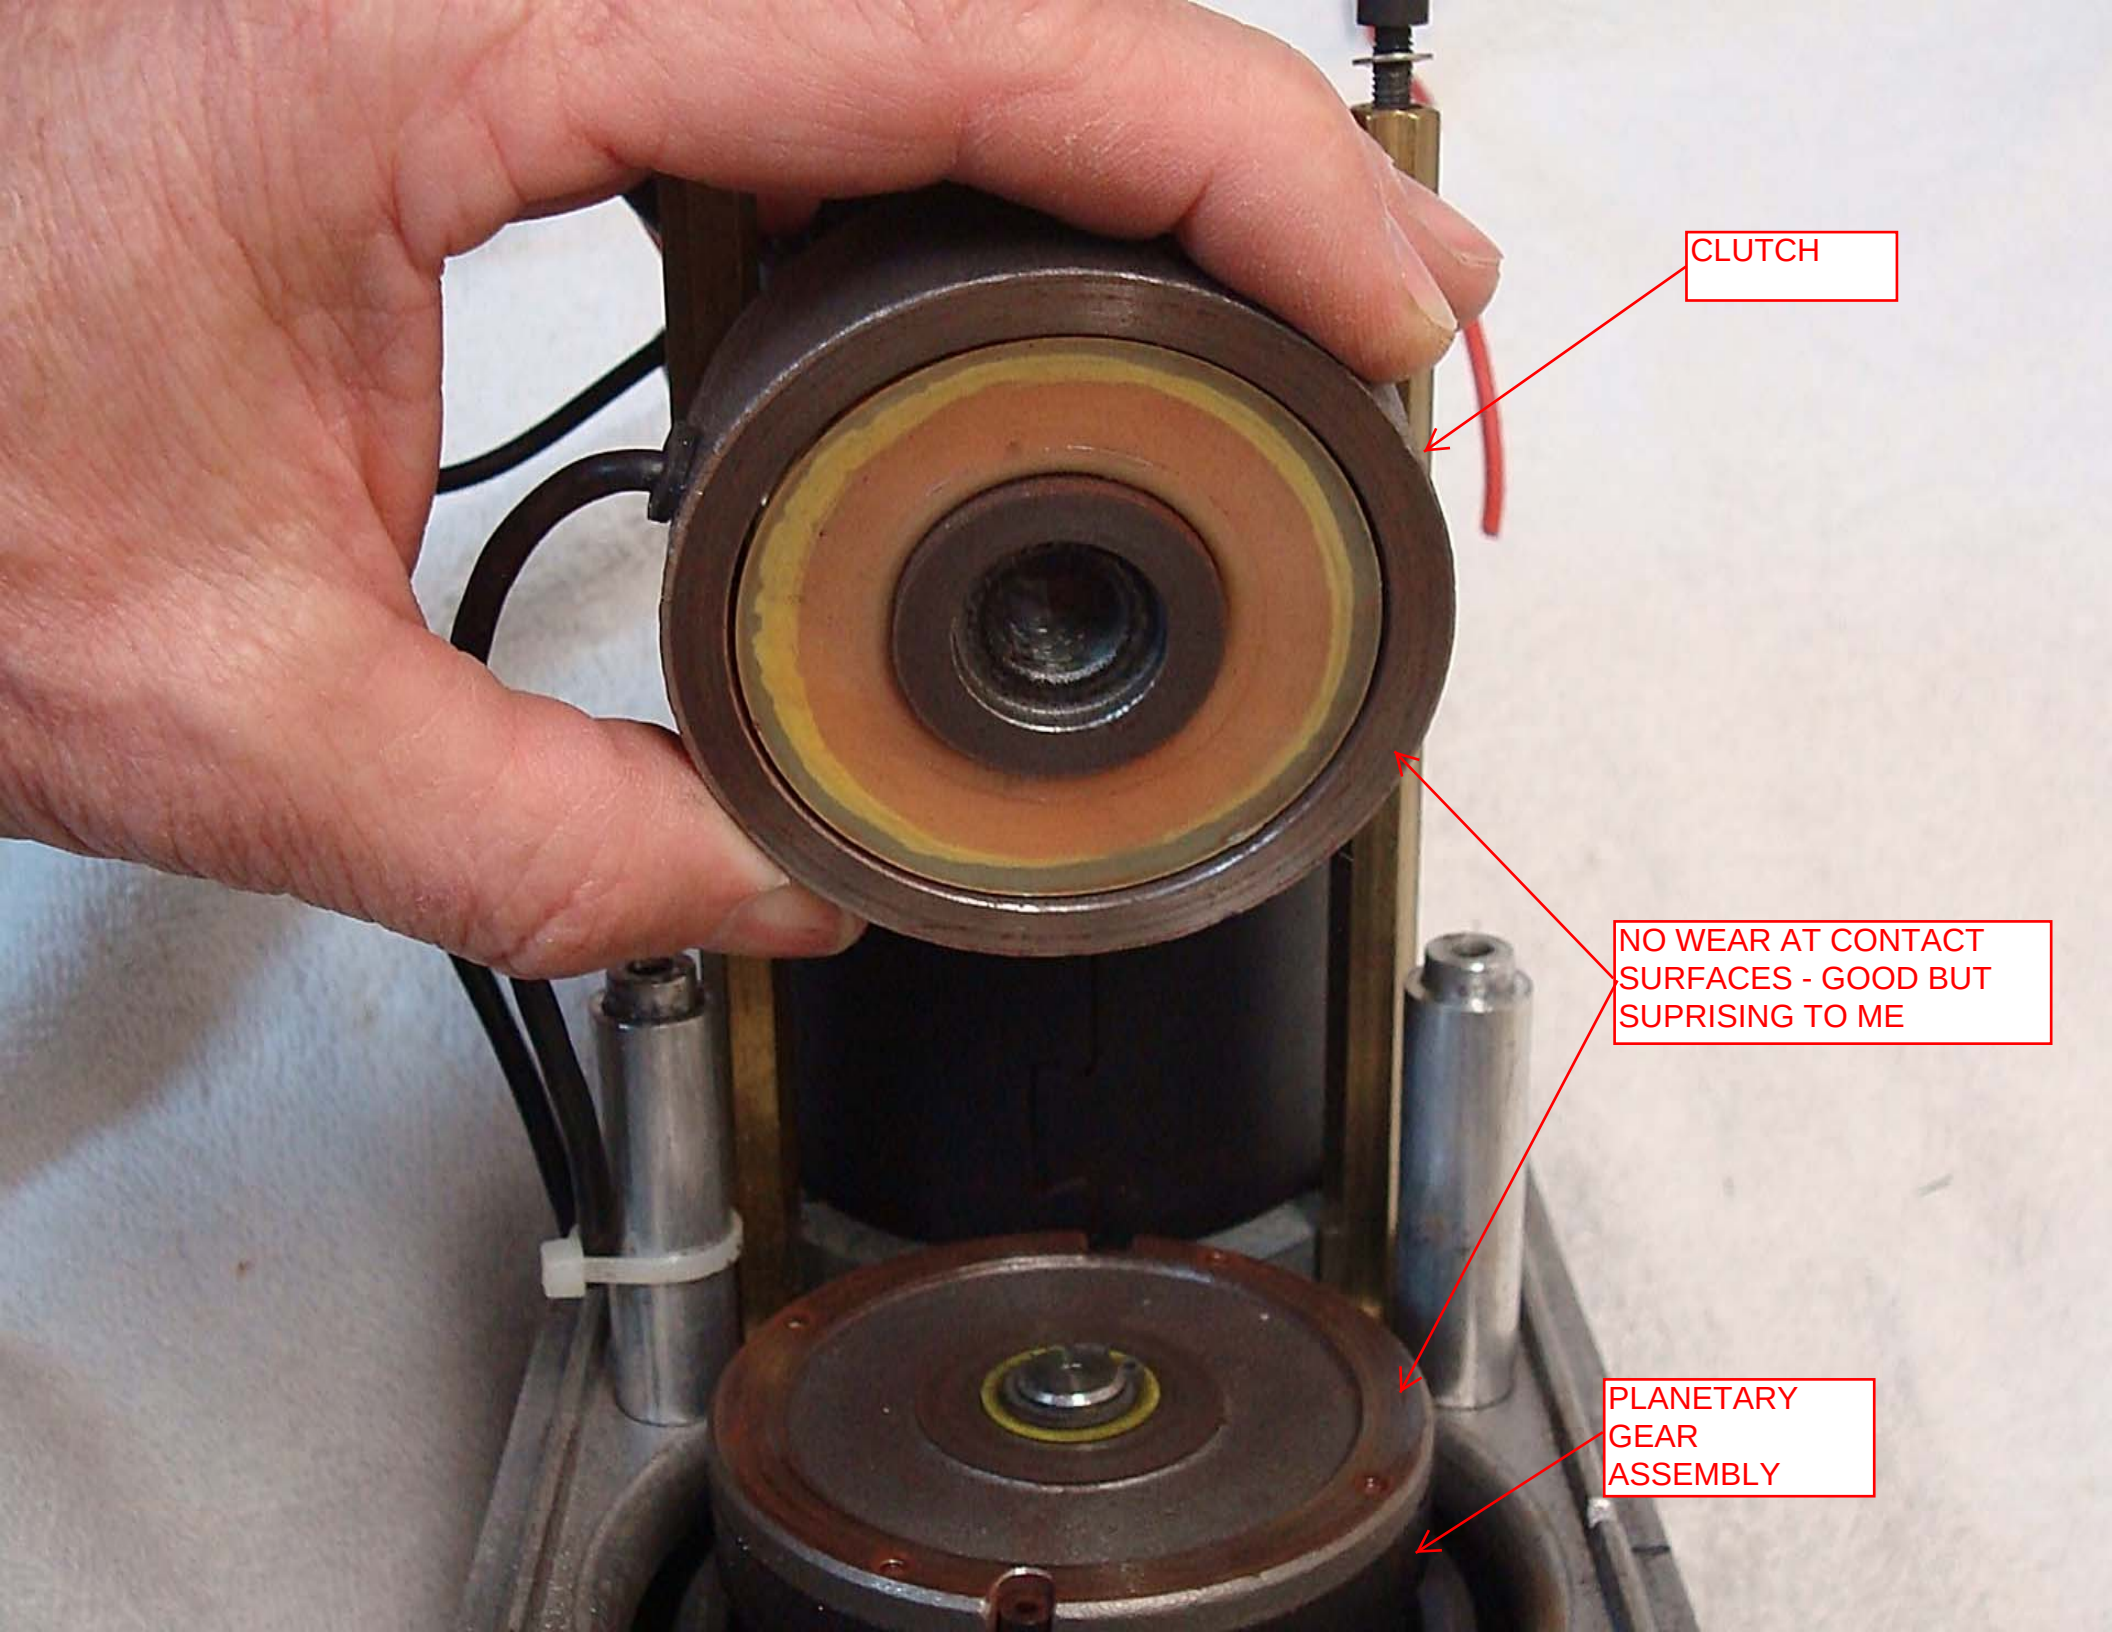
NO WEAR AT CONTACT  
SURFACES - GOOD BUT  
SUPRISING TO ME

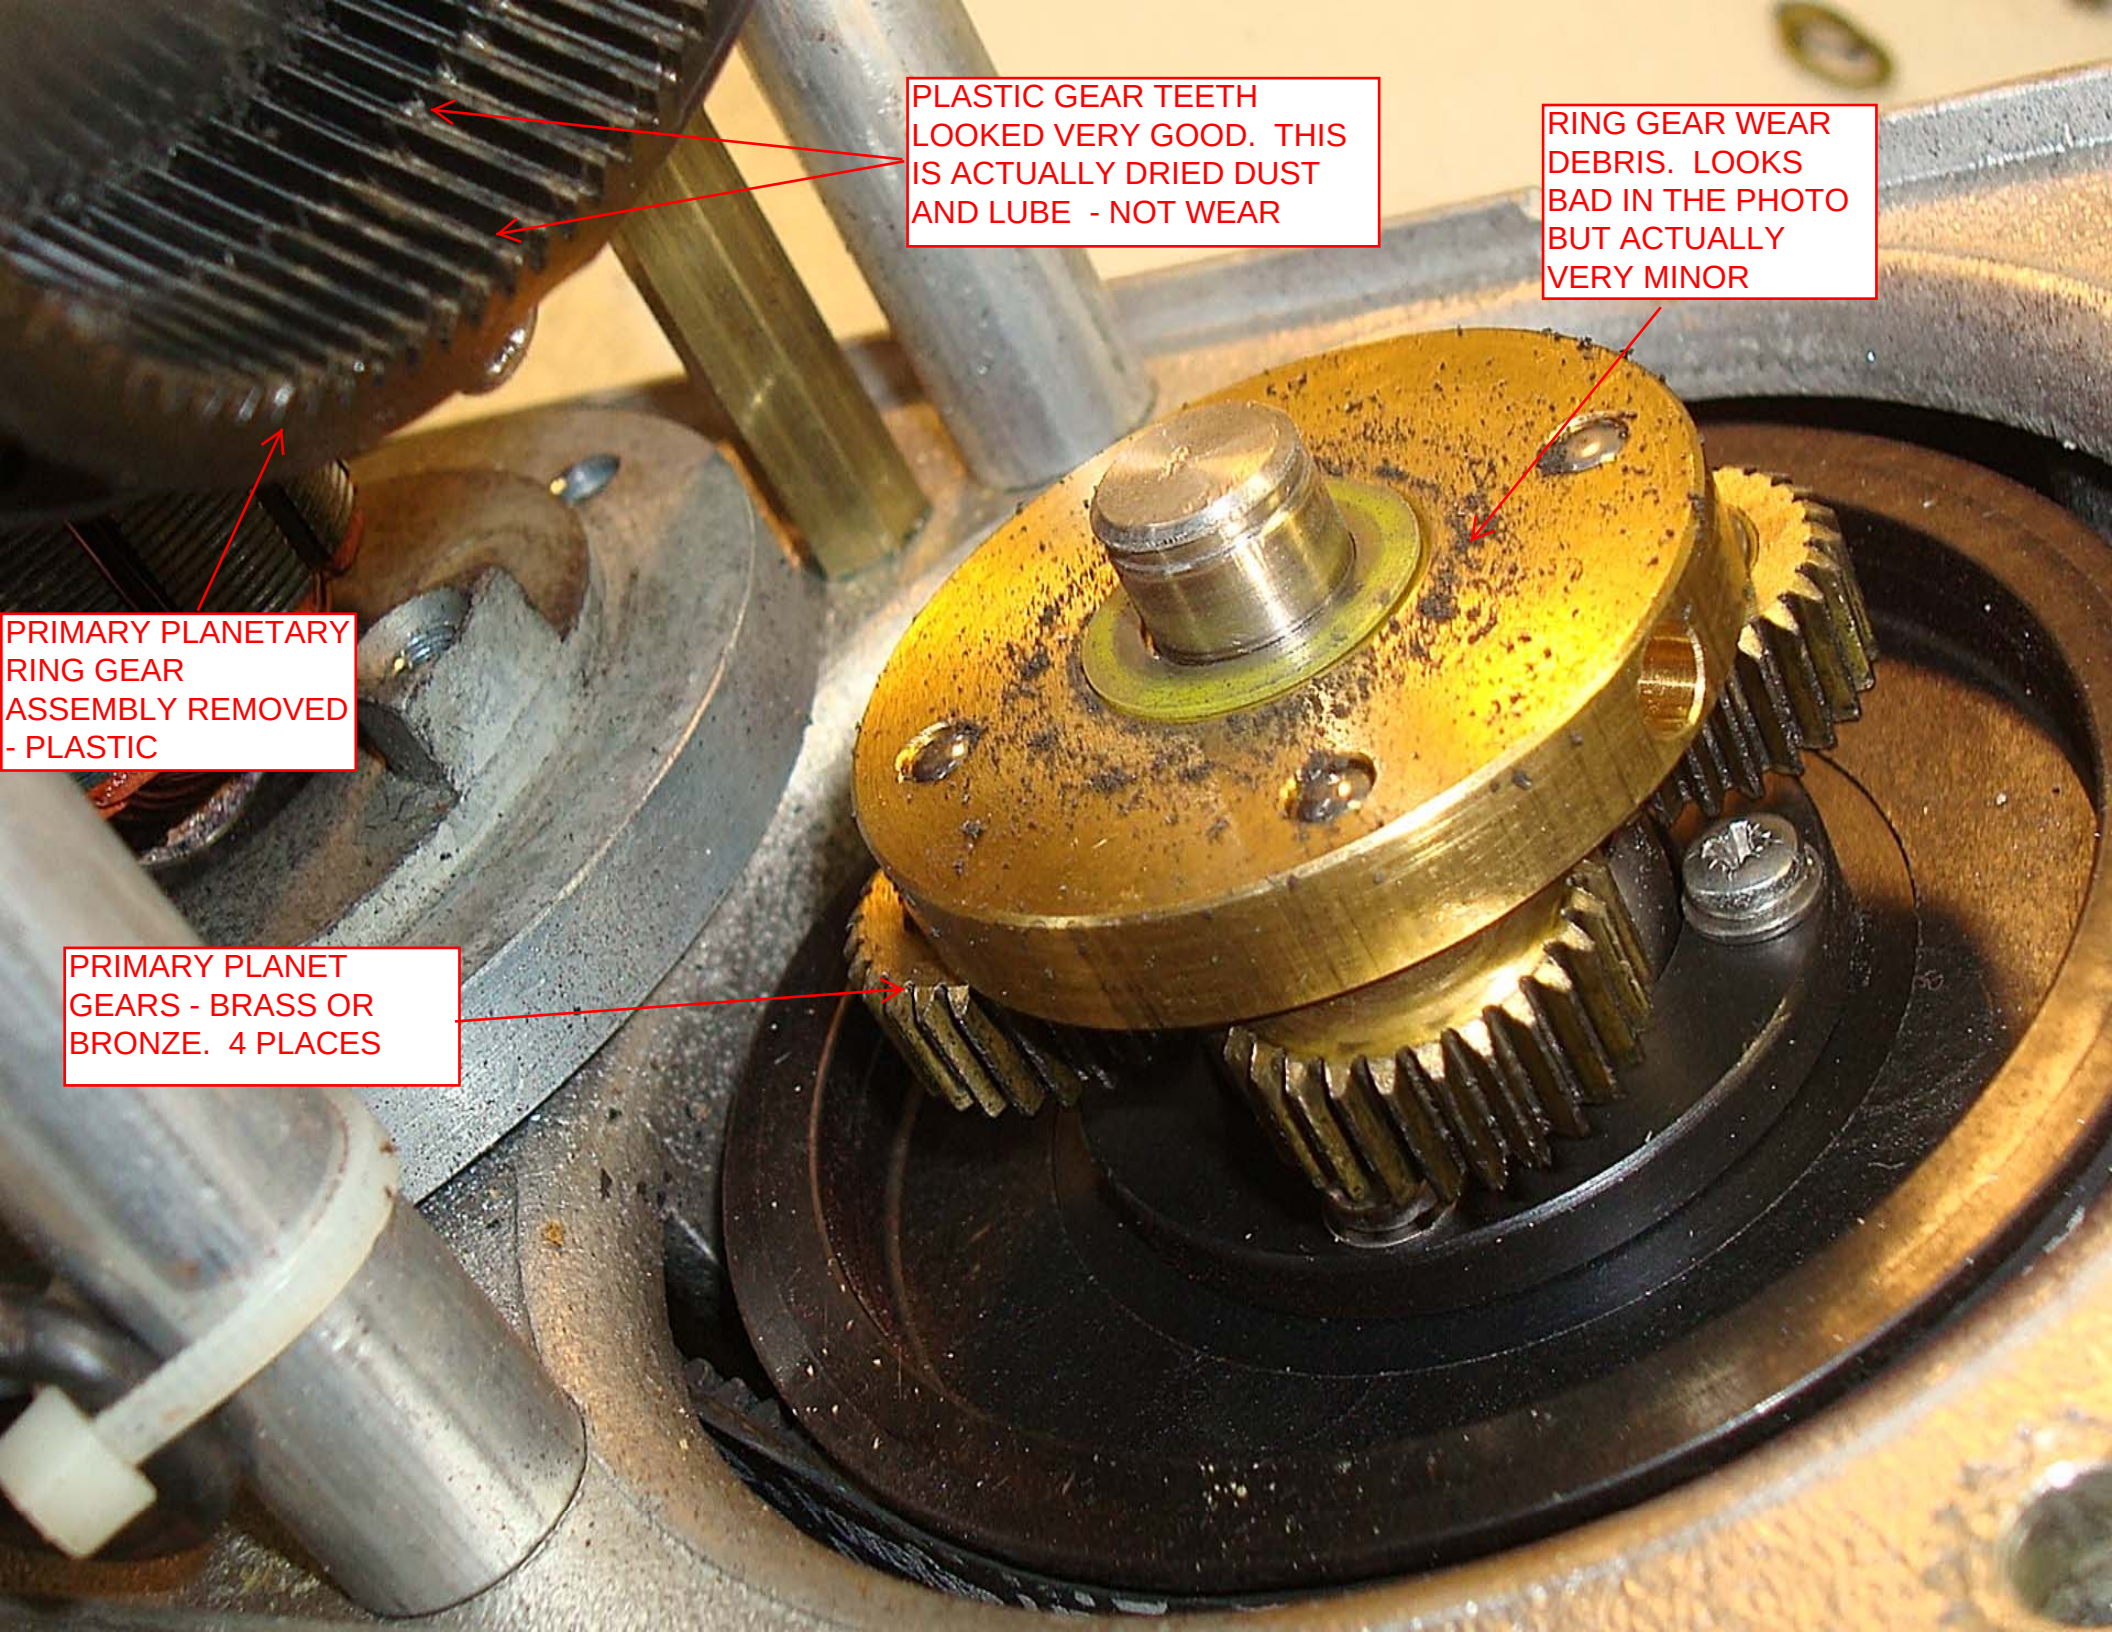
PLASTIC GEAR TEETH  
LOOKED VERY GOOD. THIS  
IS ACTUALLY DRIED DUST  
AND LUBE - NOT WEAR

RING GEAR WEAR  
DEBRIS. LOOKS  
BAD IN THE PHOTO  
BUT ACTUALLY  
VERY MINOR

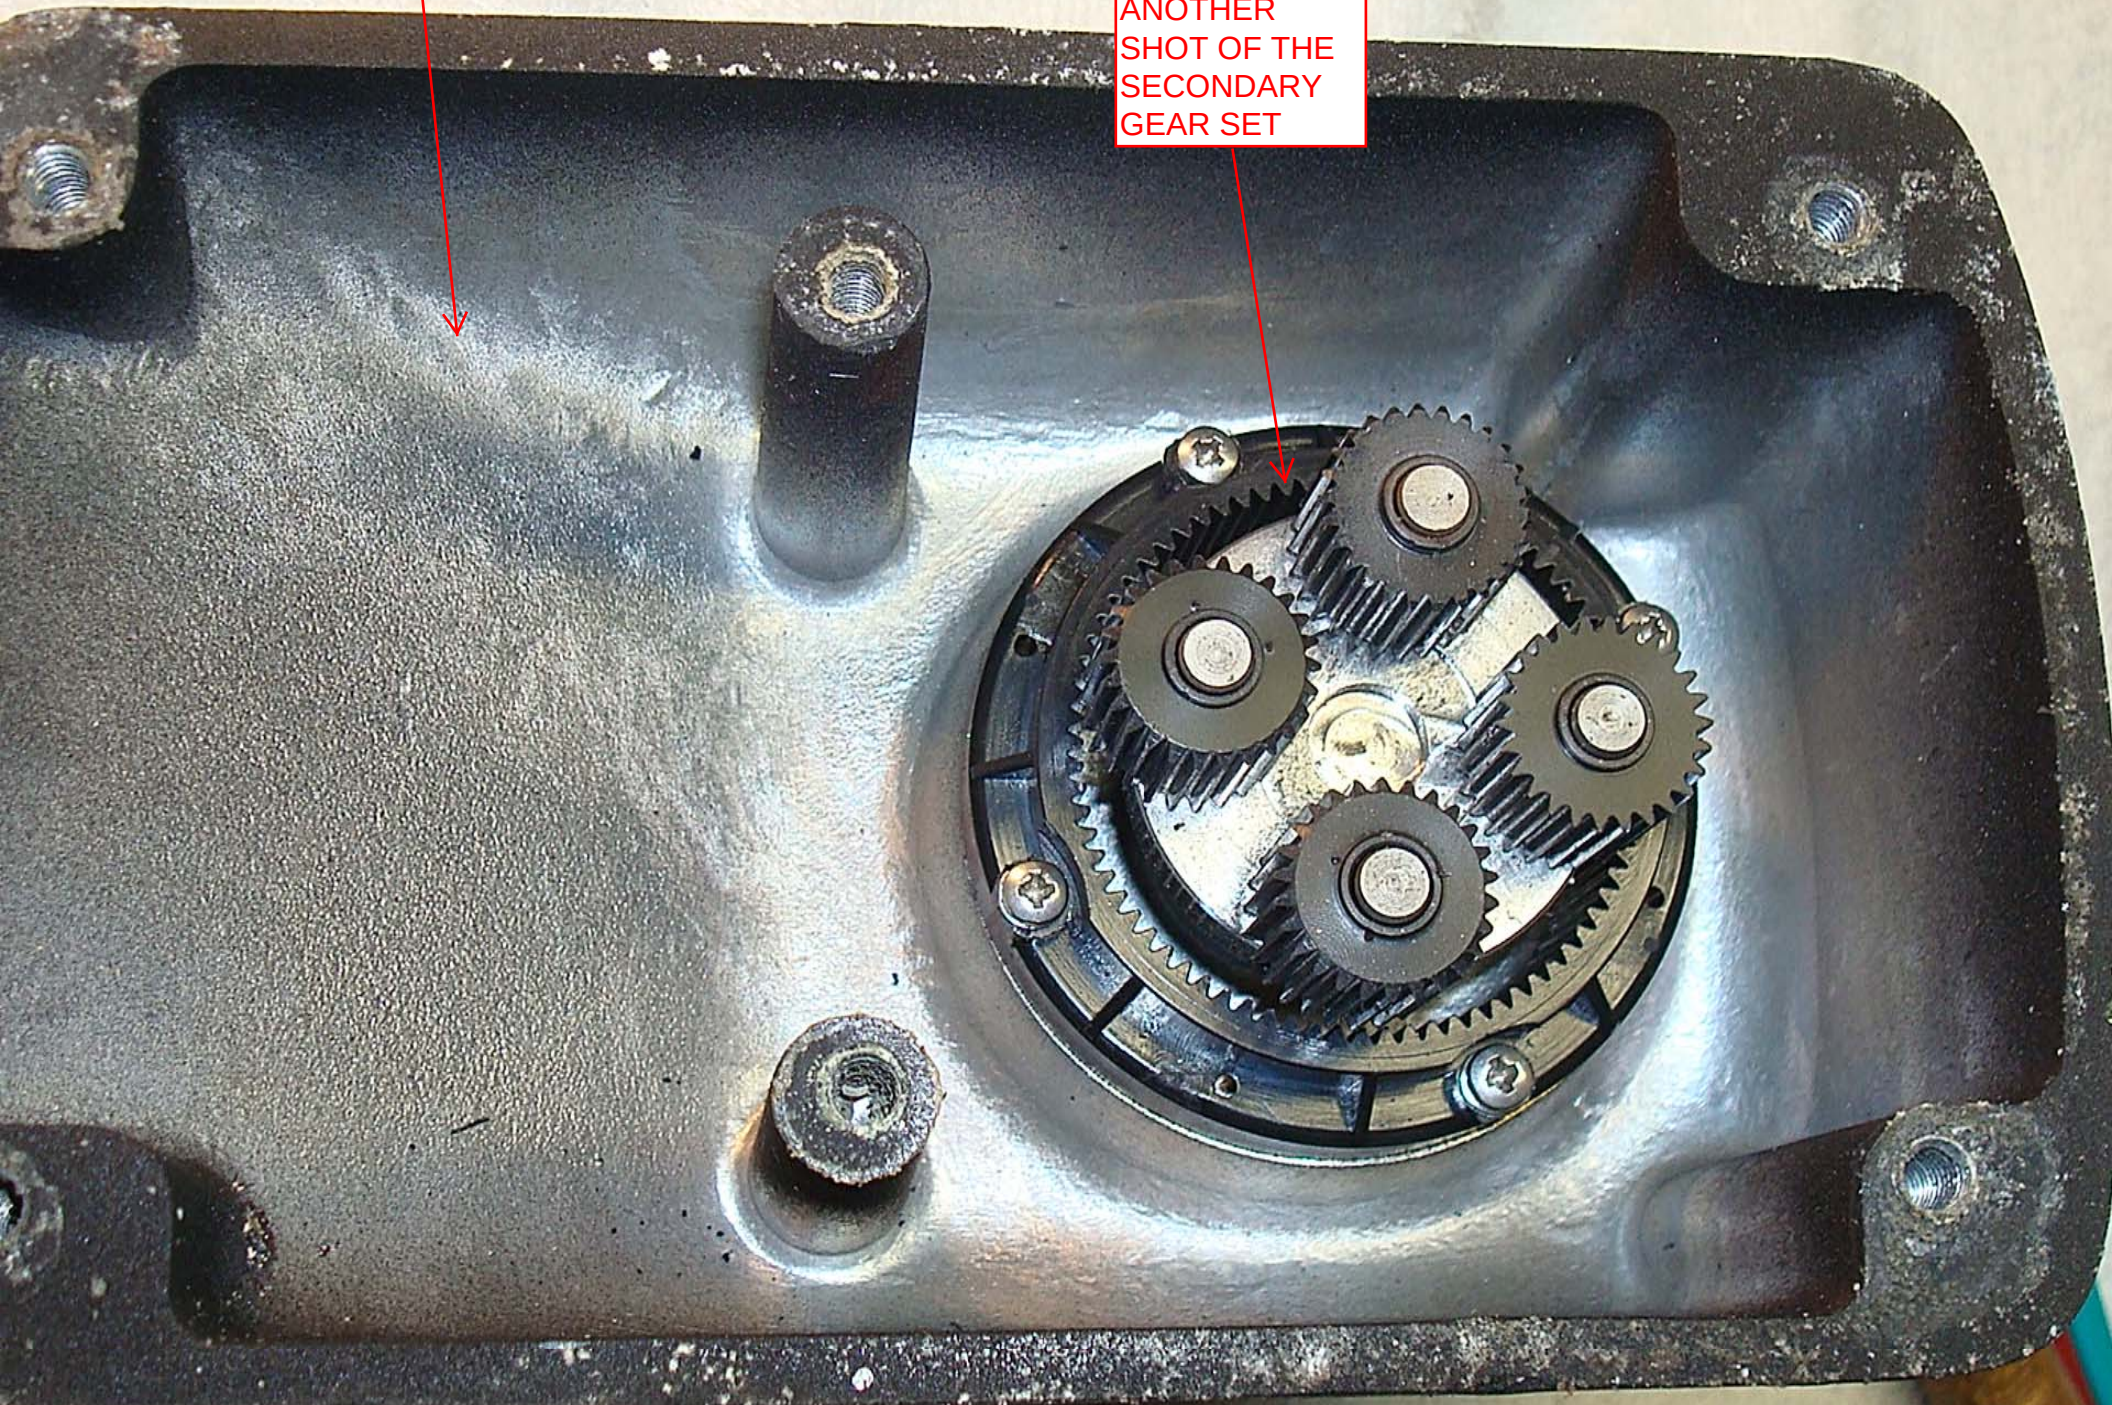
SECONDARY PLANET  
GEARS - ALL LOOK IN  
VERY GOOD CONDITION

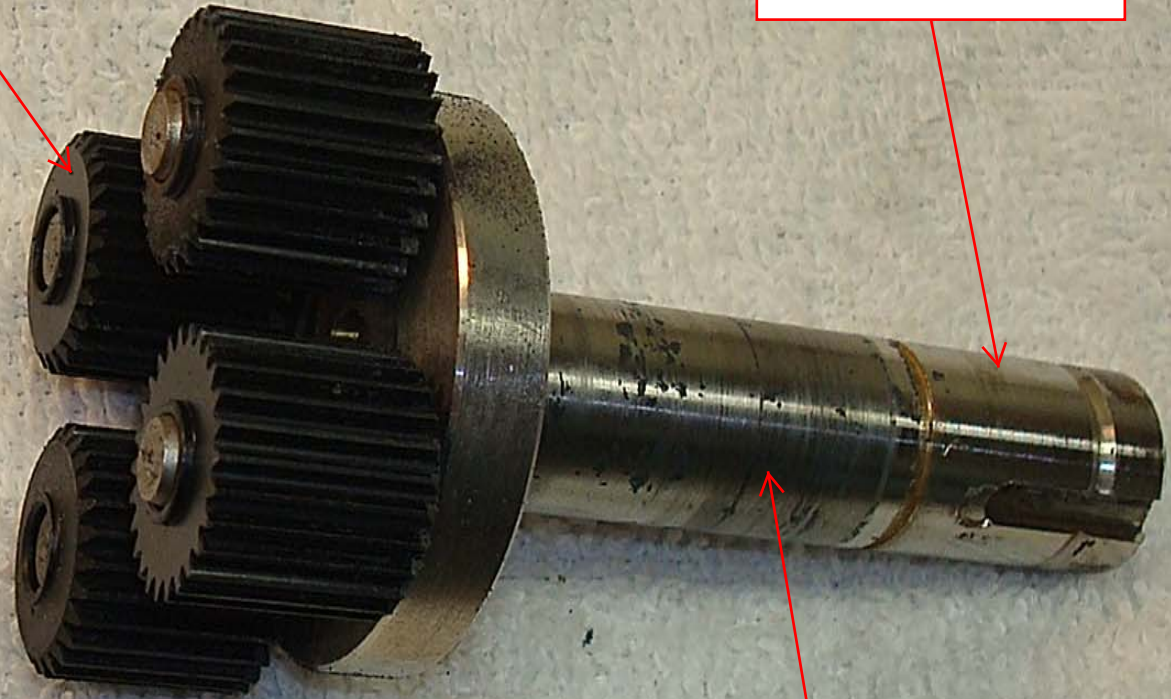
OUTPUT SHAFT BEARING JOURNAL -  
THE PHOTO LOOKS WORSE THAN IT  
REALLY WAS. THIS CLEANED UP  
WITH EMERY CLOTH AND WAS THE  
ONLY ITEM THAT I OILED DURING  
REASSEMBLY
