DRIVE MOTOR

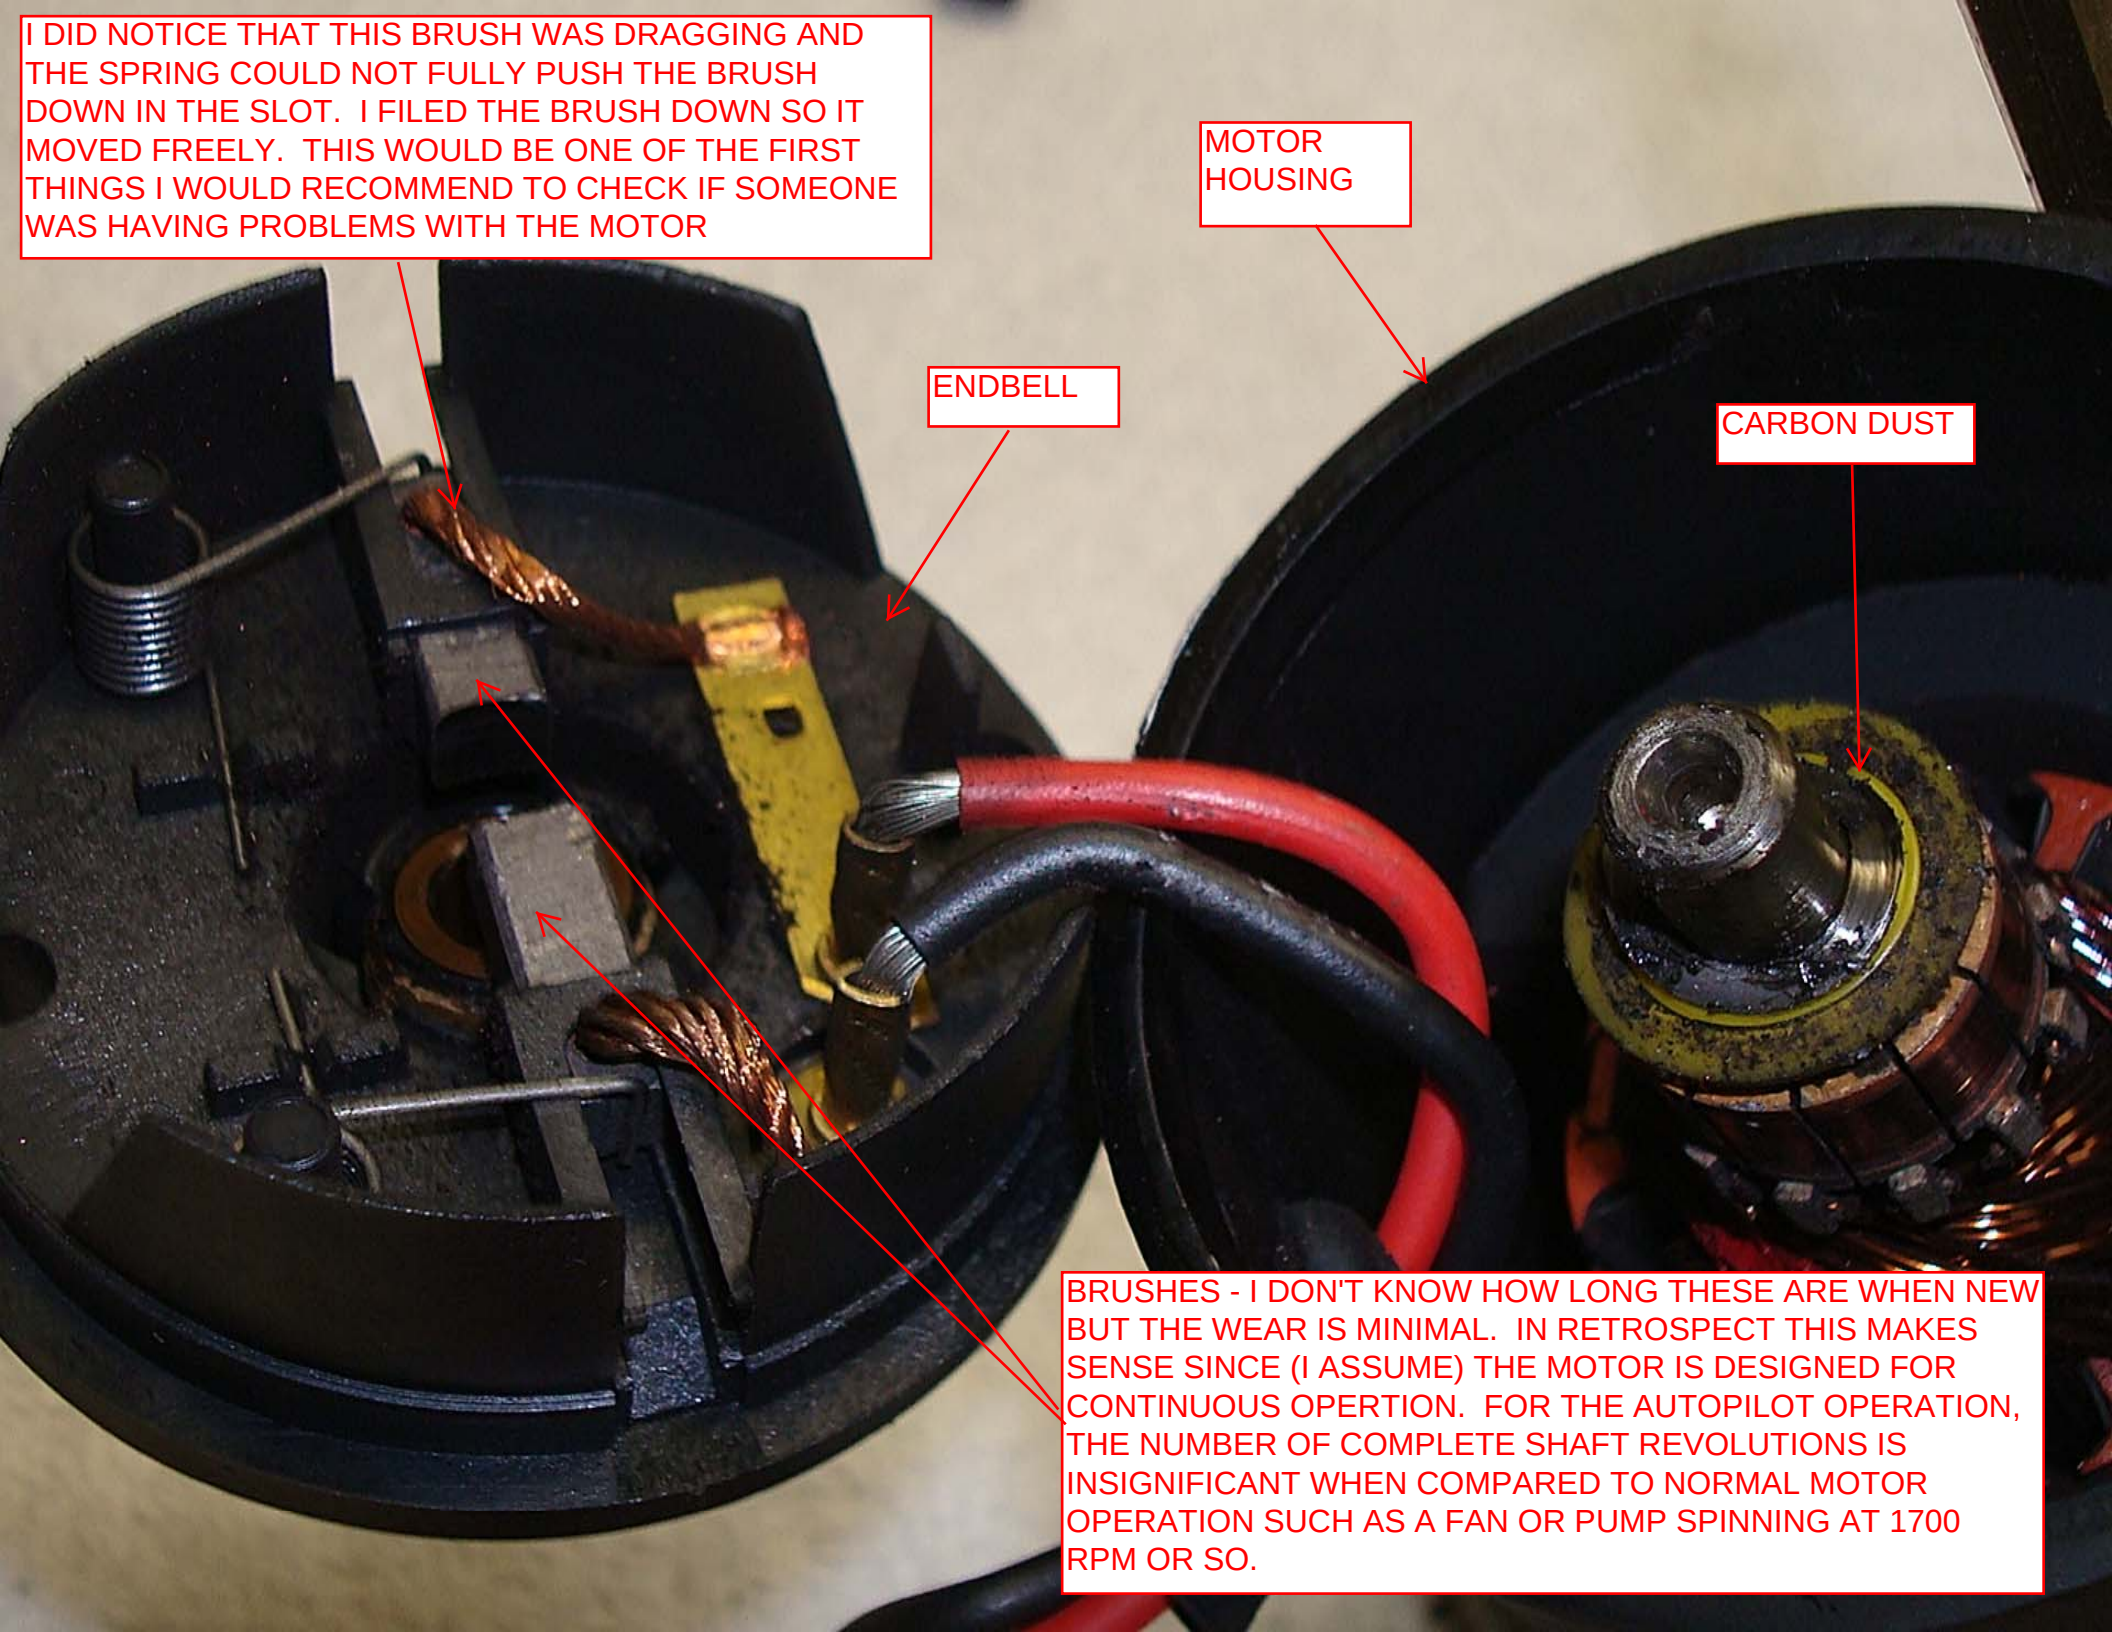
I DID NOTICE THAT THIS BRUSH WAS DRAGGING AND THE SPRING COULD NOT FULLY PUSH THE BRUSH DOWN IN THE SLOT. I FILED THE BRUSH DOWN SO IT MOVED FREELY. THIS WOULD BE ONE OF THE FIRST THINGS I WOULD RECOMMEND TO CHECK IF SOMEONE WAS HAVING PROBLEMS WITH THE MOTOR

BRUSHES - I DON'T KNOW HOW LONG THESE ARE WHEN NEW BUT THE WEAR IS MINIMAL. IN RETROSPECT THIS MAKES SENSE SINCE (I ASSUME) THE MOTOR IS DESIGNED FOR CONTINUOUS OPERATION. FOR THE AUTOPILOT OPERATION, THE NUMBER OF COMPLETE SHAFT REVOLUTIONS IS INSIGNIFICANT WHEN COMPARED TO NORMAL MOTOR OPERATION SUCH AS A FAN OR PUMP SPINNING AT 1700 RPM OR SO.

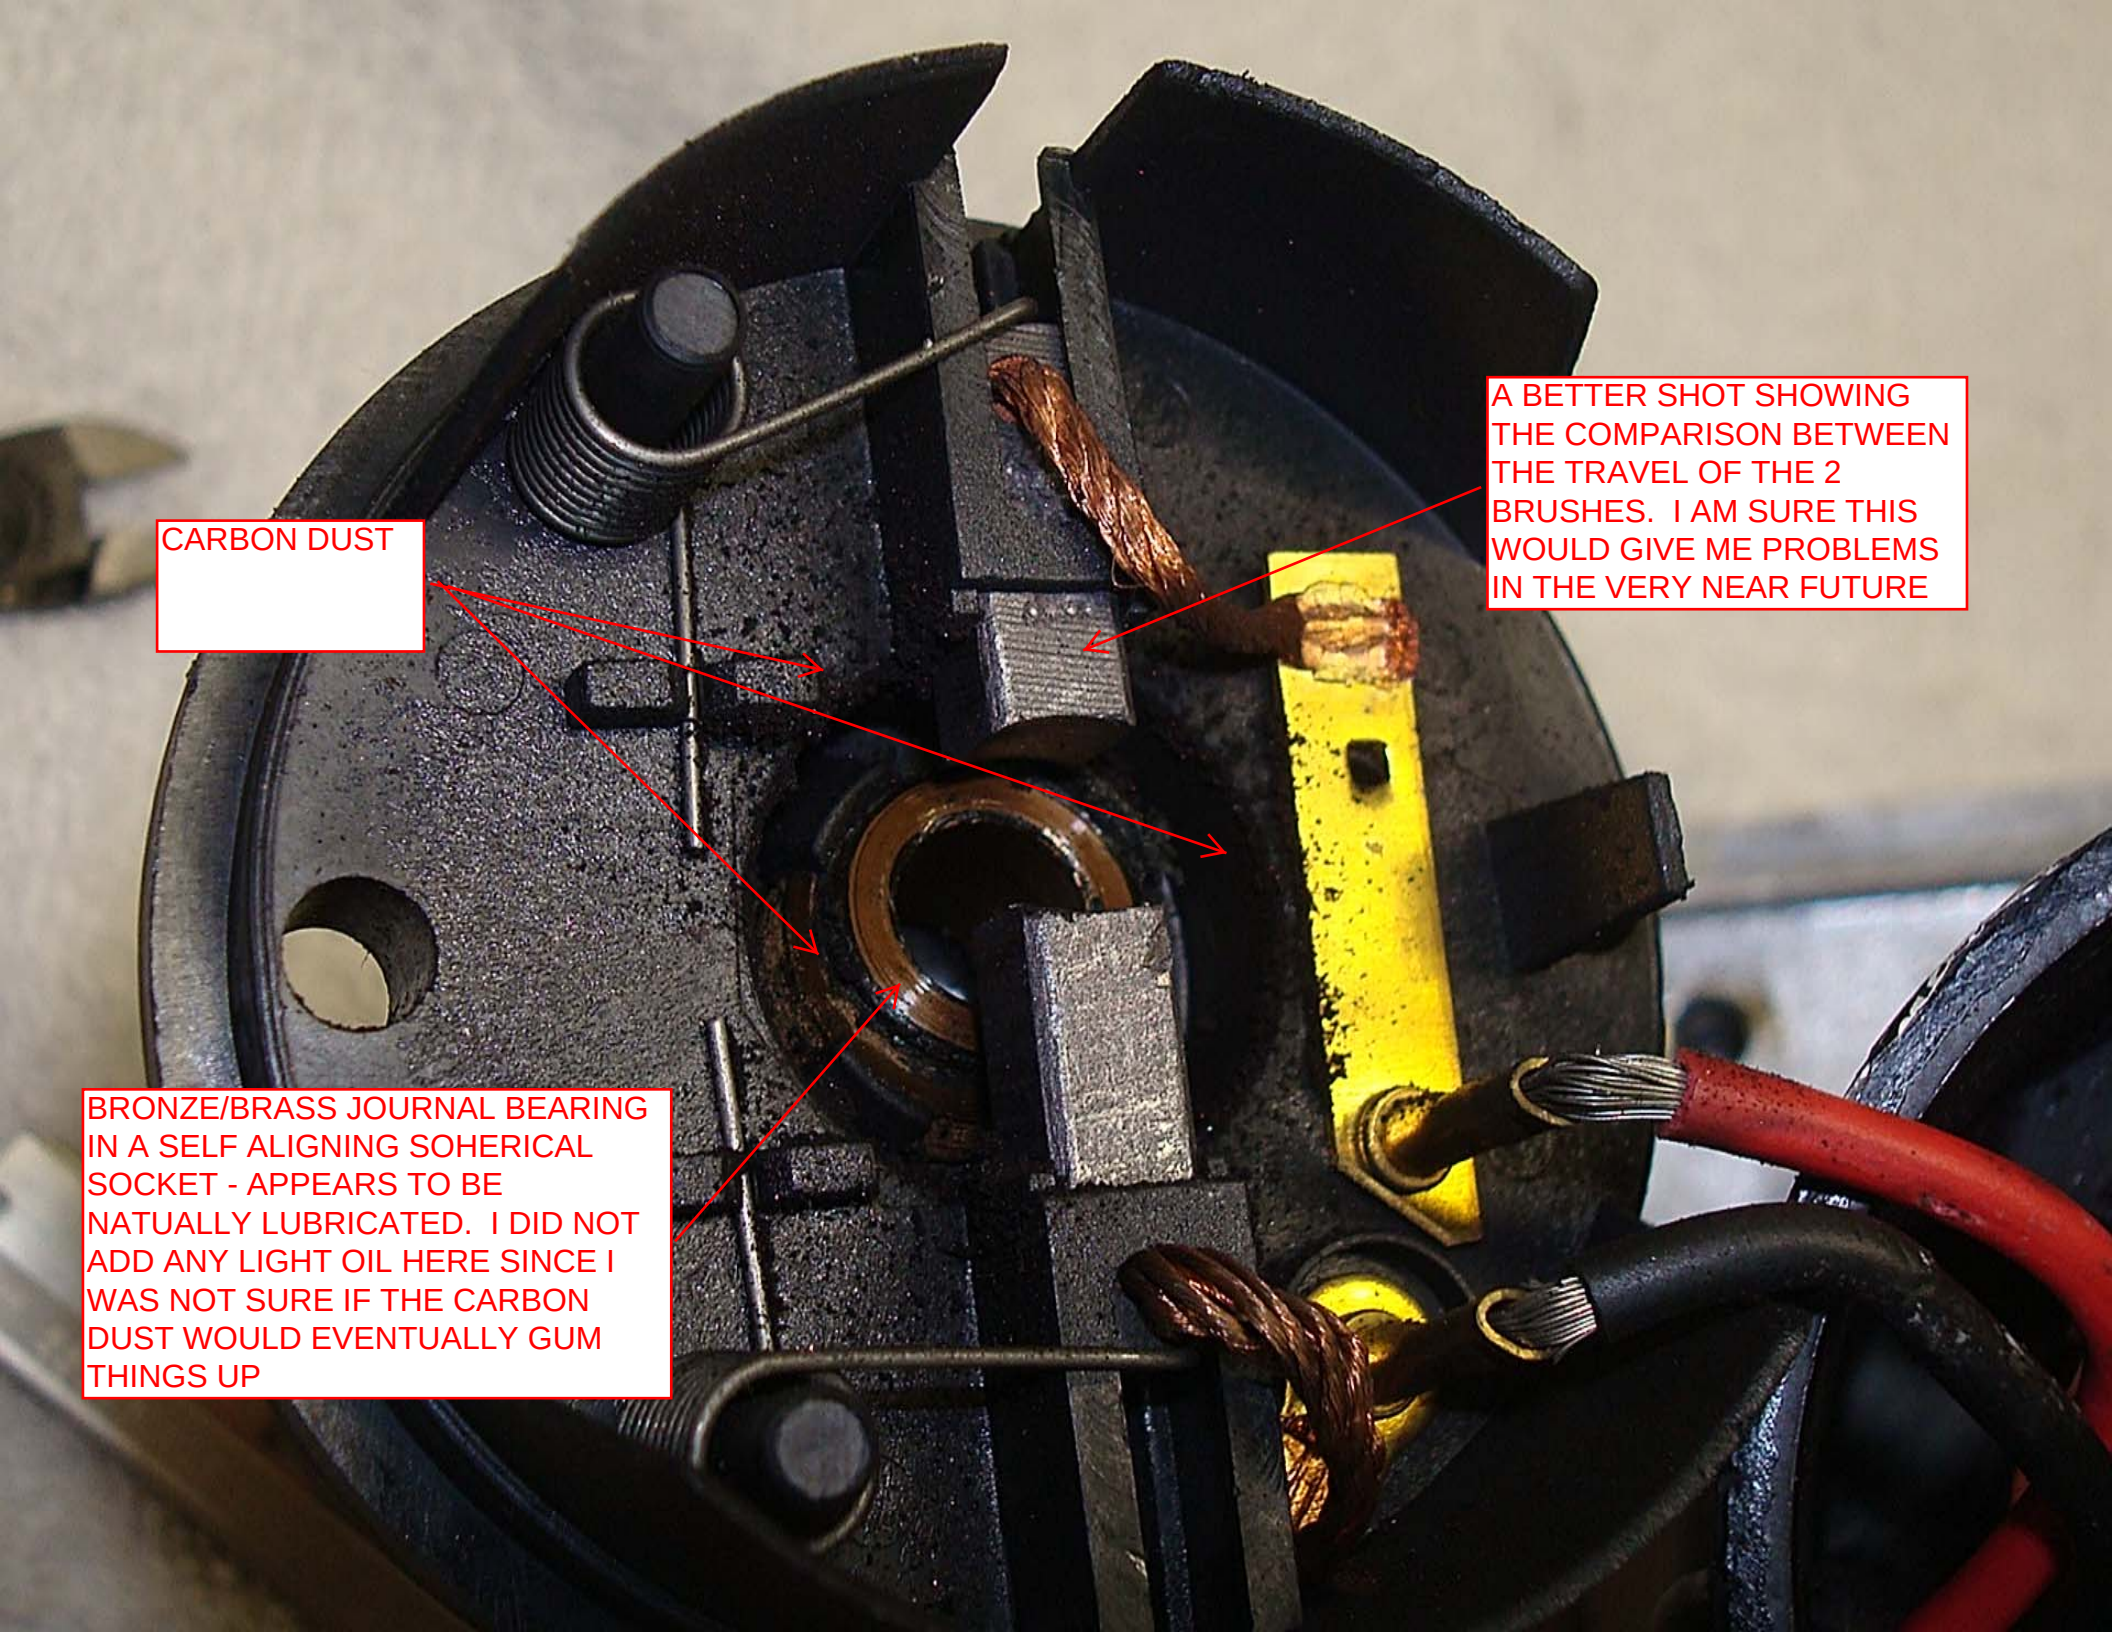
A BETTER SHOT SHOWING  
THE COMPARISON BETWEEN  
THE TRAVEL OF THE 2  
BRUSHES. I AM SURE THIS  
WOULD GIVE ME PROBLEMS  
IN THE VERY NEAR FUTURE

BRONZE/BRASS JOURNAL BEARING  
IN A SELF ALIGNING SOHERICAL  
SOCKET - APPEARS TO BE  
NATUALLY LUBRICATED. I DID NOT  
ADD ANY LIGHT OIL HERE SINCE I  
WAS NOT SURE IF THE CARBON  
DUST WOULD EVENTUALLY GUM  
THINGS UP
