Repair of Yanmar Tach-Hour meter, discussion. November 30, 2012

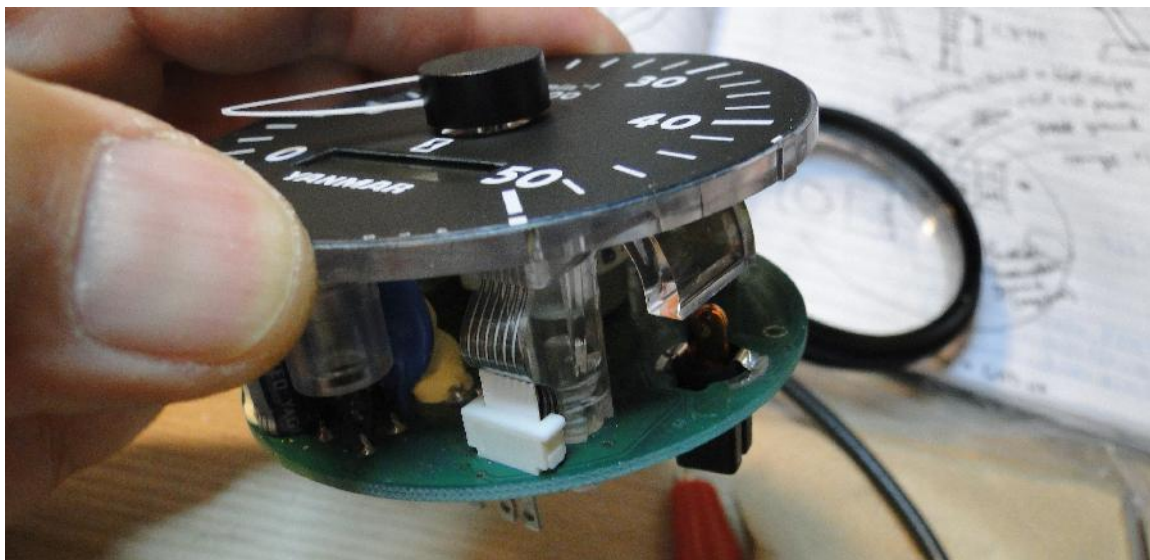
1. Tach-Hour Meter assembly lifted out of housing showing display ribbon cable and connector.

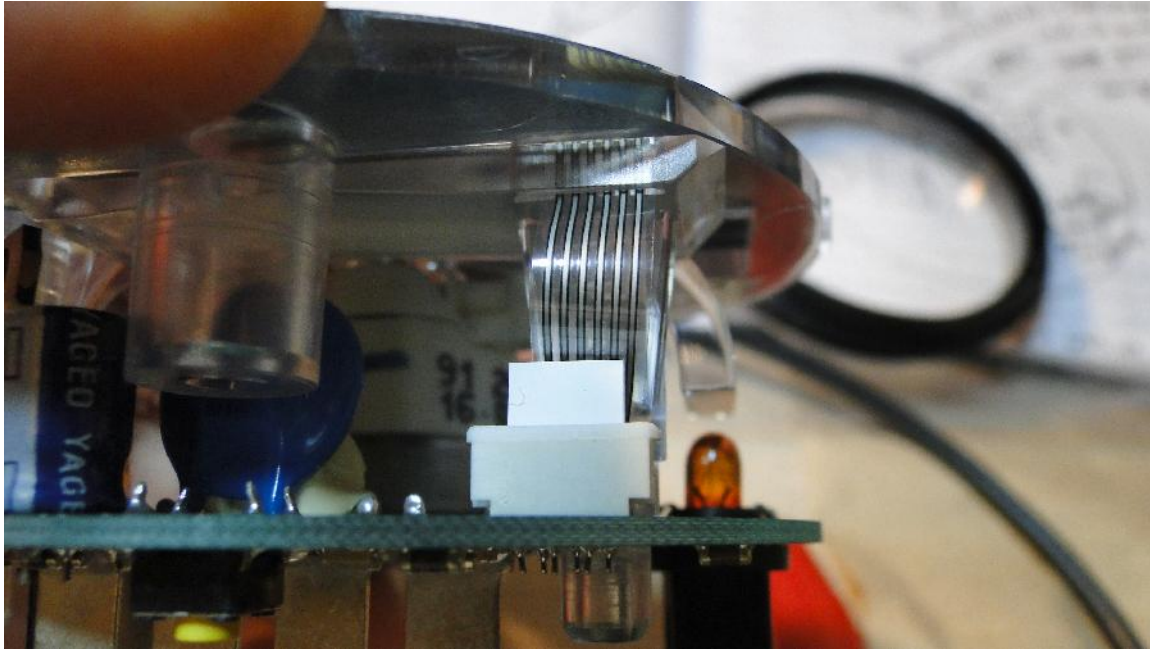
2. Tach-Hour meter assembly showing display ribbon cable and connector. Note connector collar down in the capture position.

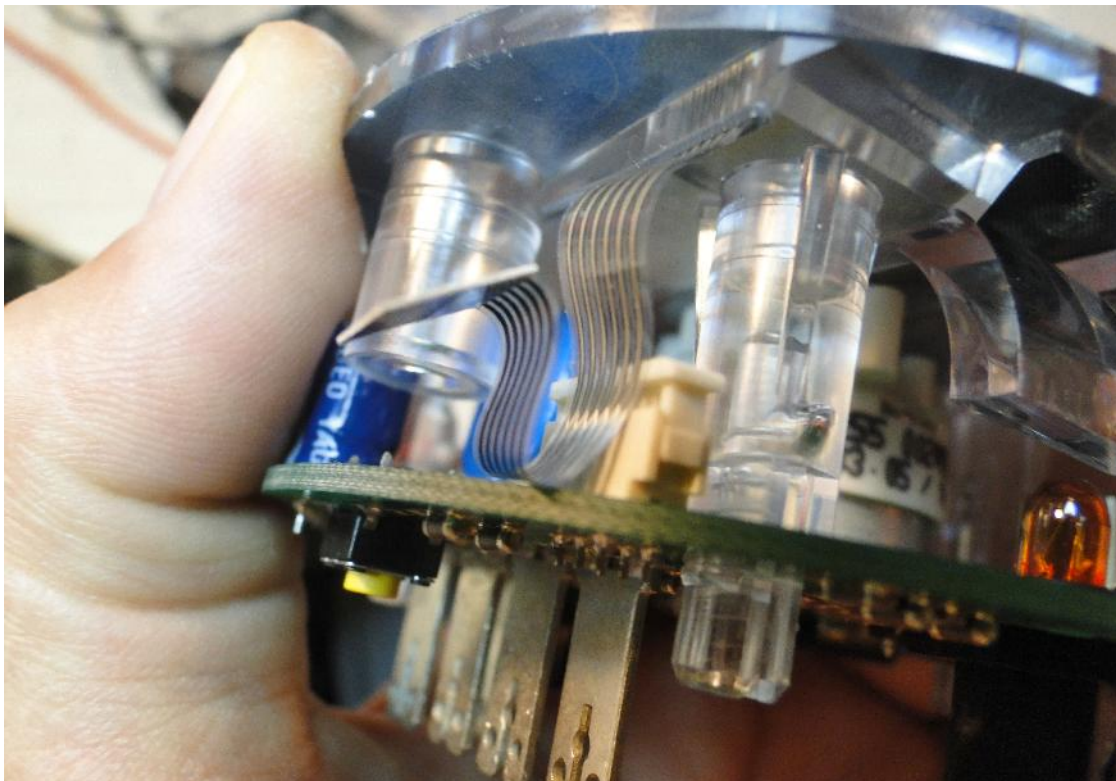
3. Circuit board end of display ribbon cable out of socket. Note socket collar lifted up in the release position. This end of the display cable and its circuit board connector were originally thought to be the source of the problem. After cleaning these connections and application of silicone grease to create a gas tight fitting, the display continued to fail.

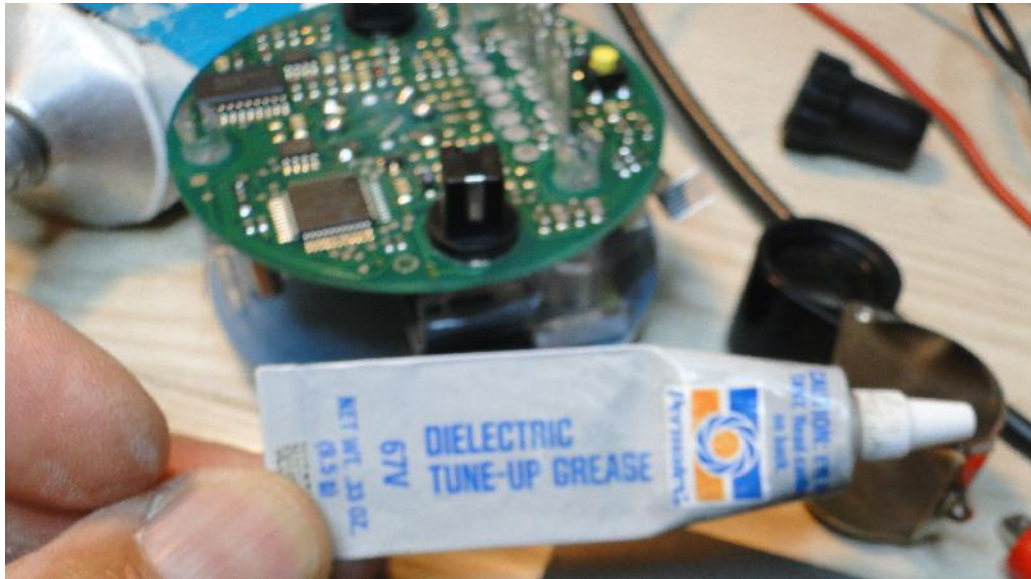
4. Silicone grease used on connector end of ribbon cable to create gas tight connection between ribbon connector cable and connector.

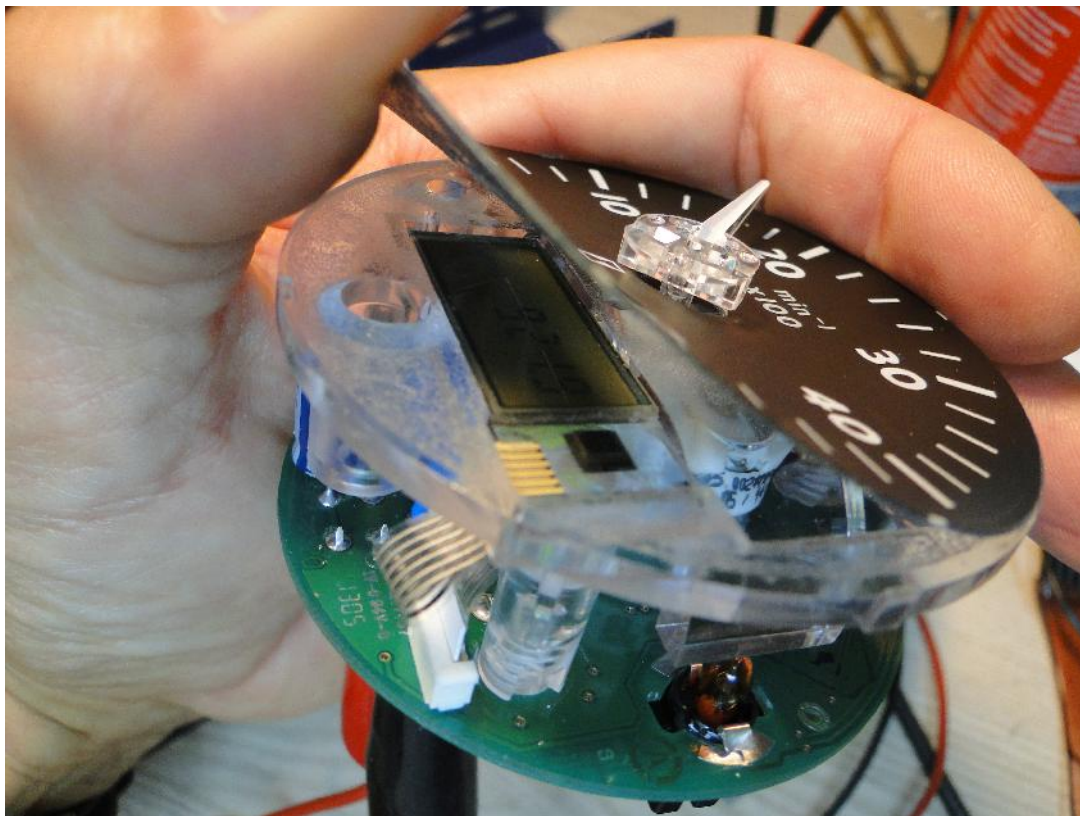
5. Thumb holding face plate up to expose ribbon connection area including LCD and IC at the right of the LDC display.

Challenge: Access to the trouble area requires careful lifting of the face display which is glued down. I used a razor blade and exacto knife to separate the face plate from the mounting face.

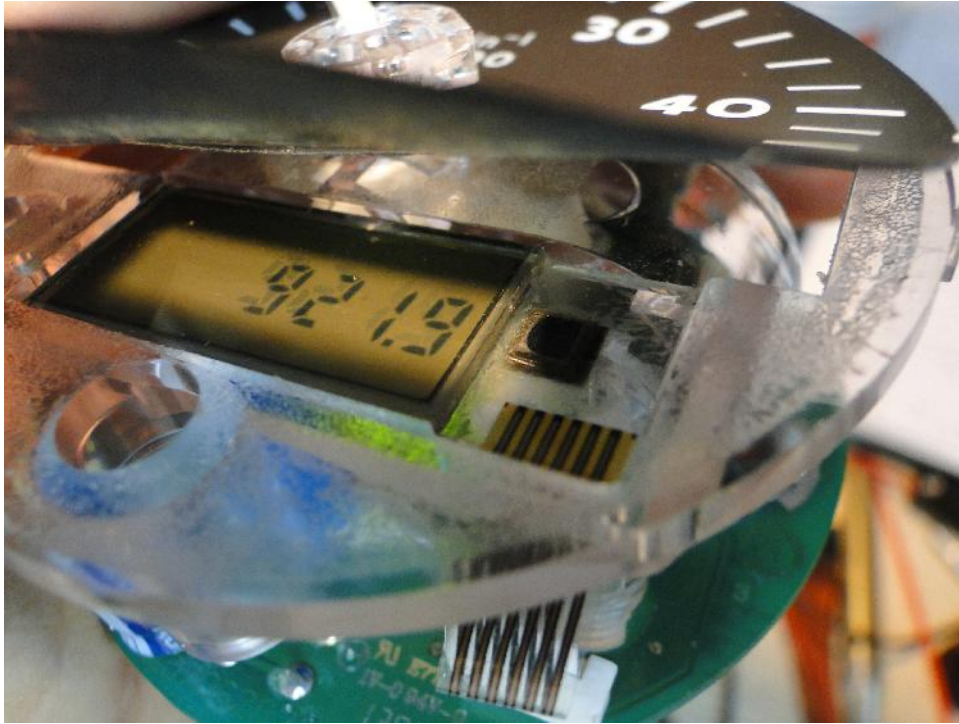
6. Thumb holding face plate up to expose ribbon connection area including LCD and IC at the right of the LDC display. A close-up of this area in the next photo.

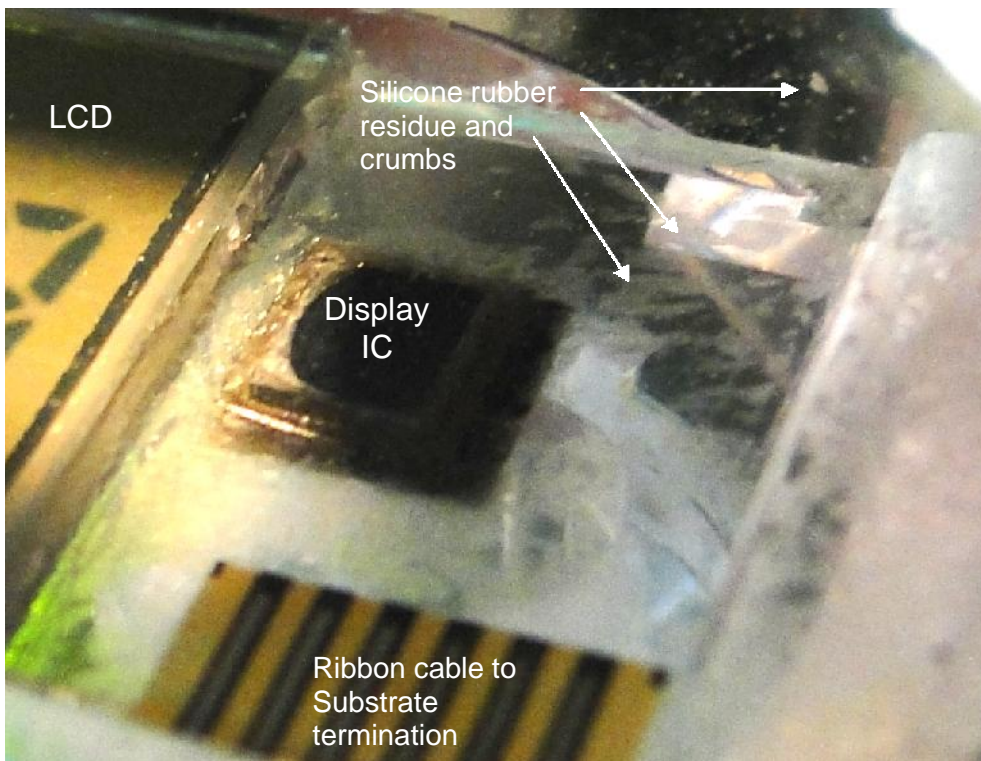
Root cause: Defective silicone rubber applied over the IC, ribbon connection and LCD substrate became conductive or trapped contaminants and/or humidity and disrupted circuit interconnections on the LCD display substrate which includes transparent Indium Tin Oxide conductors and a surface mounted integrated circuit.

7. Close up of LCD substrate area where ribbon cable connects and IC is connected. This entire area had the failed/defective silicone rubber compound applied. Residue is still present on the substrate surface. Not done yet.

Having lifted this face plate, a wooden tooth pick, chisel shaped, is used to dislodge and remove the failed/defective silicone rubber which crumbled away from the substrate, ribbon cable connection area and integrated circuit. A wooden tooth pick is recommended because it will not scratch the LCD substrate, ribbon cable or IC. The LCD substrate has transparent conductive oxide electrodes made of the transparent conductor Indium Tin Oxide (ITO).

The silicone compound covering this area flaked off and crumbled readily. It must be scraped away from all surfaces to which it was applied. A can of air is helpful to blow the crumbs away. A small stiff brush can also be helpful. Once the majority of the material is removed, a careful going over of the surfaces with a fresh, sharpened chisel flat, wooden toothpick will remove the last bit of residue. This last step is very very important because the defective silicone rubber on the surface of the LCD substrate must be fully removed to eliminate spurious conductive paths.

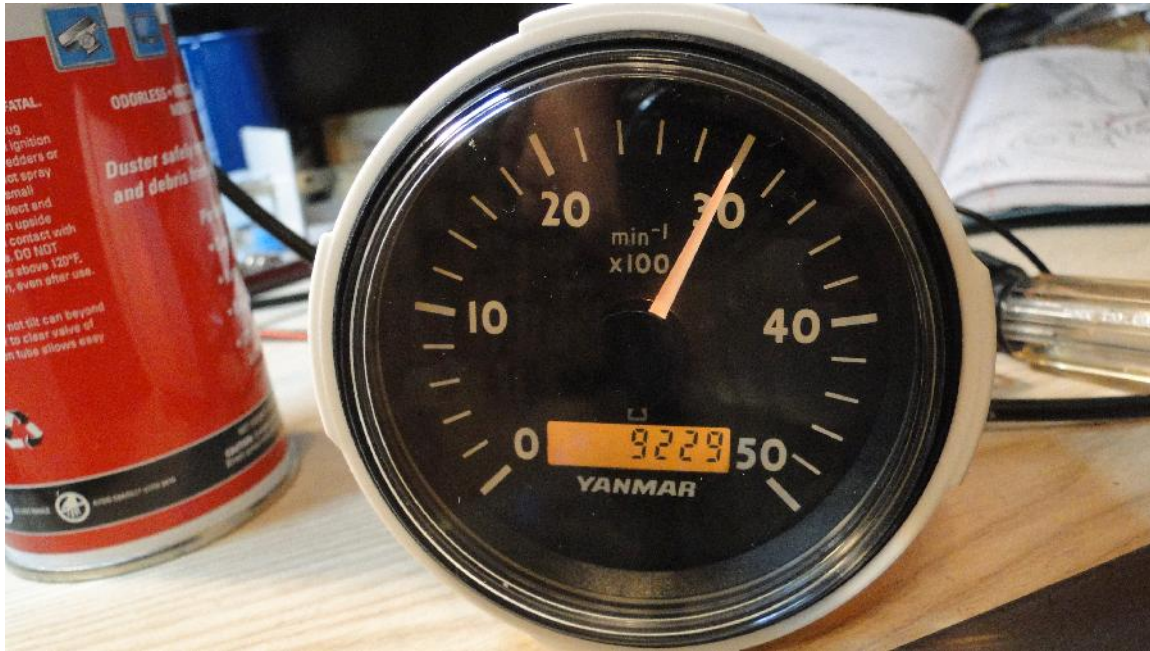
8. Reassembled Tach-Hour unit with persistent, bright, well defined numerals in hour display. Tach shows 3000 RPM with 510 Hertz square wave applied to tach input.
