# Fuel System "AQUILA" Tayana 37 #423

## Notes on Recirc. System:

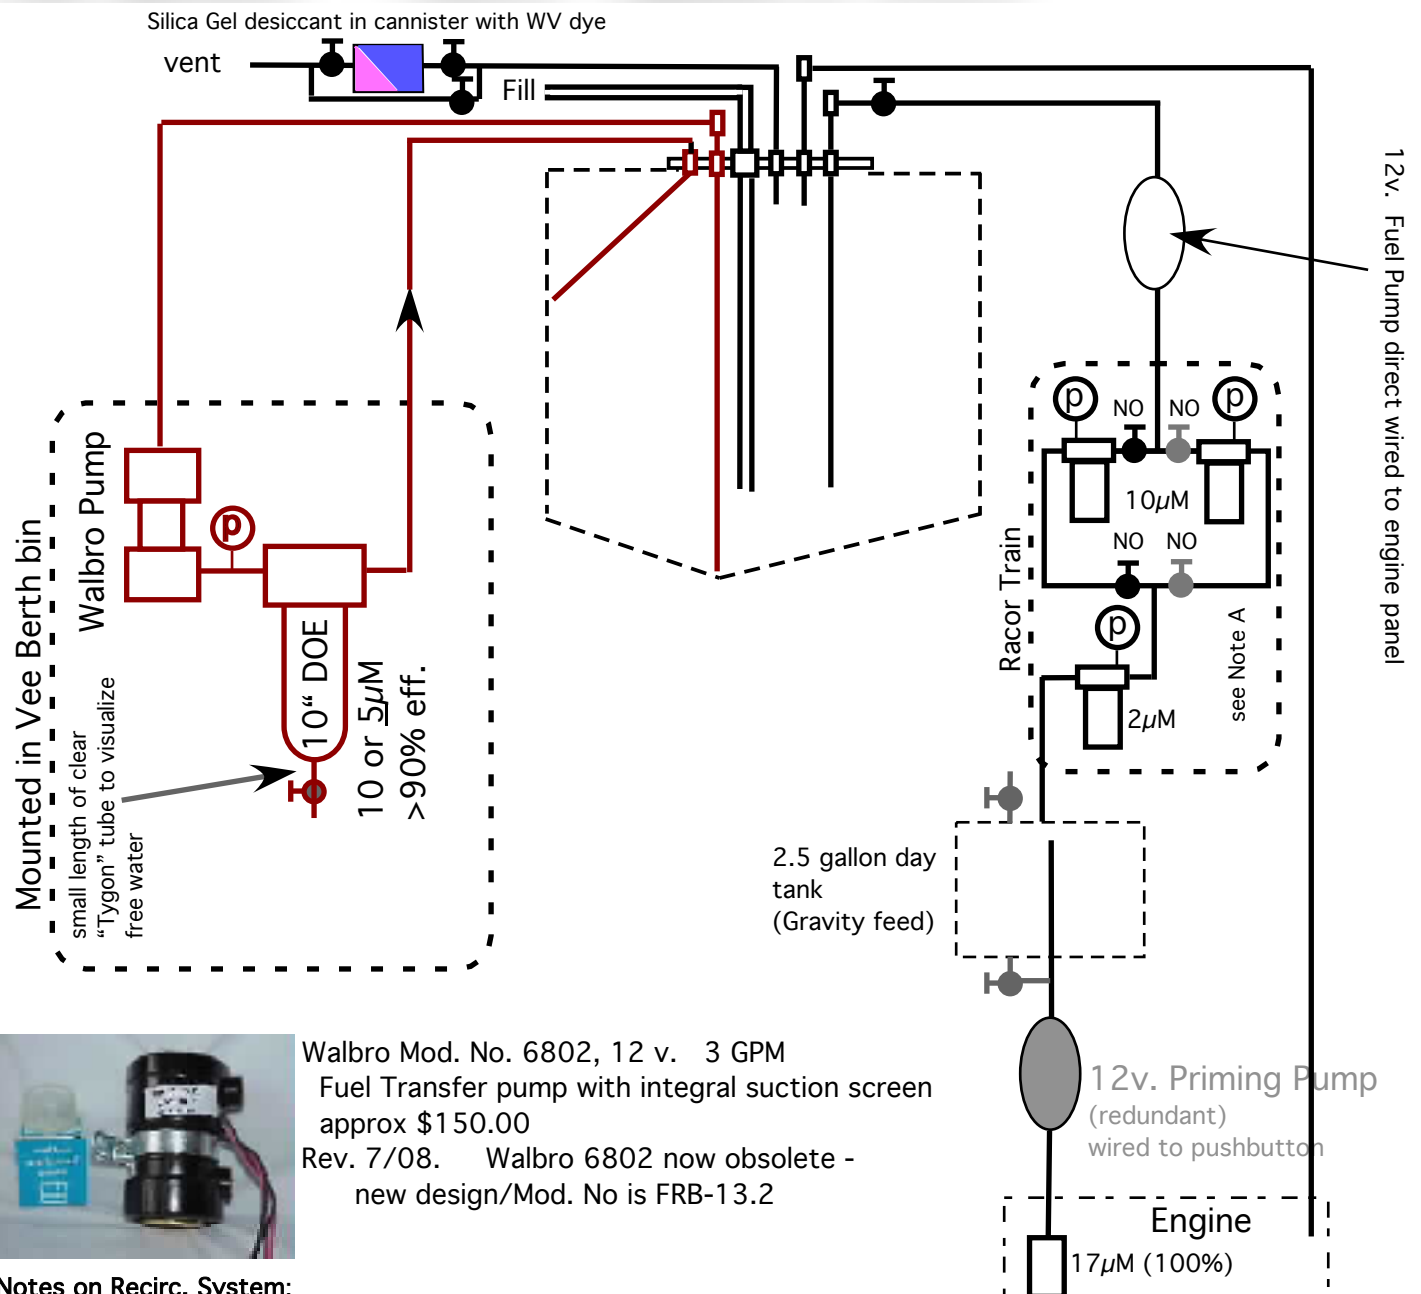
1/2" Copper (soft) tube with compression fittings (better if flared). Use standard tank fittings to enter manhole on tank. DO NOT connect recirc lines to tank vent to save applying manhole fitting !!!!! Manhole connections are simple tapped drillings. (Note - ALL copper lines to be replaced with flared stainless steel - Cu is reactive in diesel)  
Wired to main panel breaker. System routinely used when engine is on, especially if sea state is active.  
Testing of long term recycled fuel via nephelometry indicates probable background residence particulate level in tank @ less than 0,45µM

Filter housing is Shelco Carbon steel Mod. FOC104-GP4-E arranged for Double Open Ended 2.75" Ø. 10" length filter element. Cost is approx US\$80.00.

Filter is Osmonics Hytrec (spun bonded polypropylene depth media) PN GX15-10X, changed ea. 6 mos after initial polishing. Removal Efficiency probably at 95% (w) at micrometer rating. Cost@ US\$8.00 ea.

Walbro has integral screen @ approx 100µM. (needs to be cleaned @ 3-4 mos.)

Suction Dip-tube inlet located at very bottom of tank.

Water knock-out via clear tygon tube + cock in bottom of recirc. bowl.

Note A - 12v differential P (w/set point) switch added and run to flashing diode (w/440ohm R) at engine panel

Note B PPropylene Hytrec swells in contact w/ oil - change @ 6-9 mos.

Use EPDM (ethylenepropylenediaminemonomer) O-rings on Fltr. Housing to prevent swelling.

Complicated Racor train now redundant - removed and replaced with single Racor.

Note D Changed to 5µM recirculation filter. Need to change all copper to stainless tube - Cu is reactive.
