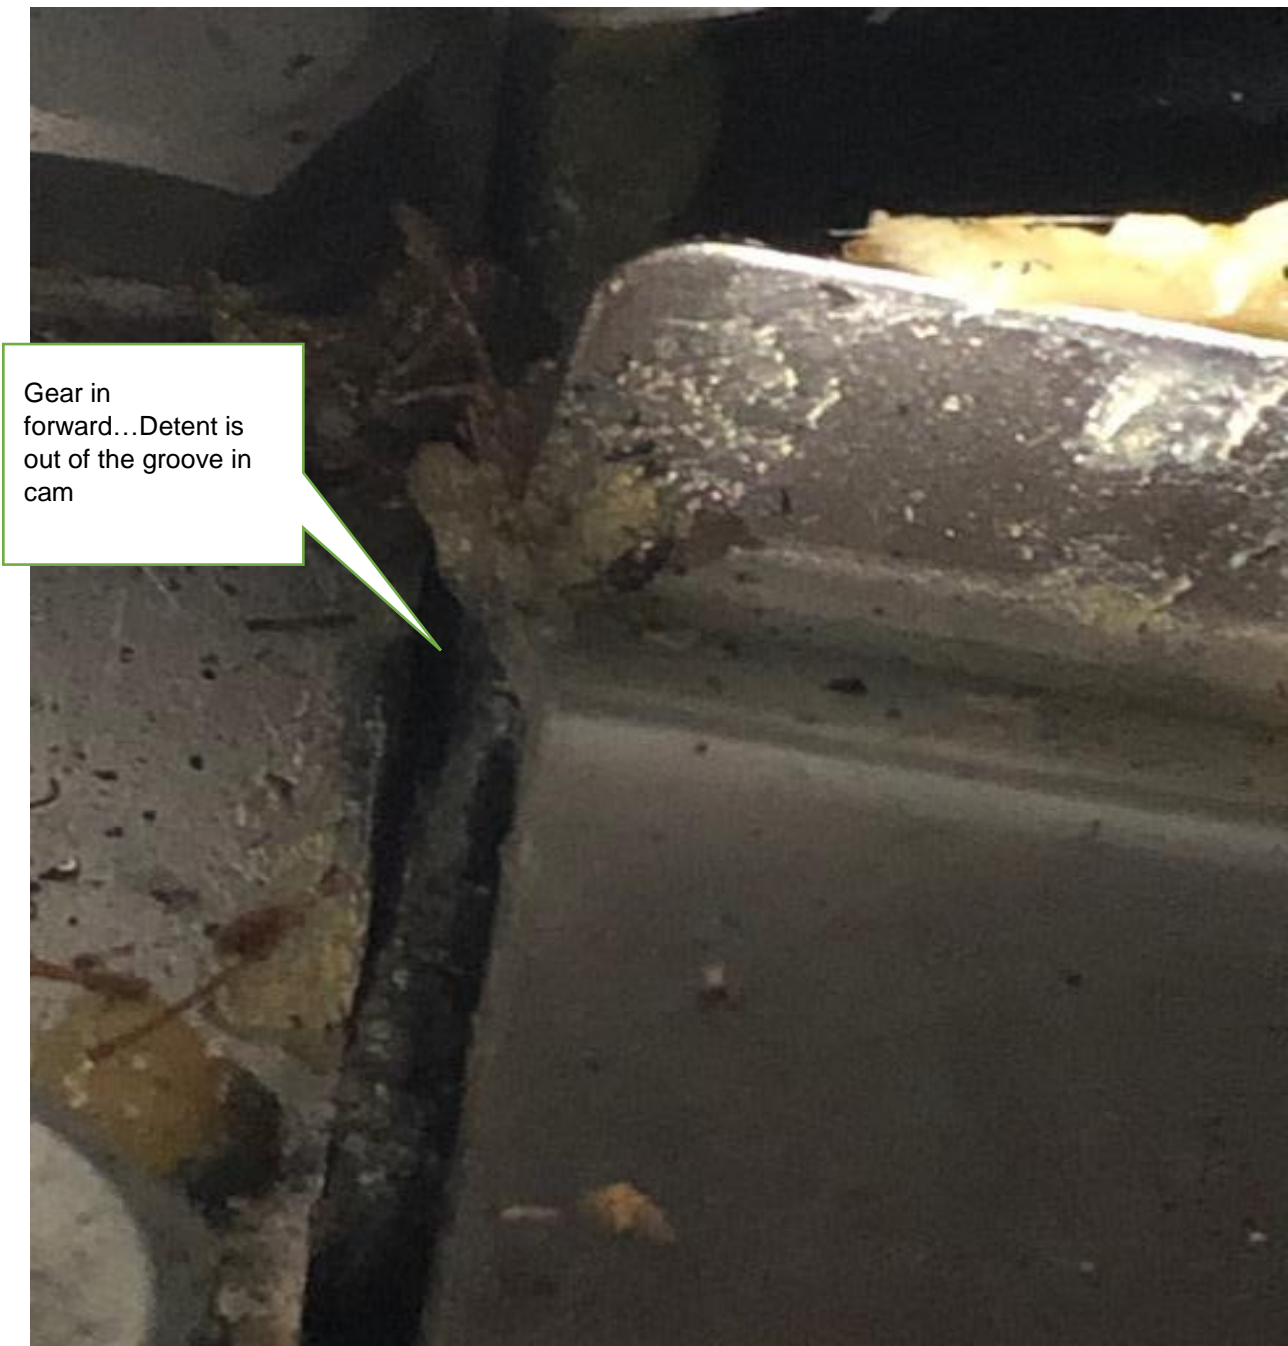
Gear in forward...Detent is out of the groove in cam
