Hindsight

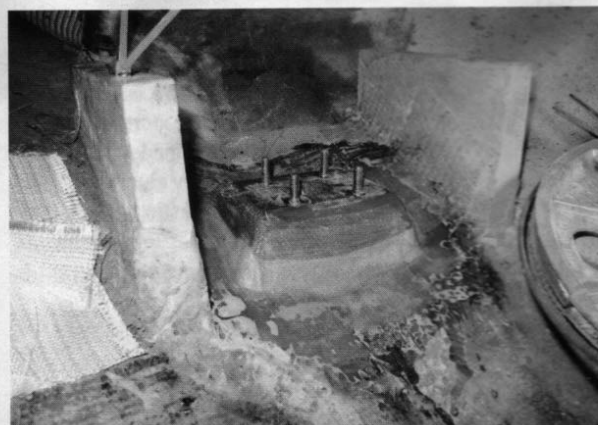
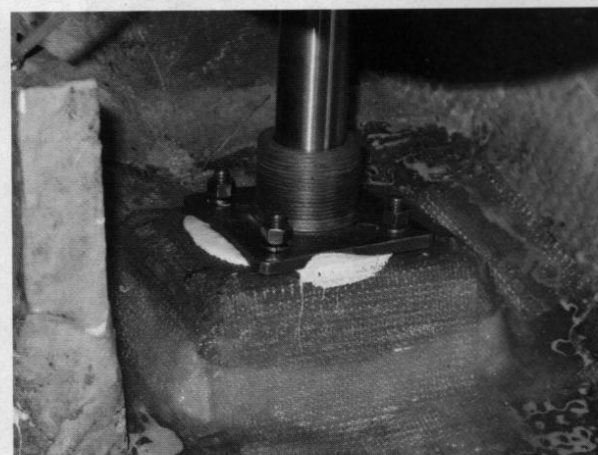
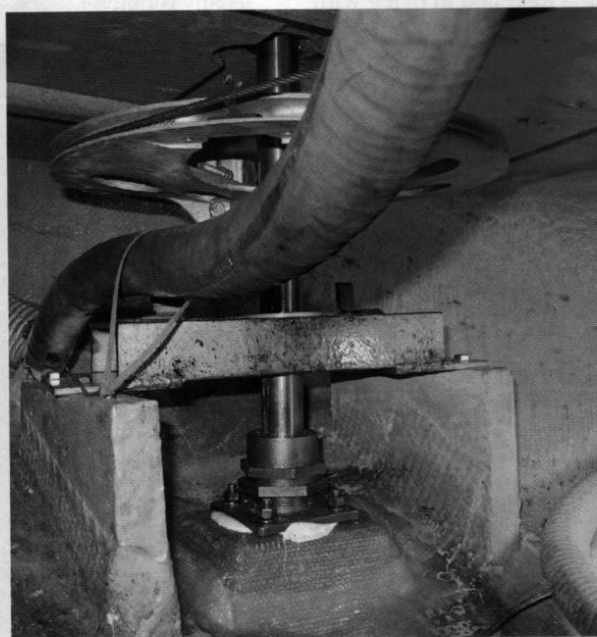
The upper bearing, above left, was a plastic bushing in a wooden block and was getting worn. Jim fabricated a new one out of Delrin sandwiched between aluminum plates, above right. Jim glassed the block for the lower bearing to the hull after aligning it with a pipe, at left, then assembled the bearing and shaft seal to it using 3M 5200 as the sealant, below left. Once everything was back together, Jim's steering system was as good as new, or even better in parts, below.

the upper bearing, quadrant, stop collar, and the hull. After tying the rope to the stock, I stood the rudder up and used the mainsheet tackle to pull it into the hull.
