SUBJECT: C310 Boom Mount

(Relates to Boom used with Standard Sails without In-Mast Furling)

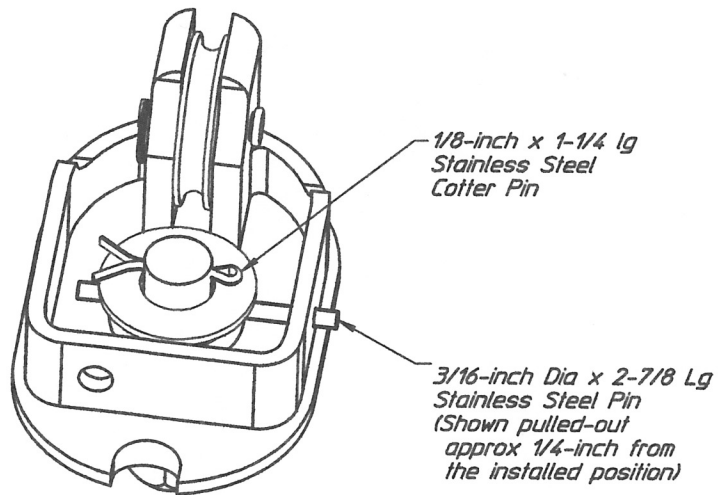
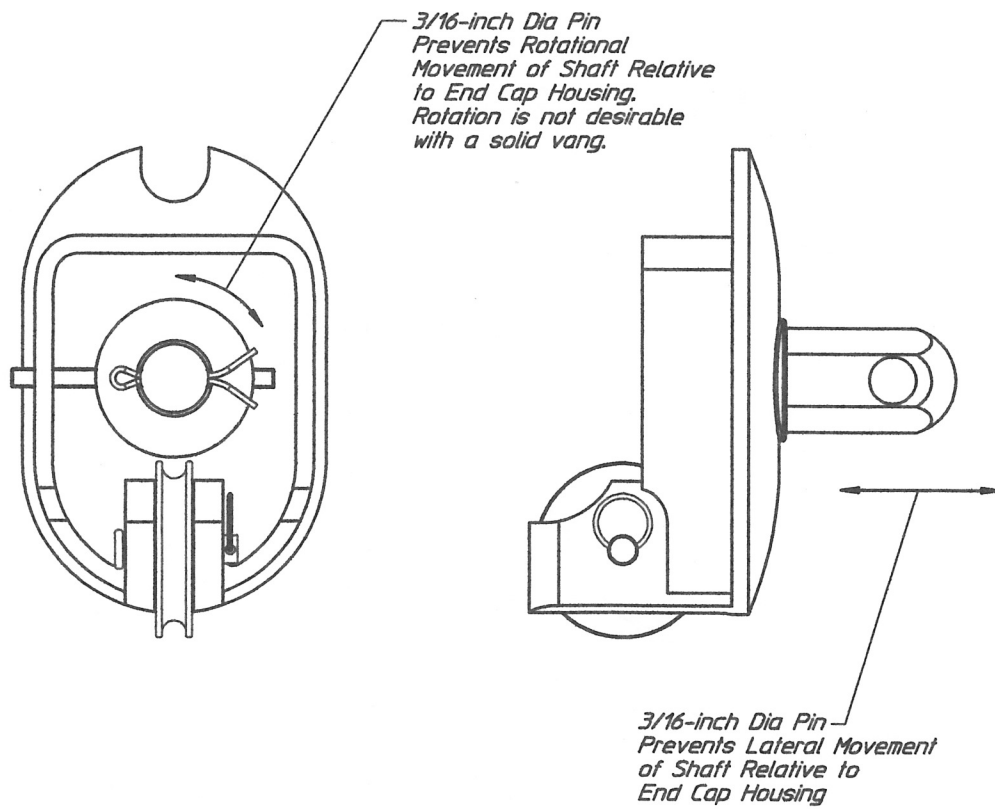
C310 BOOM END CAP ASSEMBLY

Back in June (2003) there was some discussion on this List regarding the boom mount. Apparently several C310 owners have noticed issues where the gooseneck shaft mounts to the boom forward end cap. From those messages I took a close look at mine, I suspected mine had the problem and so I contacted my dealer. A positive indication that something isn't quite right is if the boom forward end cap can rotate on the shaft it is mounted to, or has excessive fore-aft end play. There was also an annoying squeak from this area when sailing in light winds.

There were several comments on this discussion List about the size of the cotter pin (visible through the boom where the reefing line exits, forward port) and about the number and size of washers that go on just before the cotter pin. I even speculated that a clevis pin would be desirable in place of the small cotter pin. Well, it turns out that there is an easy fix. If yours is like mine, it is simply a case of a missing pin and perhaps an undersized cotter pin. There is supposed to be a 3/16-inch-dia x 2-7/8-inch long stainless steel pin that engages the boom end cap and the gooseneck shaft. This pin positively prevents fore-aft movement and also prevents the boom from rotating about its centerline axis (which isn't desirable with a solid vang as the C310 has). Additionally, there is a heavy flat washer and then an 1/8-inch-dia cotter pin as an additional measure.

My dealer and the factory were very helpful in resolving this issue and I'd bet they'd be helpful to others with this same issue. I installed the parts myself and it was easy and took about 15 minutes (30 if you count the time to get your buddy a beer), but requires two sets of hands. You basically loosen the outhaul line and disconnect the front of the boom from the mast (no need to remove the sail as the solid vang and topping lift tend to balance things by themselves). You then remove the four screws that hold the end cap and tap off the end cap (each side a little at a time) being careful not to drop it on the deck or hatch below it. If the cotter pin isn't 1/8-inch dia, then replace it. Then slide the 3/16-inch pin through the end cap and through the shaft. I coated all stainless steel-to-aluminum interfaces with anti-sieze compound for future ease of dis-assembly. Then tap the end cap back on, re-install the four screws and re-secure the boom to the mast. You may need an extra set of hands for this part and I found it helpful to adjust the vang line tension to aid in getting things to line up. Re-tighten the outhaul and that's it-all fixed. I have created an illustration that shows what the inside of this assembly looks like (see page 2 of this .pdf file).
