Browsing the [HunterOwners.com](http://HunterOwners.com) archives, I read several threads from owners who'd found their compression posts completely rotted away. The pictures were enough for me to bare my compression post, and sure enough, mine had rotted away to the point where it didn't provide any structural support.

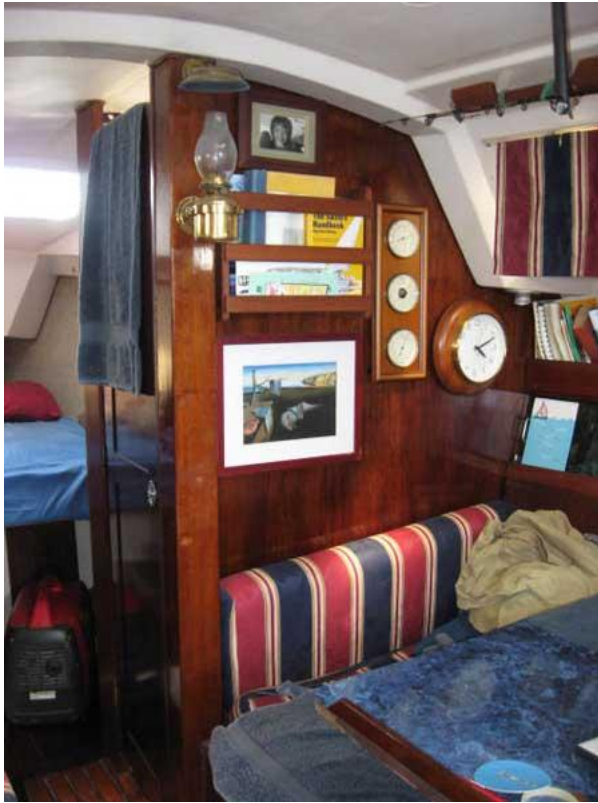
The compression post is hidden inside the post upon which the oil lamp is mounted in the photo to the left. There's three strips of mahogany nailed to it on the cabin side and the back side is covered by the bulkhead and door jam to the head.

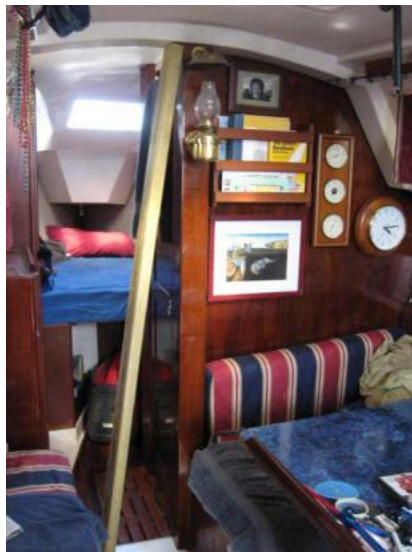
I wedged a very dense 2"x4" between the top and bottom cross-members to support the mast when I removed the post.

Here it's just resting in place, waiting to be pounded in. This turned out not to be enough support, as I had to pound the old post out. I should placed another 2x4 on the other side of the post with a jack so I could force the cross-members apart. I'll need to do that before reinstalling the new post or I'll tear it up while putting it in.

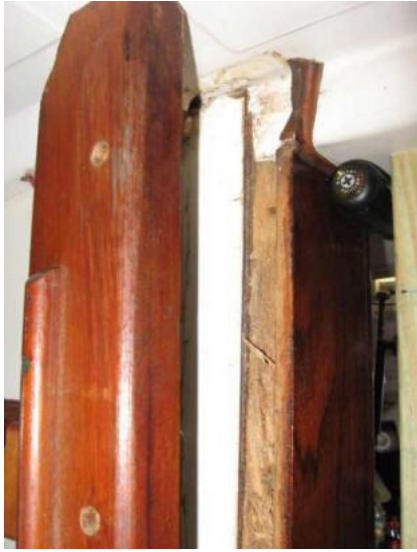
Here we see where the door jam to the head (backside of the post) has been pulled away, exposing a small portion of the post behind the mahogany cover boards.

The post doesn't look too bad here, but when I poked it with a screwdriver the old wood just crumbled.

Half of the brass screws had to be drilled out to remove the door jam because the heads were easily stripped trying to unscrew them.

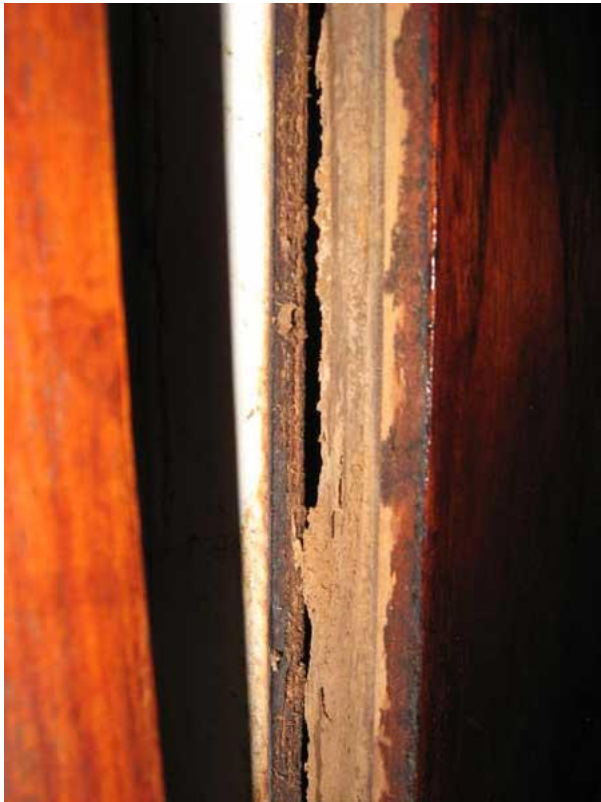
Here's a close-up that better shows the rot.

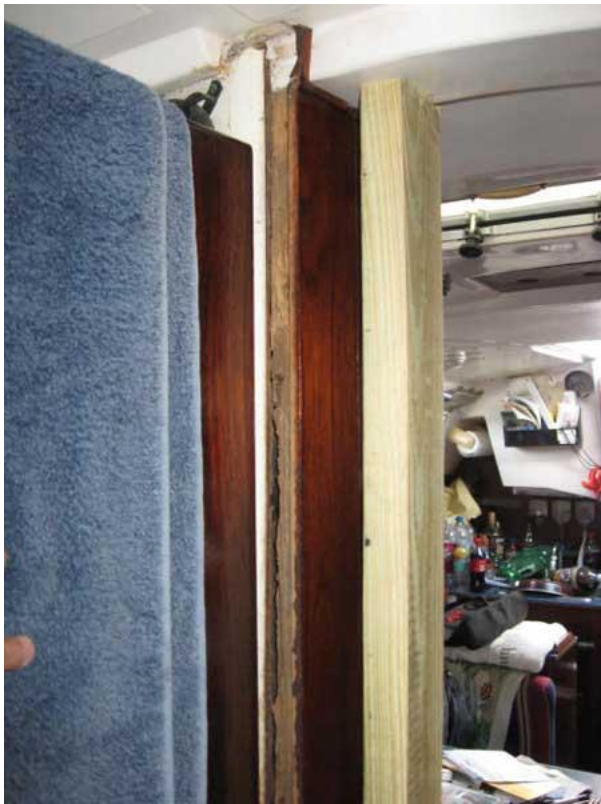
Here the door jam has been completely removed, showing half of the compression post.

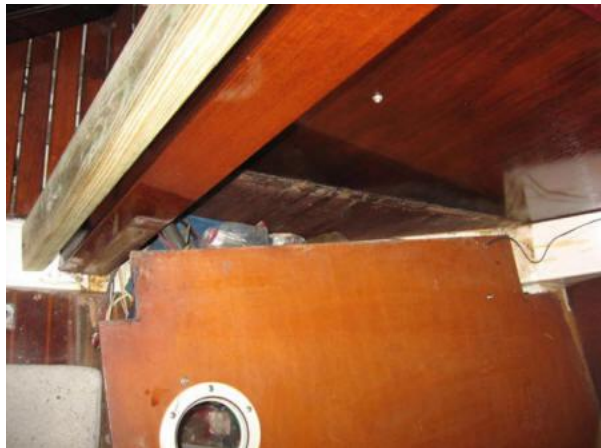
The seat has to be dismantled in order for the post to be removed.

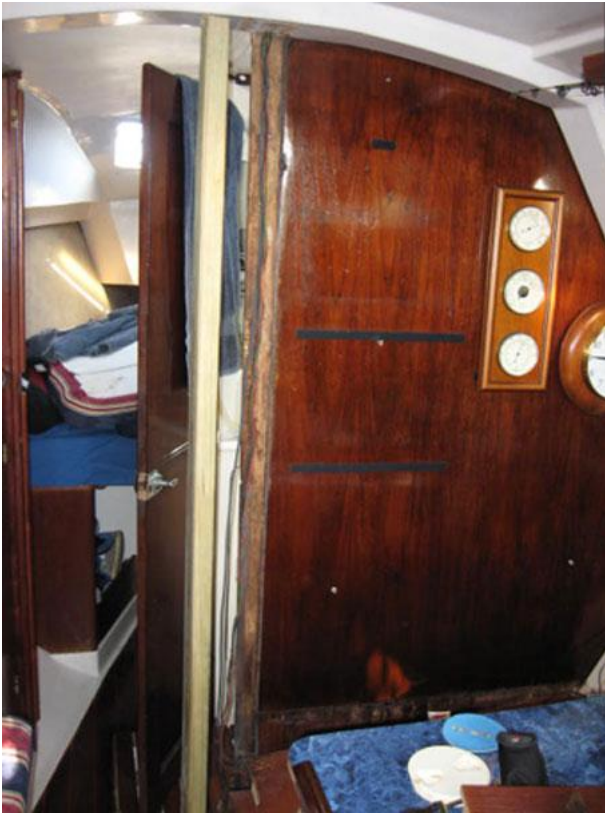
In this photo the post has been removed.

It's now apparent that the portion of bulkhead hidden behind the post has rotted away as well.

A jack would have made this removal much easier and was absolutely necessary for reinstalling the post. The post had to be repositioned three times once the new bulkhead was installed and the jack made that very easy.

I had to decide whether to just cover it up with the new post or completely replace the bulkhead. I decided upon the latter.

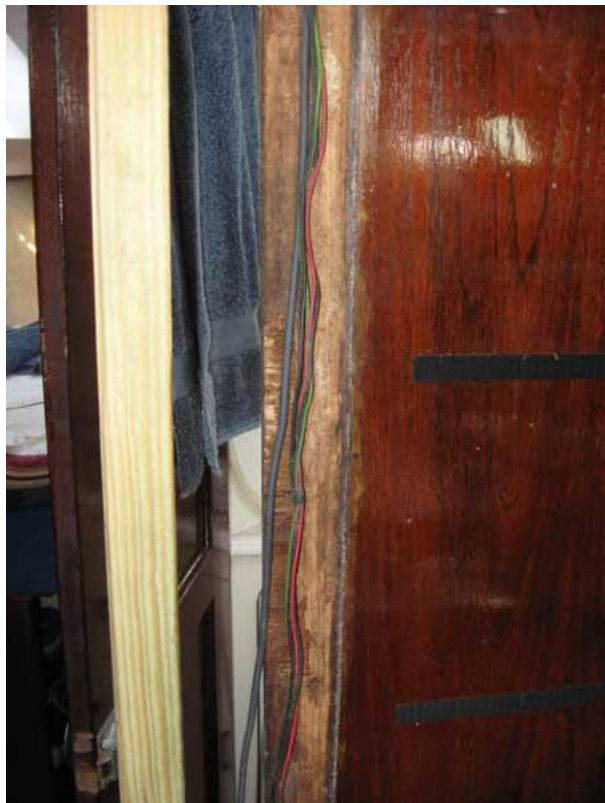
Closer view of the rotted bulkhead.

There's nothing left for a few crumbs of plywood sticking to the laminate on the head side.

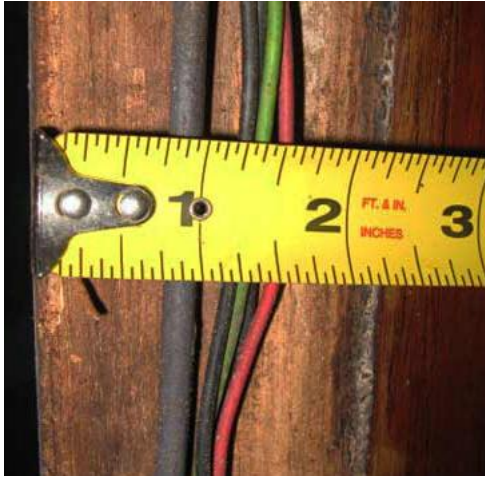
Close-up of the rotted portion of the bulkhead.

These are the original wiring going up inside the mast. The black wire is a 6ga. grounding wire.

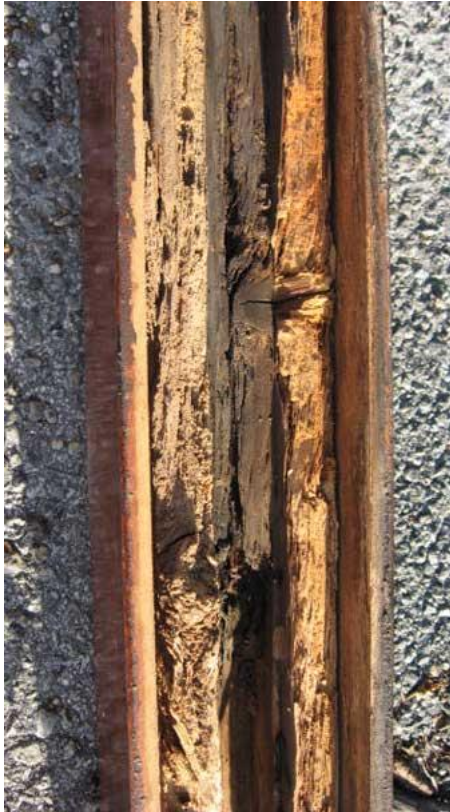
I was surprised to discover that the original compression post was nothing more than two untreated 2" x 4" fir studs with a 1" channel cut down the center for the wires. No wonder it rotted away.

Apparently, the masts are never stepped at the Hunter factory. Stepping the mast and sealing the contact was a dealer responsibility; some dealers were better at this than others.

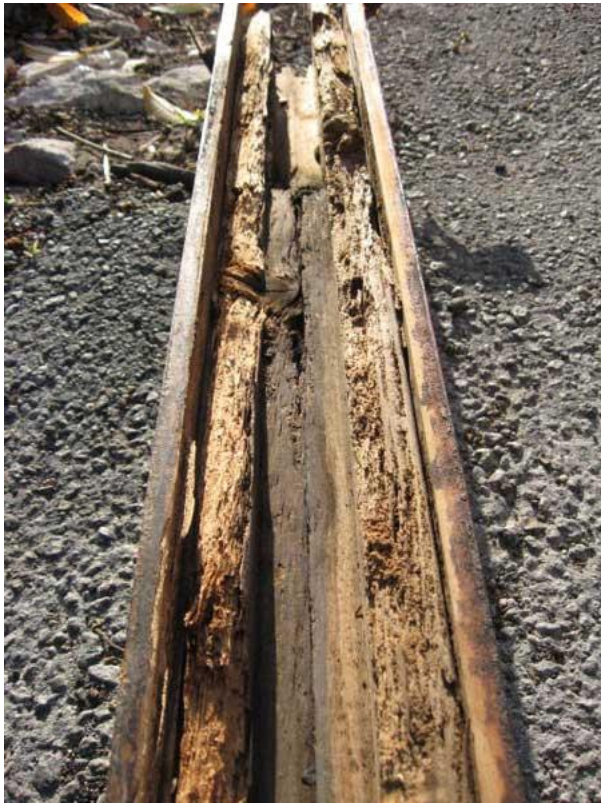
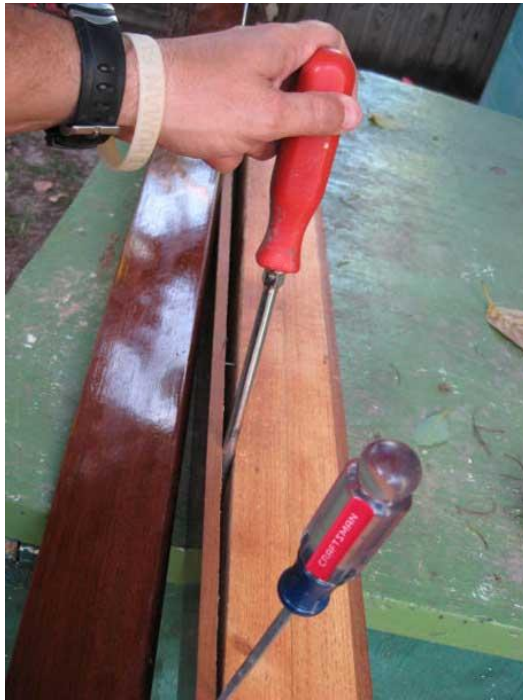
Prying off the mahogany cover boards.

It appeared as though these boards might have once been glued on and set in place with a few brad nails. However, the glue had long ago disintegrated, making the boards easy to pry off.

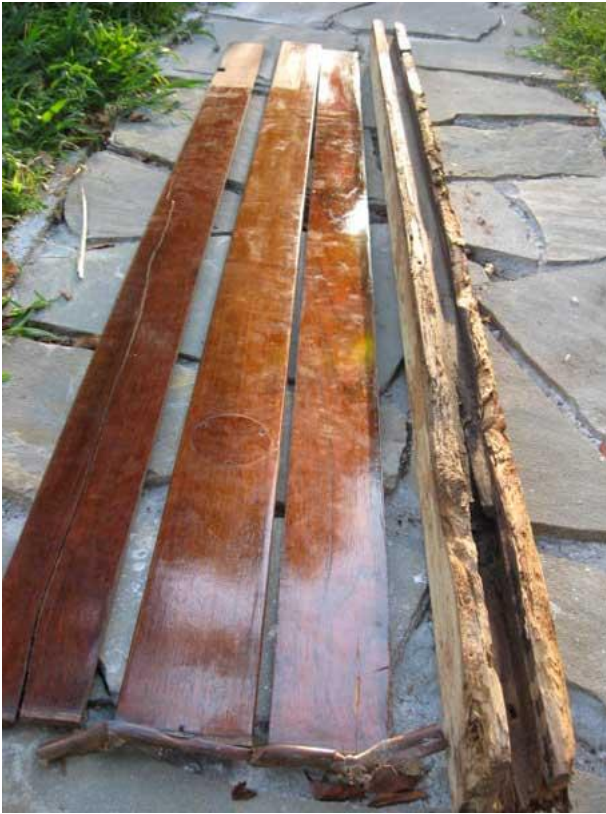
The the mahogany boards removed from the rotted post.

Note the cracked board on the far left. This was because I only had one support 2x4 in place during removal. I'll need to jack-up the cross-member to reinstall.

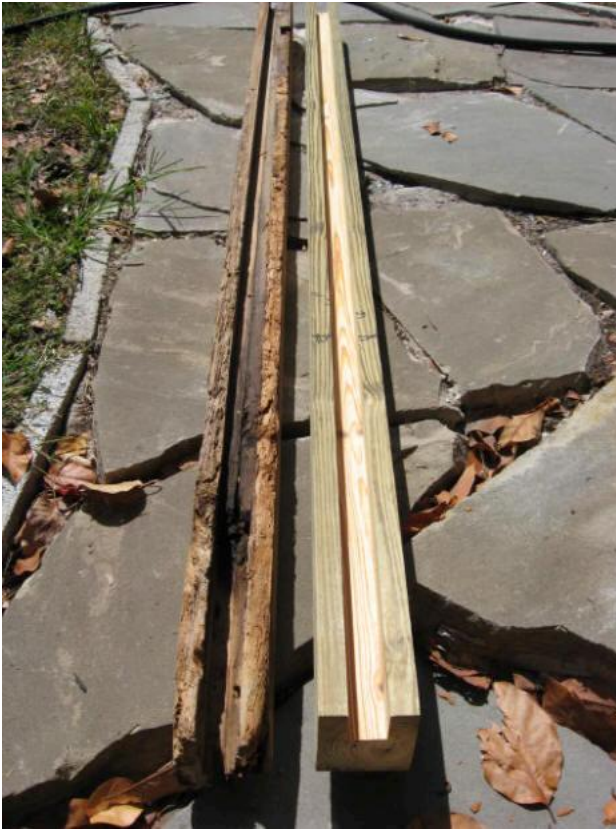
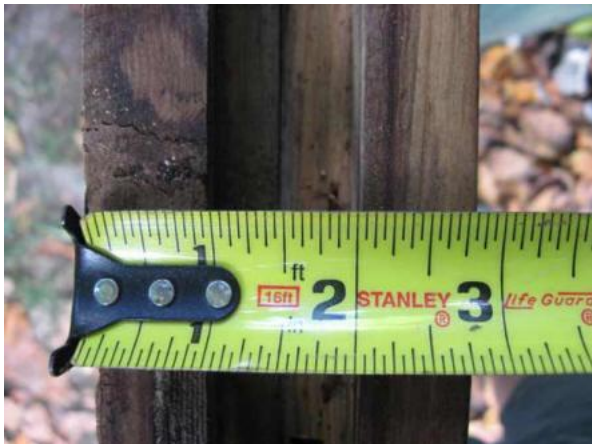
Dimensions of the old post.

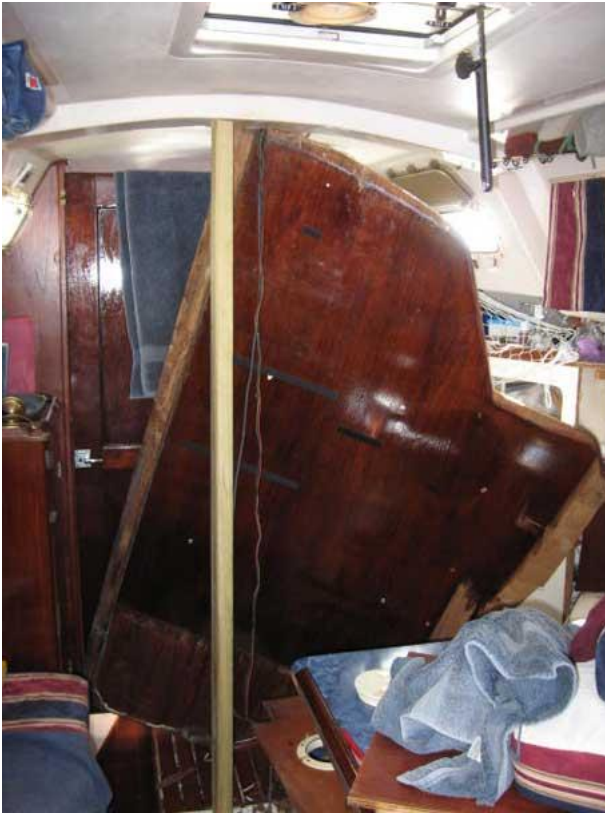
There were a number of hidden screws inside cabinets that had to be identified and removed before the bulkhead would come free.

When the boat was manufactured, this bulkhead was placed inside before the cabin top was lowered-on. Thus, once freed from its mounts, the bulkhead won't fit out the companionway and must be cut.

Removing the main bulkhead.

The new bulkhead will need to be constructed in two pieces so it'll fit through the companionway.

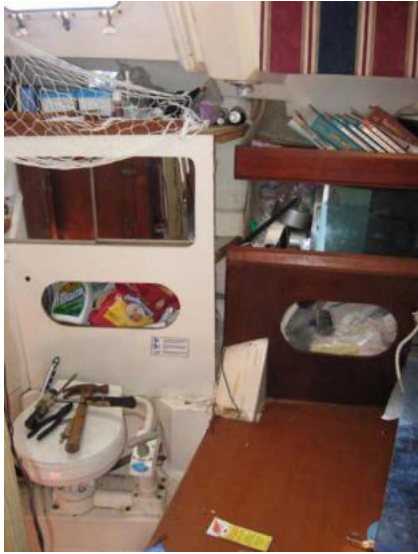
Screws in the dark wood cabinets were hidden under the burlap carpet type material that lines these storage areas.

Others were hidden on the head side, again, inside the cabinets.

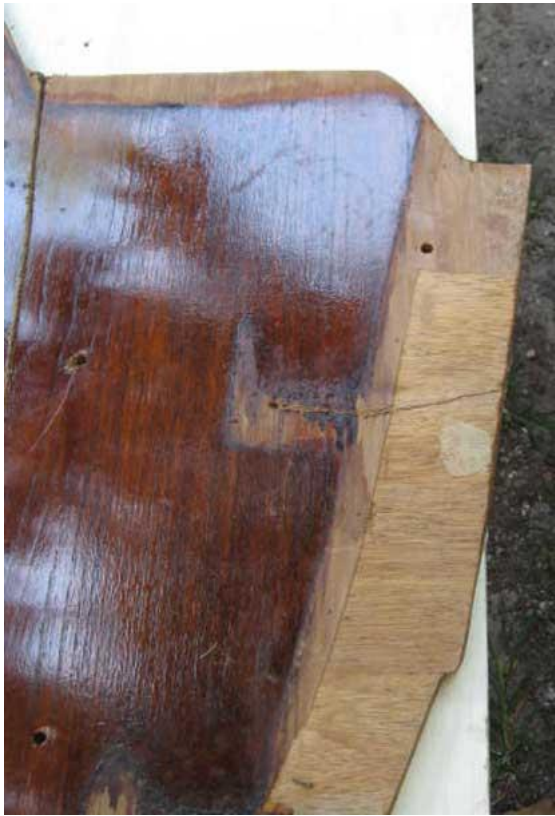
Unfortunately, the bulkhead is slightly larger than your standard 4'x8' sheets of plywood.

I'm going to cut it out anyway and hope the missing portion won't be critical.

Update: This short section didn't turn out to be very important. Nevertheless, since I had already cut out a replacement, I just slipped it in place once the bulkhead was mostly pushed in. The only thing it may accomplish will be to keep small items from falling off the shelf in the head storage cabinet.

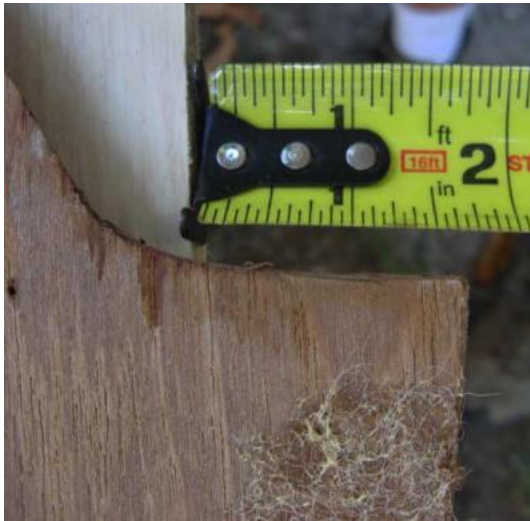
A close-up measurement of the overlapping size.

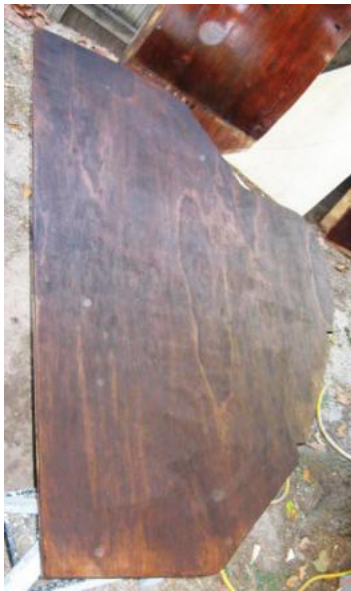
This new plywood didn't take the stain (red mahogany) as well as I'd hoped. The grain won't match very well either.

By comparison, you can see the old bulkhead at the top of this photo.

I've ordered a sheet of mahogany veneer to cover this side from [veneersupplies.com](http://veneersupplies.com). I think this is the only way it'll look acceptable.
