## HUNTER 34 FALSE BILGE PROBLEM

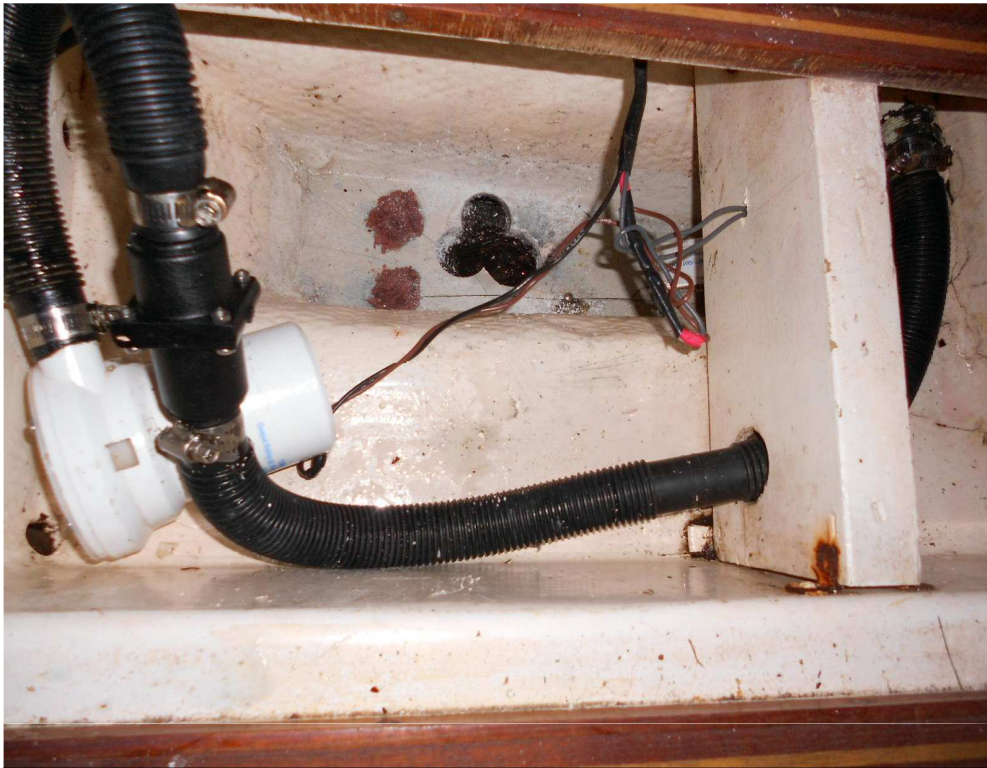
**Fall of 2014, after many years of trying to ignore or hide it with various products, I decided to take a look at the false bilge issue. I already knew about water being trapped there and had plugged up the 2 or 3 screw holes where it was seeping from. That's the pinkish spots you see on the false bottom.**

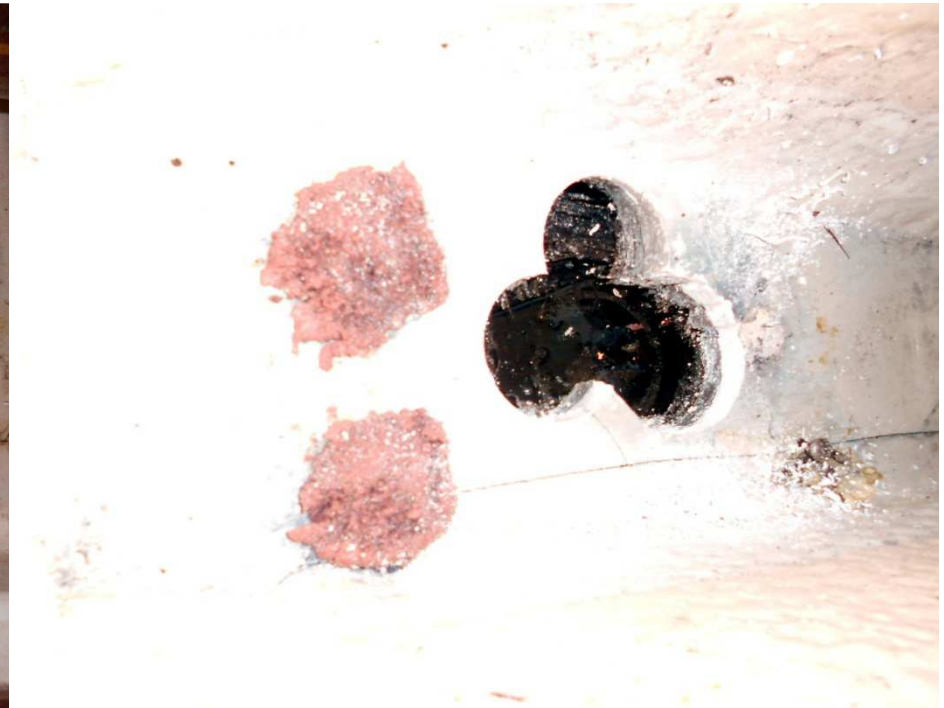
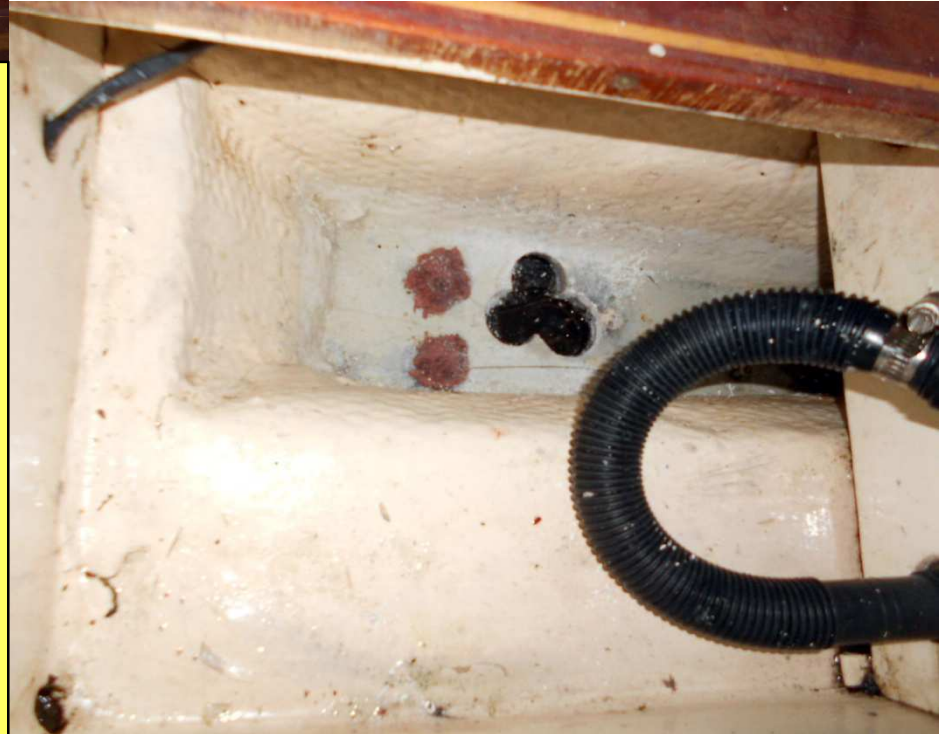
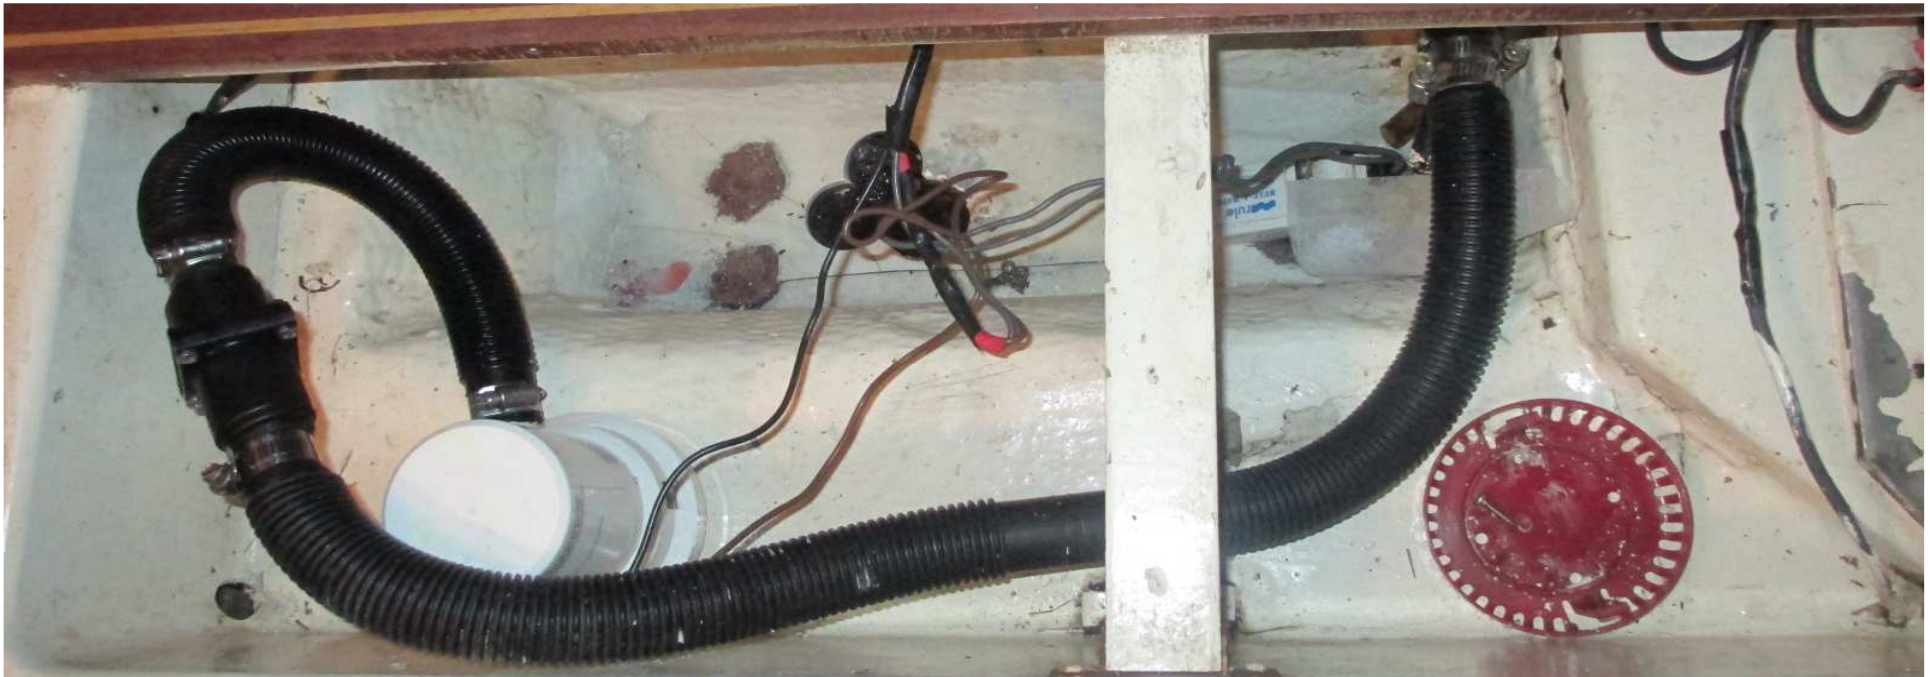
**After haul-out for the winter, armed with my hole-saw, I cut 3 holes in that false bottom. Reeking from the smell, I pumped more than 2 gallons of fouled water with my shop-vac.**

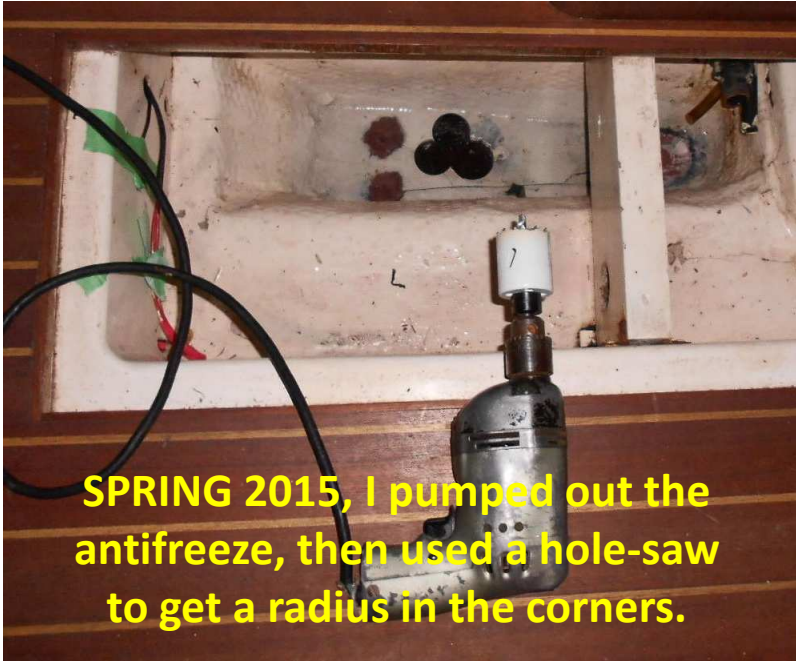
Since it was late October, I had decided that the project would wait until Spring of 2015, so I pumped non-toxic antifreez through the bilge pump to make sure no water was left in that extra long and curvy hose, Once that done, I dumped antifreeze in the bilge to avoid possible damage from left-over water freezing.

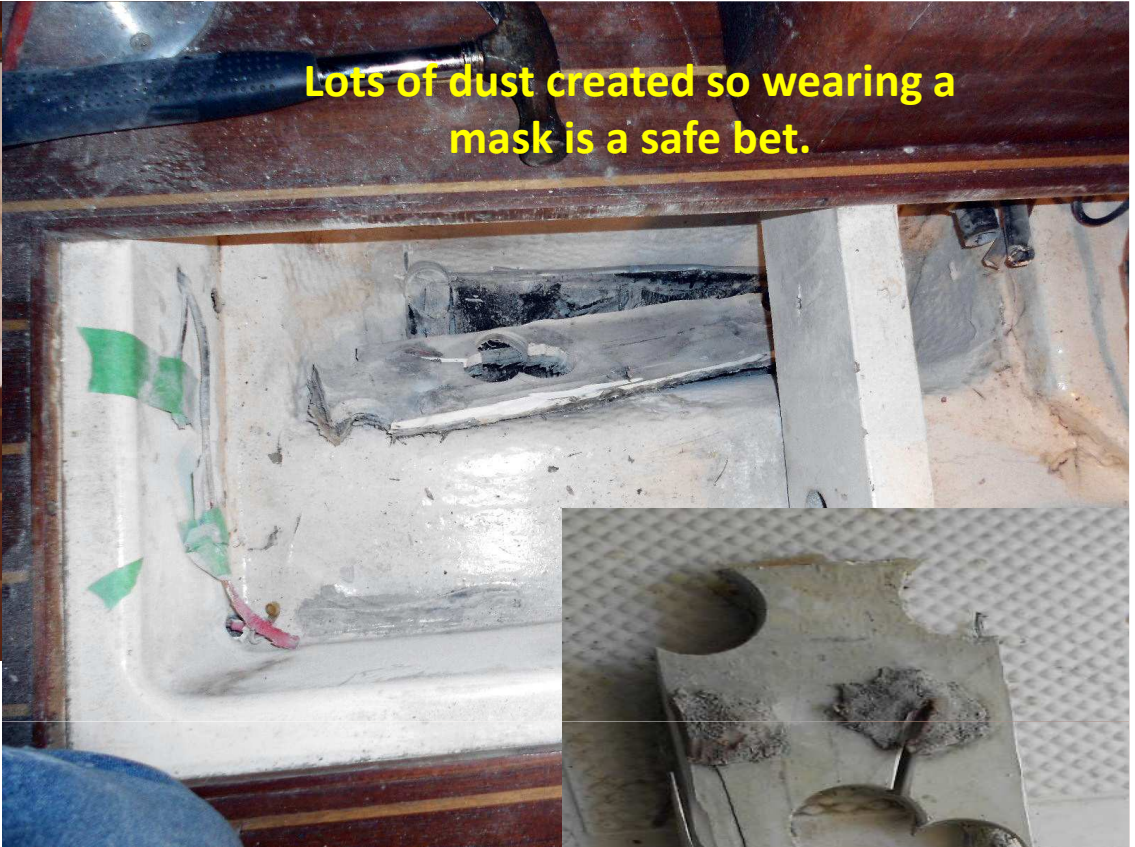
**SPRING 2015, I pumped out the antifreeze, then used a hole-saw to get a radius in the corners.**

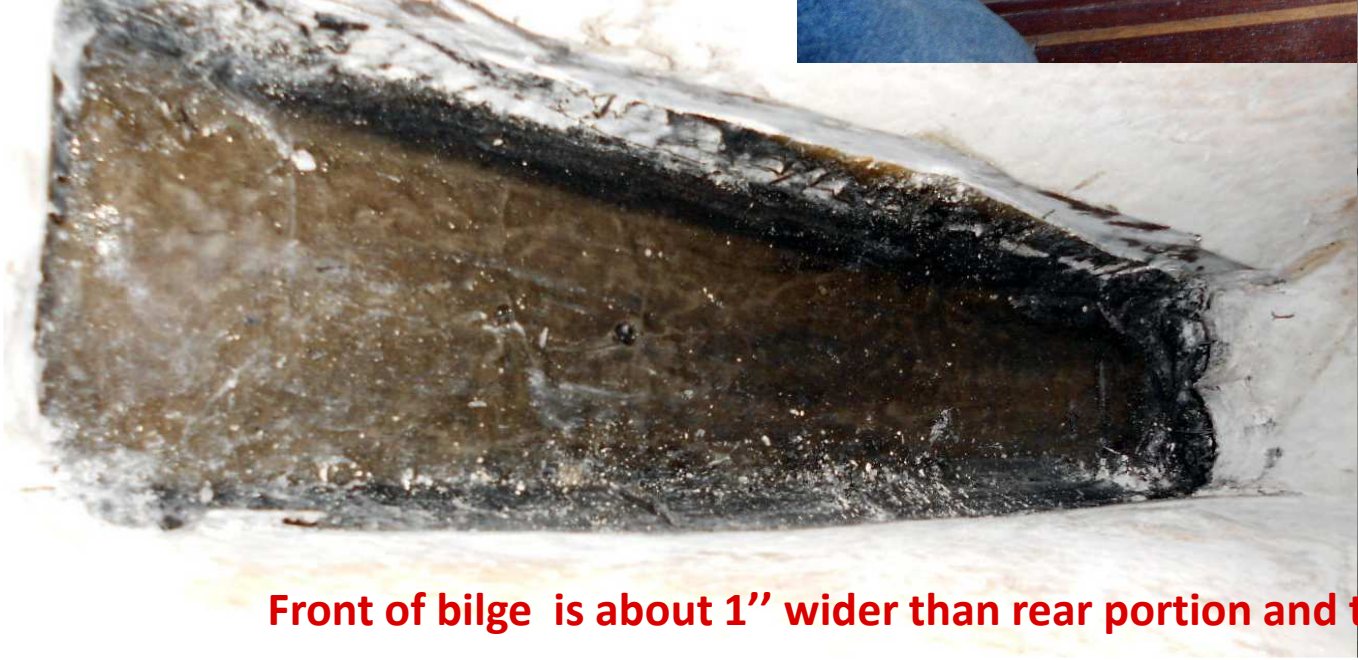
**Also using a 4 1/2" cut-off wheel and a multi-tool, I cut alongside the walls.**

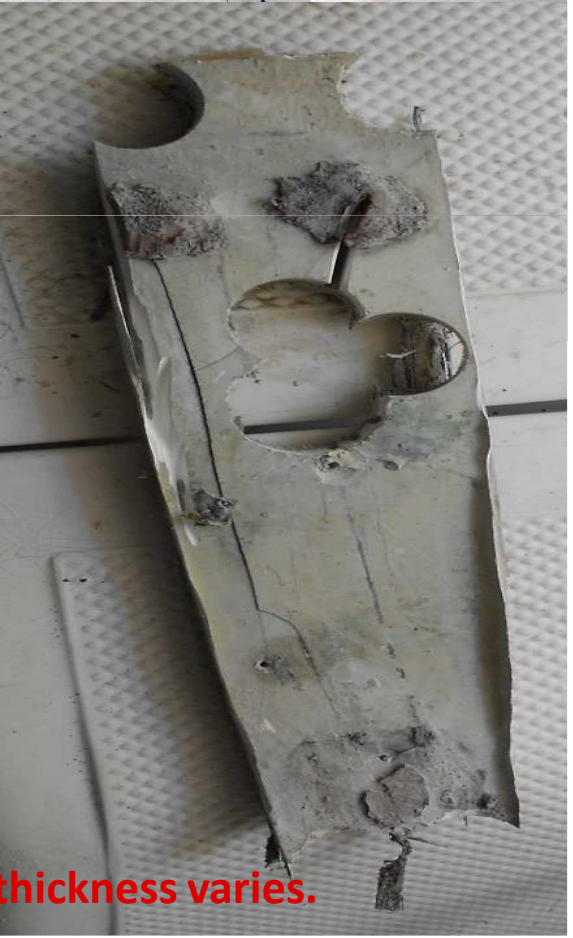
**Front of bilge is about 1" wider than rear portion and thickness varies.**

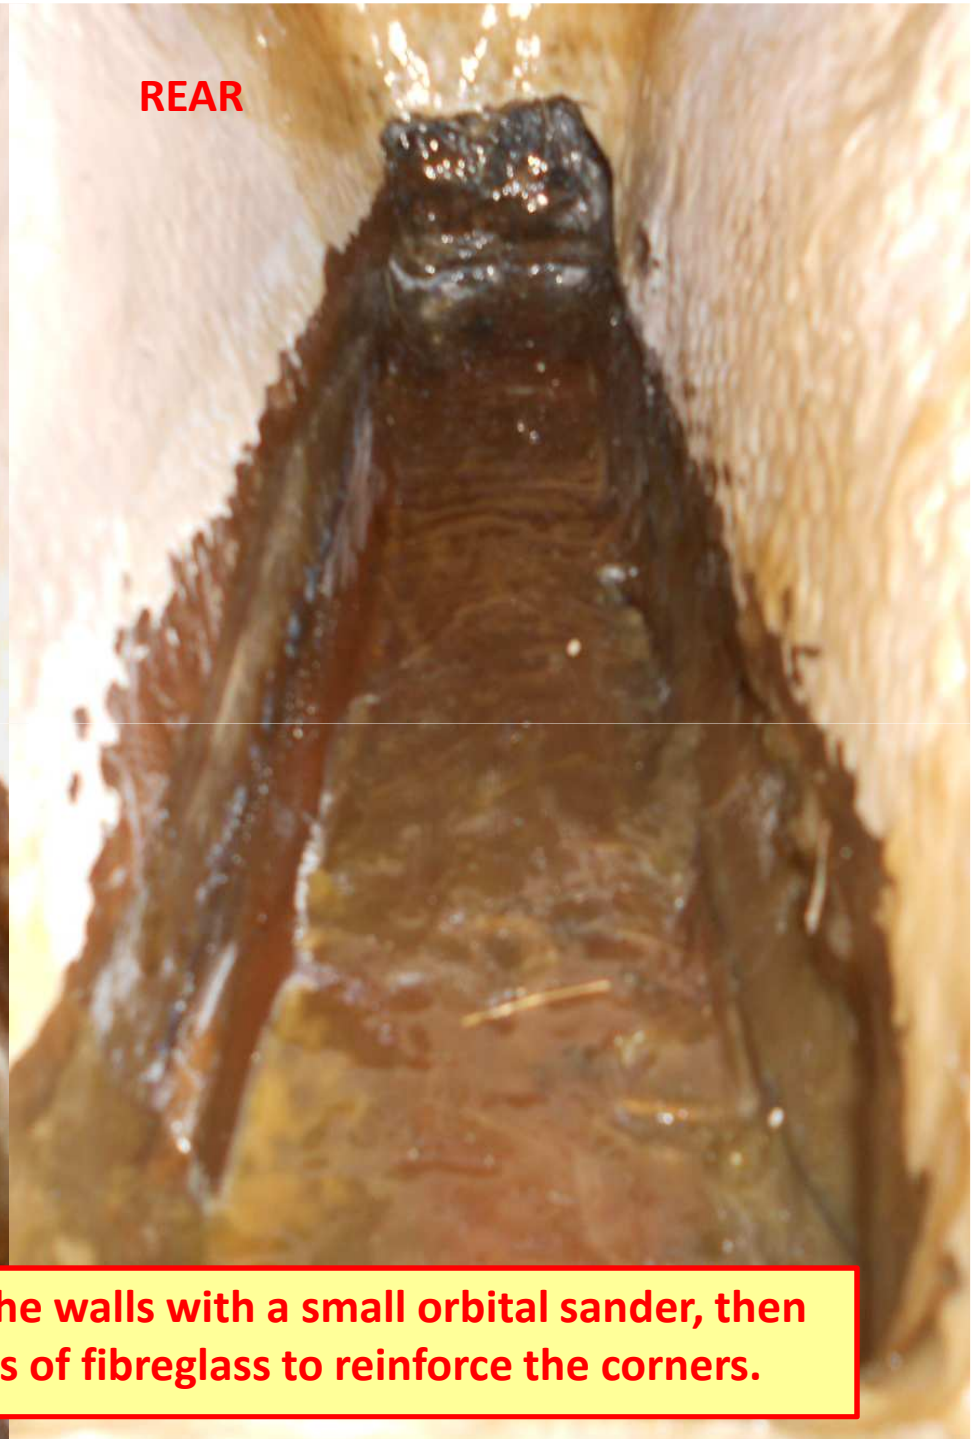
**REAR**

**After cutting was done, I smoothed-out the walls with a small orbital sander, then cleaned and patched with several layers of fibreglass to reinforce the corners.**

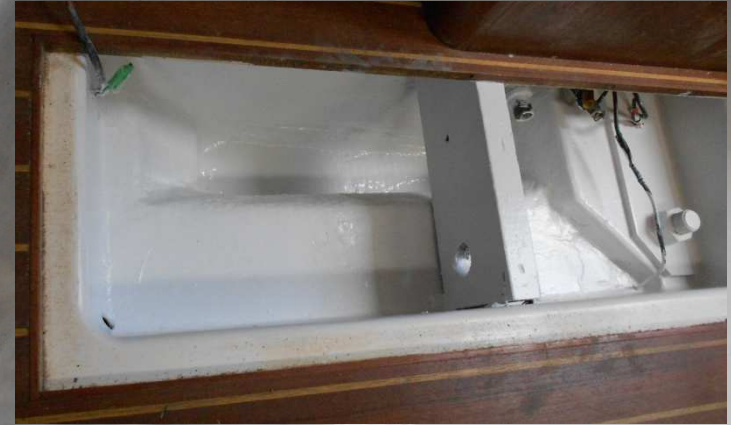
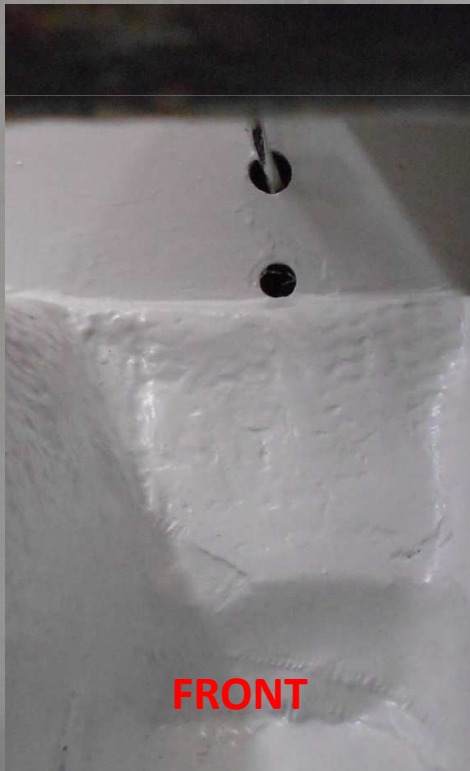
**FRONT**

I left the reinforced rear section opened after checking that water seeping from the packing gland was getting to the true bilge through that opening.
