SERVICE BULLETIN

To: Beneteau Owners
 From: Neil Pryde Sails International
 Date: August 8, 2015
 Reference: Classic Mainsail Reefing

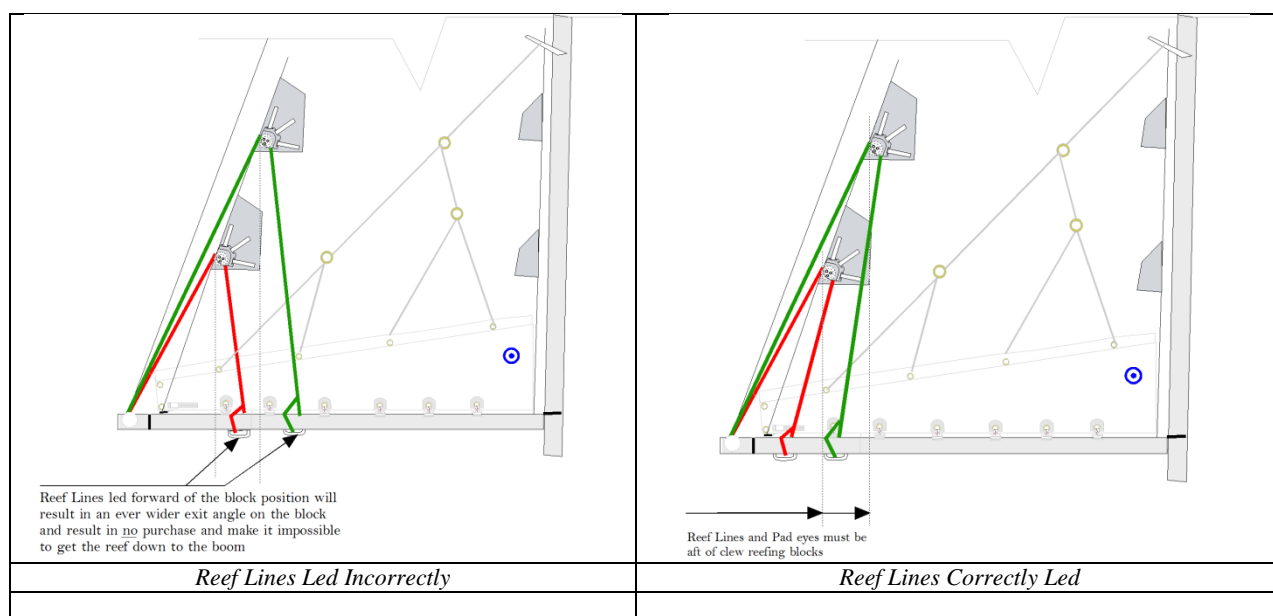
1. Occasionally we have customers who have damaged a reef tack block (s) by winching the block into the gooseneck fitting. Often both the block body and sheave are damaged and will need replacement
2. This is a result of too much force being used to reef the sail...which should not be the case.
3. After investigating a recent case, we found that the owner or yard had set up the clew reefing lines too far forward on the boom. As the sail was reefed with blocks in this position, it was virtually impossible to pull the clew reef down...and more and more pressure was applied which brings the reef tack block into the gooseneck fitting and results in damage.

1. The reef pad eyes are allowed to 'float' along the bottom of the boom. Normally the reef line goes around the boom and through this pad eye and then is tied around the line to close.
2. It is imperative that this pad eye be aft of the reef block when the sail is reefed.
3. By having this pad eye and reef line aft of the block location the block will turn smoothly and provide a true 2:1 purchase on the reef making it easy to reef.
4. We suggest marking the location of each pad eye as a reminder for the following season installation.
