Screensaver  
Hunter 49 Owner's Review  
[general@it4u.com.au](mailto:general@it4u.com.au)  
<http://screensaver49.spaces.live.com/>  
Nov 2009  
HIN

Screensaver  
Hunter 49 (2008)  
Hull HUN49158K708

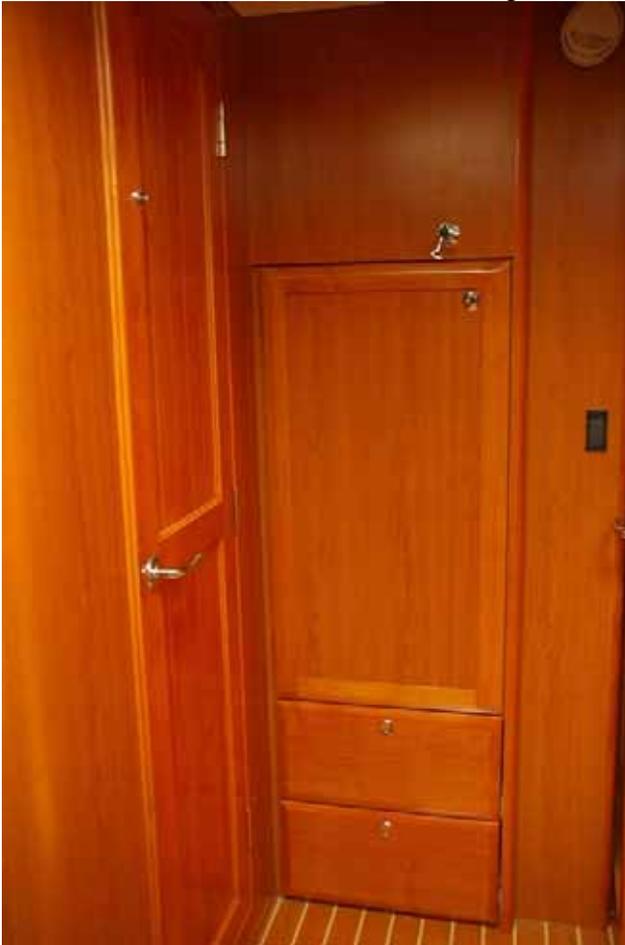
The master wardrobe has a space above it which is not well used, and when one s living onboard for an extended period wardrobe space is premium. This cavity could be easily used, and is left blank for those who might install TV in the master bed room.

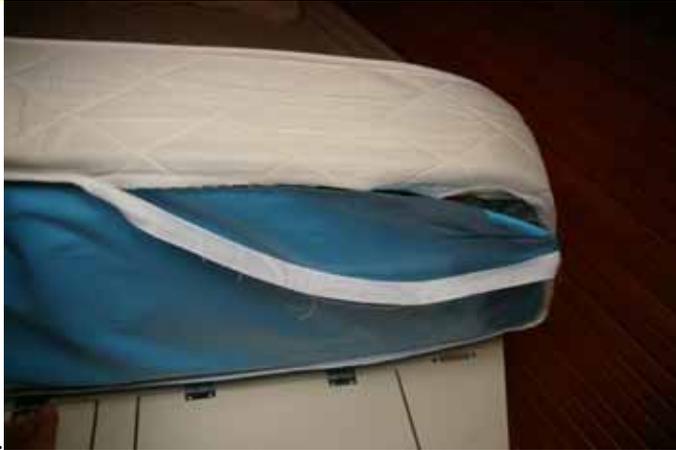
We purchased the upgraded memory foam mattress, but the seam after 6 months has

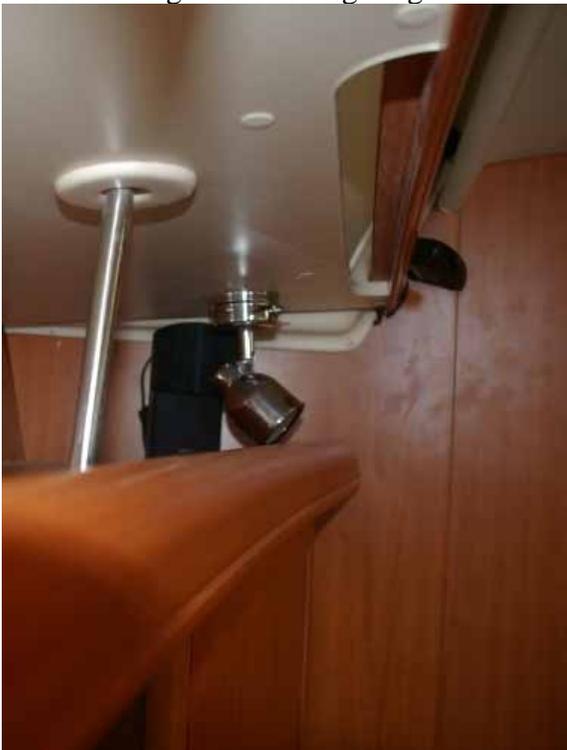
The placement of the two down/reading lights again does not allow them to be used as reading lights, they literal light up the shelf good mood lights which were perhaps the intention, but each should be another 20mm towards the centre line then they could be used as reading and mood lighting

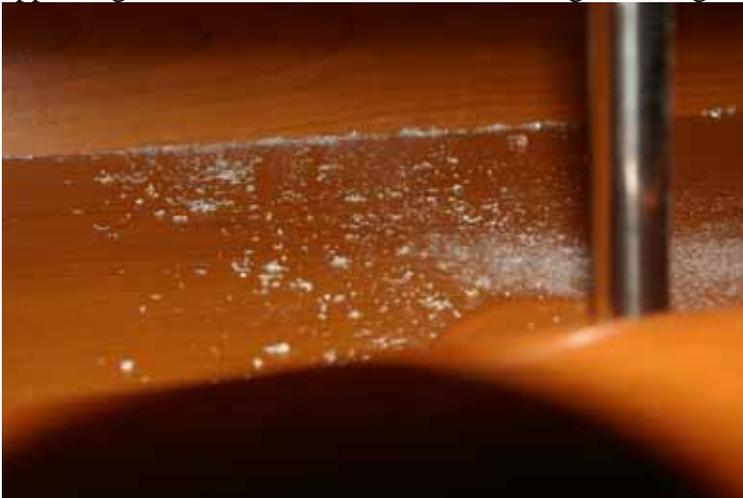
Construction material remains scattered through the boat, mainly in inaccessible spots, but initially through the bilges, and transom. I'm still curiously getting metal work appearing on shelves, which look like drillings or filings, finding bolts and washers.

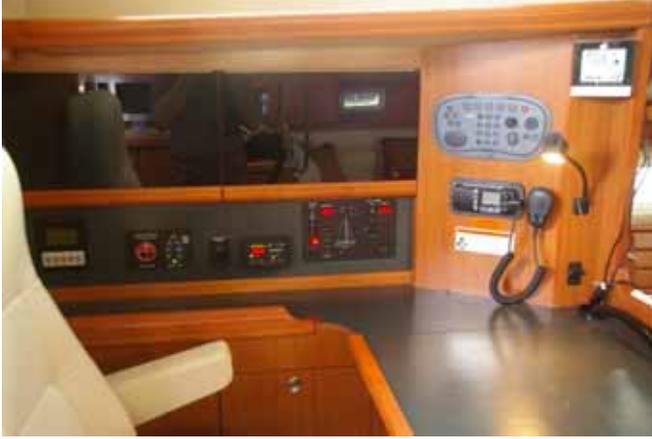
Some added local equipment which was installed had its cutouts done without reference to where I wanted them or what else was going in the Nav station so be sure everyone knows what you want, where to allow for full utilization.

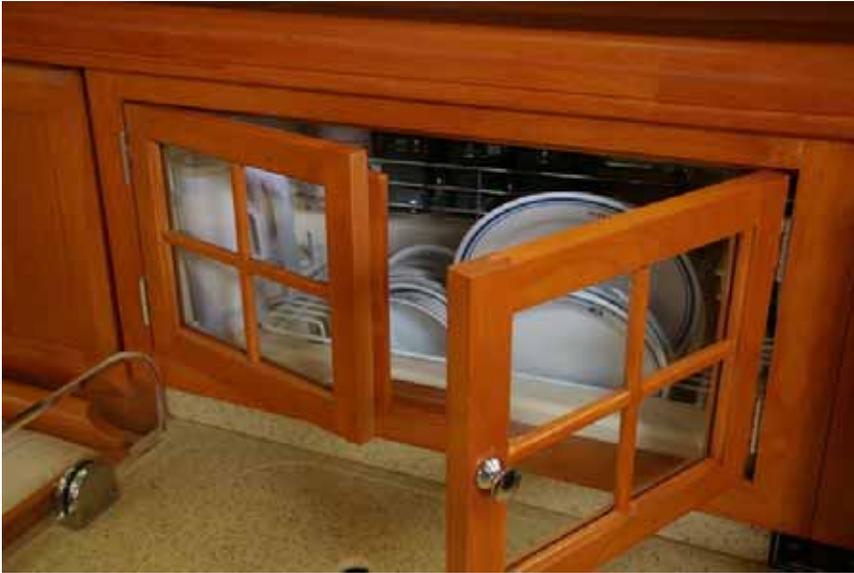
The dish cupboard combination marketed by Hunter works well, however I doubt the designer every used it while on a heel. We will add a clip to the forward door so that half can remain closed.

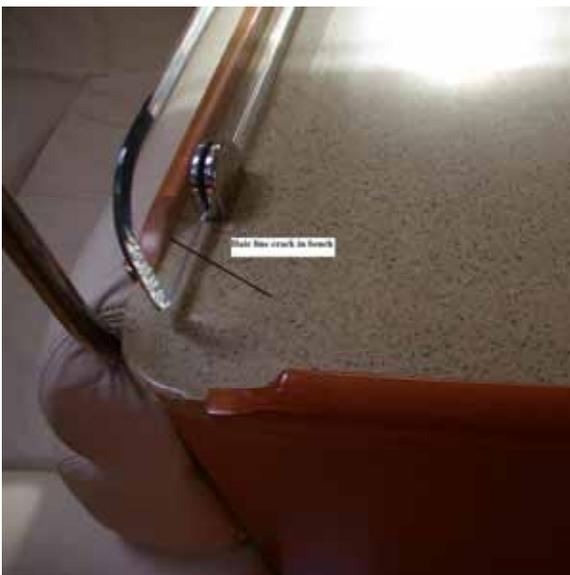
Our bench top has developed a **hair line crack across the corner**, it almost invisible, but it can be felt with the finger nail and was detected during cleaning.

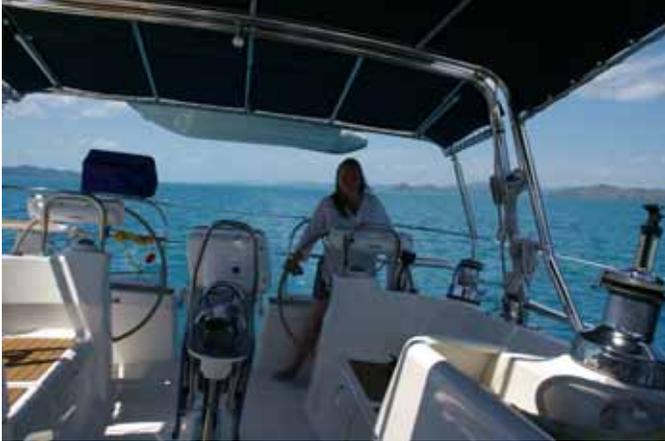
When combined with the Mike Harker special fitted Biminis including davits, and the solar panels on top, high quality water proof external speakers, BBQ starboard and a couple of stainless down lights, you have the ideal area for entertainment and safety. Everyone is very impressed, and the only slight negative is I believe the Davits will require additional strengthening.

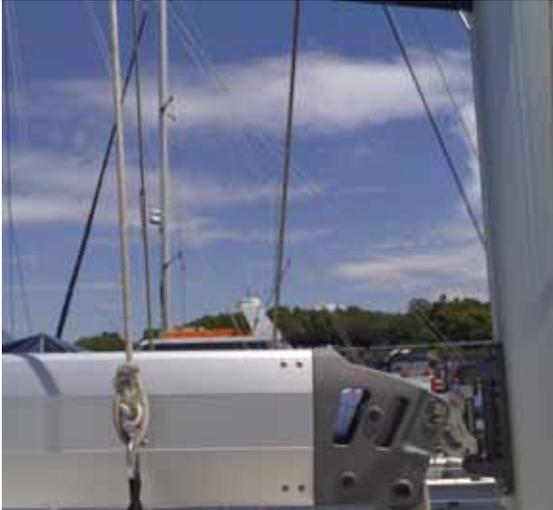
The excess weather helm prompted some investigation which lead me to believe the Rig was grossly out of tune and could well be contributing towards the excess weather helm. A weight hung on the main halyard sits approximately 0.5m (19") behind the mast step, along way back or a lot more rake than the 0.025m (1") recommended.

At this point the masthead should be raked so that a weight hung on the main halyard hangs about 1' behind the mast step.

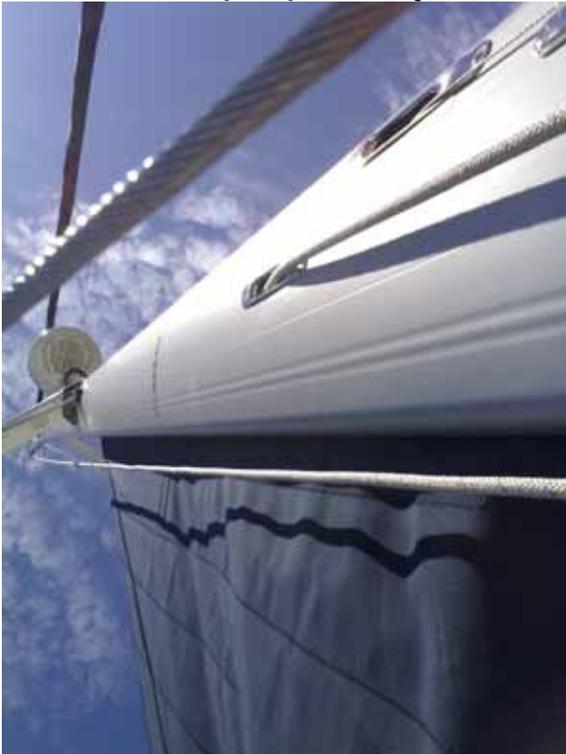
I cannot accurately measure the bend given it should be measured at its deepest point, but I would estimate its in the order of 100mm (4") about double what it should be according to the documentation:

"The maximum amount of bend should be no more than 1% of the length of "P" for the standard rig and no more than 2" [50mm] for the furling"

One might be tempted to say adjust the forestay some more. The problem with that is it's already fully adjusted or reduced. **I have yet to resolve this one way or the other.**

I have sought expert qualified advice and confirm that the Rig is not in tune with Hunter specifications, and it can't be adjusted to meet those specifications. It was also noted that the mainsail track visually appeared pinched at the second spreader, the cause unknown.

**Update: The quote is \$1380.00 to resolve this.**

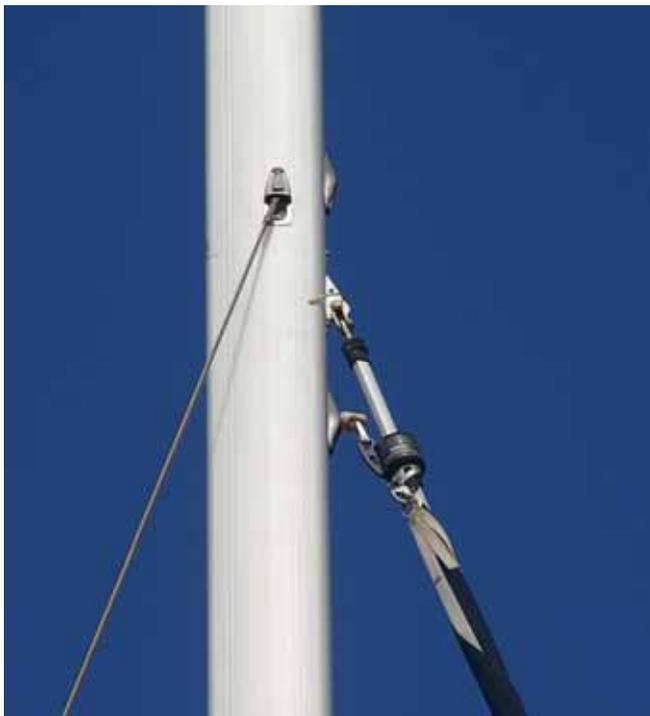
Also the Sail is slightly too big and as can be seen in the above picture you can't tension it up any more, as already the halyard is trying to pull the furler into the mast. So once the forestay issue is resolved (ie shorter) **this will then require a sail cut and change**, as already the sail has slight wrinkles due to lack of tension.

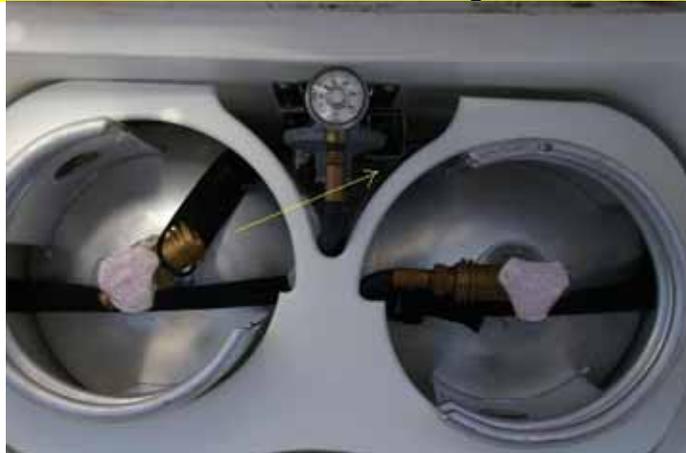
The Gas Bottle compartment has two gas bottles located in under the starboard cockpit seat. Located between the bottles is a solenoid which can be activated from the galley and effectively shuts off the gas. **This solenoid is miss placed, such that you can't actual remove the rear bottle without leaving the solenoid forward and out of the way**

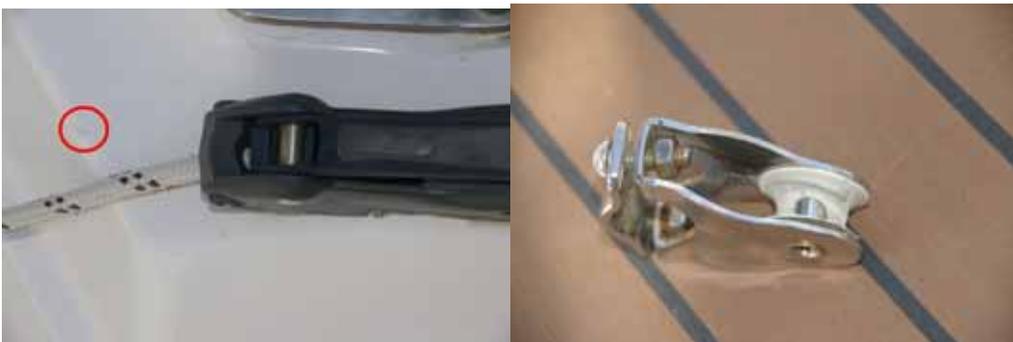
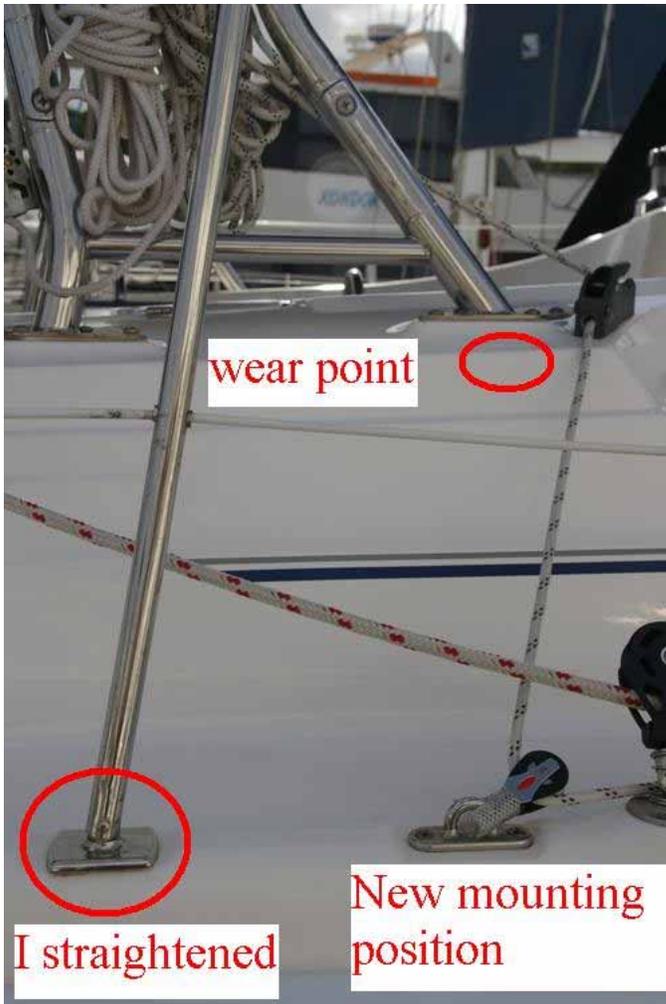
The furling line for the Jib runs along blocks on the stanchions. This route causes the fuller line drag across the corner of the cabin top and has worn a groove through the gel coat. The block also seized, and slid up the stanchion giving it extra leverage then substantial bending stanchion. Firstly the block should not have failed; the cleat should not be mounted where it is such that the furling line is drawn across the deck.

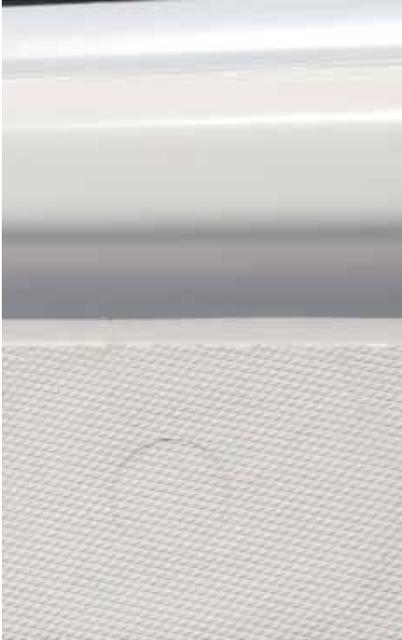
Two round marks have appeared in the foredeck and look like they are pre cut for some option, or addition. The a few more appeared and it became apparent that the water and waste filler wholes had be pre drilled in the wrong place in the factory. These were later repaired but not like new.

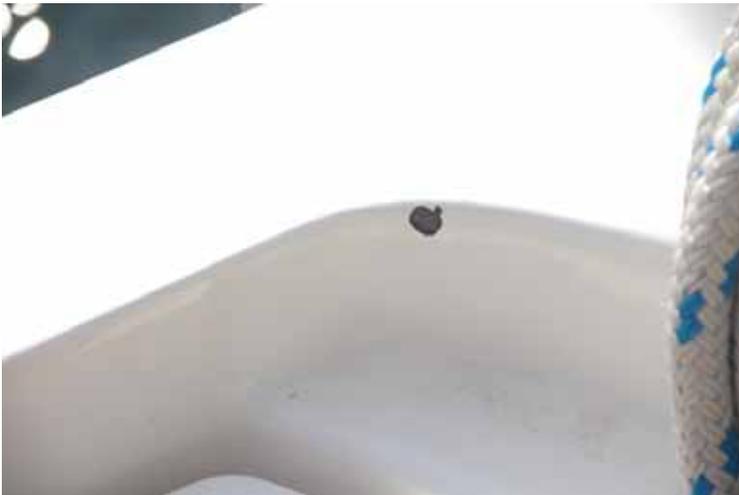
A few air pockets have resulted in the gel-coat falling out mainly round the cockpit area. As these weren't done by us, I can only assume they happened somewhere between the factory and delivery, and the repair or touch up has dislodged.

Clearly warranty doesn't work how I would image. The stress cracks, air pockets in the gel-coat, alternator, and forestay are some of the rejected warranty issues

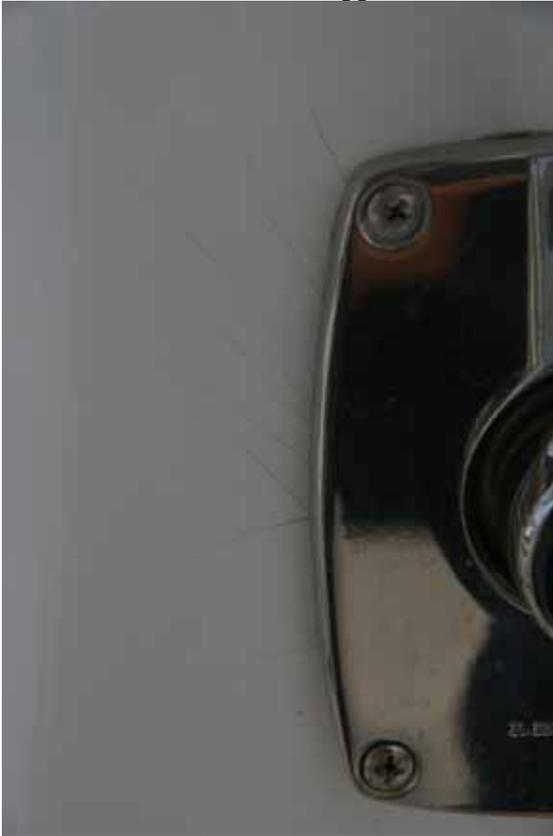
A stress fracture has also appeared.

I'm told these sort of things are not warranty. But its not "fair ware and tare" or damage by us.

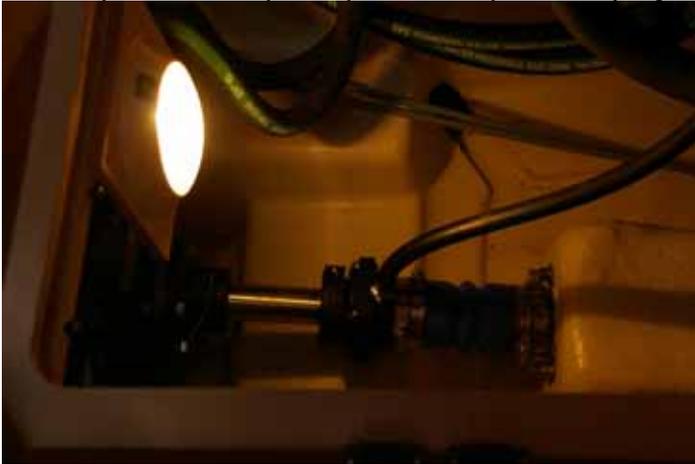
Entry to the rear engine compartment is obtained through the closet ( a smart idea), to access water intake filters and propeller shafts etc. A light is installed, but it has a tendency to shine in your eyes, where you are trying to look.

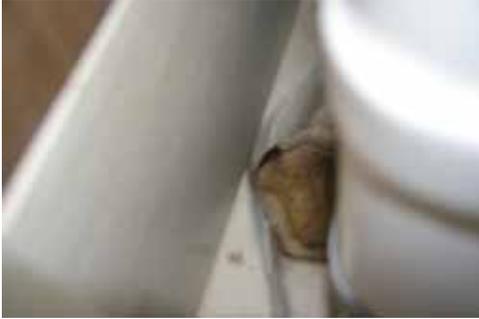
Generator side drain going no where

The interesting thing is on the Hunter video (bottom image) it shows what appears to be the whole I'm looking for interconnecting the generator compartment with the main bilge

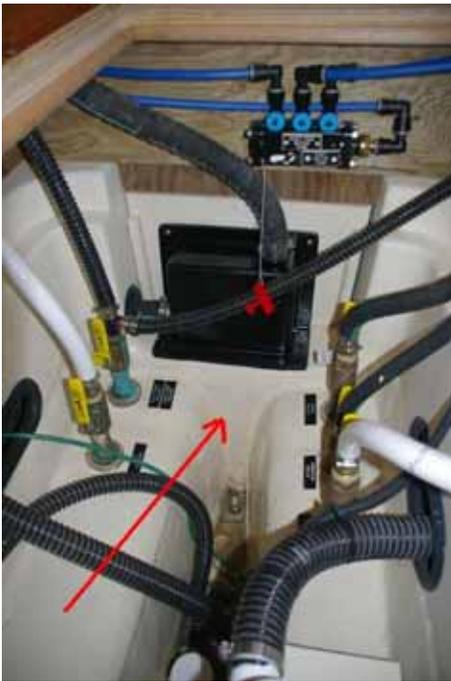
Our bilge

Underneath the main engine and the generator, is what effectively amount to molded trays in built into the bilge, so any fluids which leak out from say the main engine remain trapped under the main engine until there is approximately 4-5 cm of fluid depth where it will then overflow into the next down line chamber under the generator.

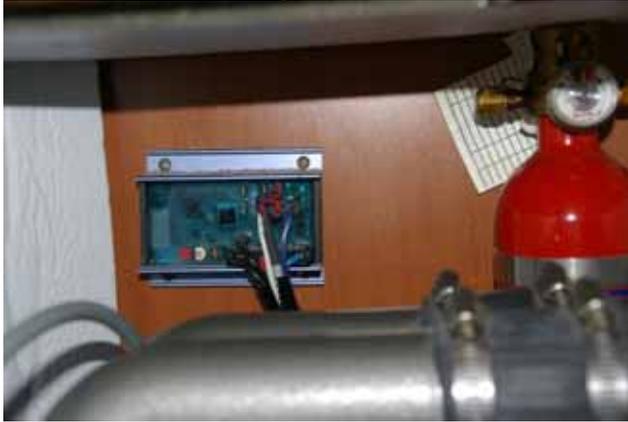
In our case there are a number of ways to return charge. I am now aware of 3 49's that have had alternator issues, me being one. In my case the regulator failed first followed by the alternator, and

I chose the high power alternator as did the others, and each of us had the additional batteries. Both main engine and genset /xantrex/freedom charge system have a tendency to run flat out for a period of time ie 100amps and 120 amps respectively. The freedom unit currently will overload ( @ around 130 amps) if its asked to recharged a set of 50% depleted batteries, which is the maximum they should be allowed to run down to. The charging system can reach 14.2v at times. While typically its only for a few minutes I believe (yet to be proven though) that this is or will contribute to failures. In my case I'm will be seeking to limit the charging systems to not exceed 80% of their respective capacities.

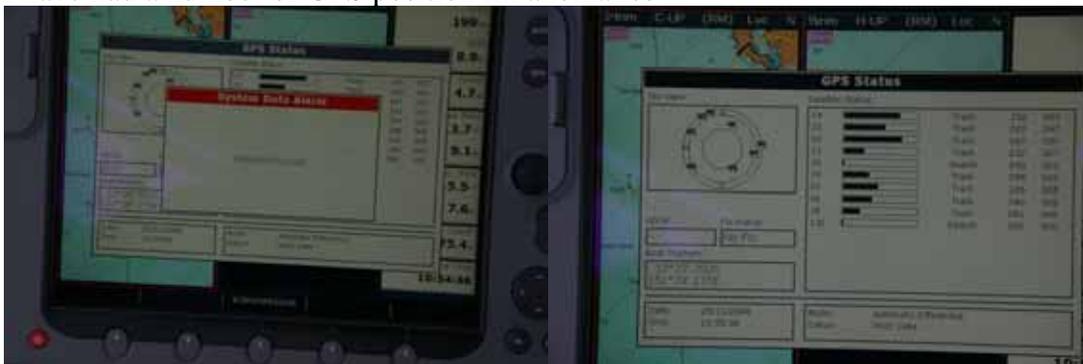
I have had a number of GPS position fix anomalies

To date these have not been resolved and Raymarine seem to just accept them because of their low frequency. Should this occur at a crucial time the results could well be catastrophic. To date I have probably had about 6-10 occurrences of this.
