This is a review of how the steering system and upper rudder bearing was overhauled on a 1991 Hunter 30T. The steering system was in bad shape due to lack of service while living in salt water. My thanks for the excellent technical support and "how to" ideas from Edson, Norton Yachts Hunter Dealer in Deltaville, VA and Eddie Breeden at Marlow Hunter factory in FL. This work was done in a local yard by yard technicians under my direction (mostly...).

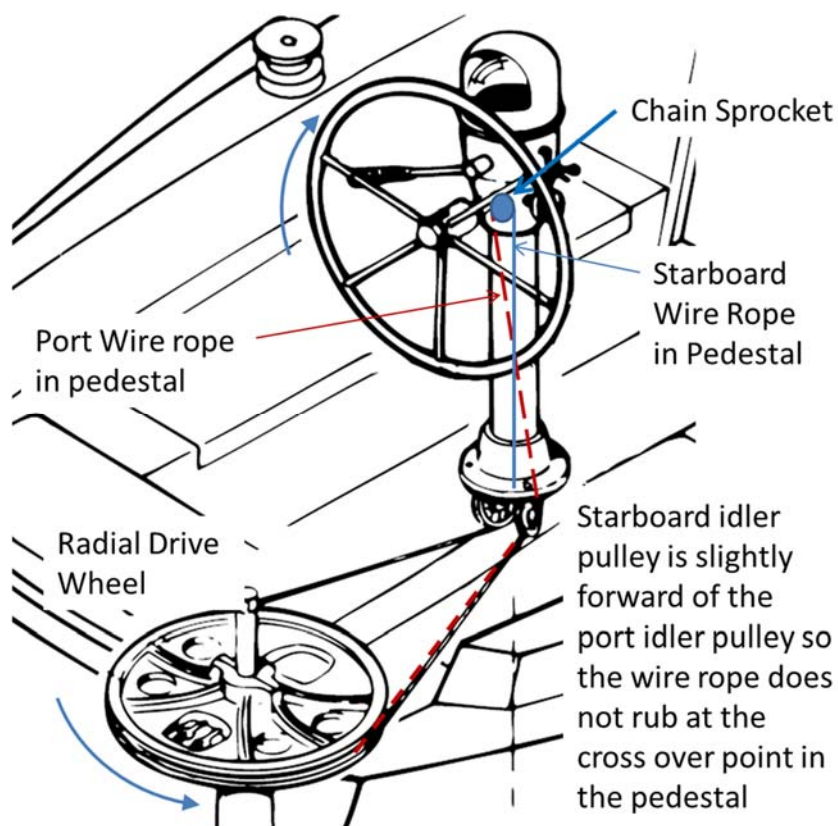
Turn steering wheel and chain sprocket toward starboard pulls up on port wire rope inside pedestal, which then crosses over in pedestal and pulls on the starboard side of rudder radial drive wheel. Note: EDSON tech said the port wire rope in the pedestal should cross in front of the starboard wire rope. In other words the port wire rope is closest to the bow and the starboard wire rope is closest to the stern. But they do cross in the pedestal with the port wire rope exiting the pedestal through the starboard idler pulley at the base.

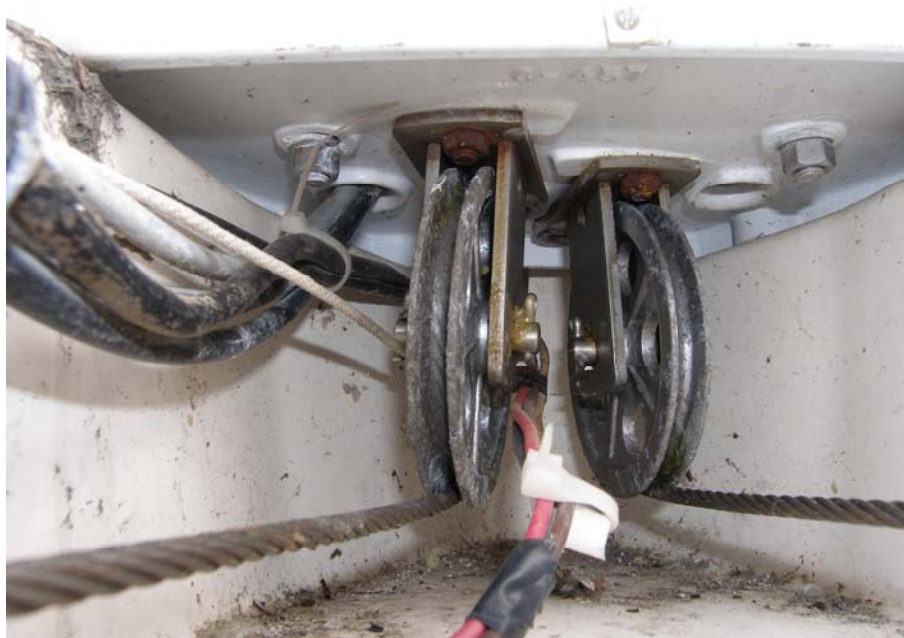
Drive wheel with deck cover removed. I gasped the first time I saw how lacking in maintenance the steering system was. Wheel, wire rope and ss chain were replaced.

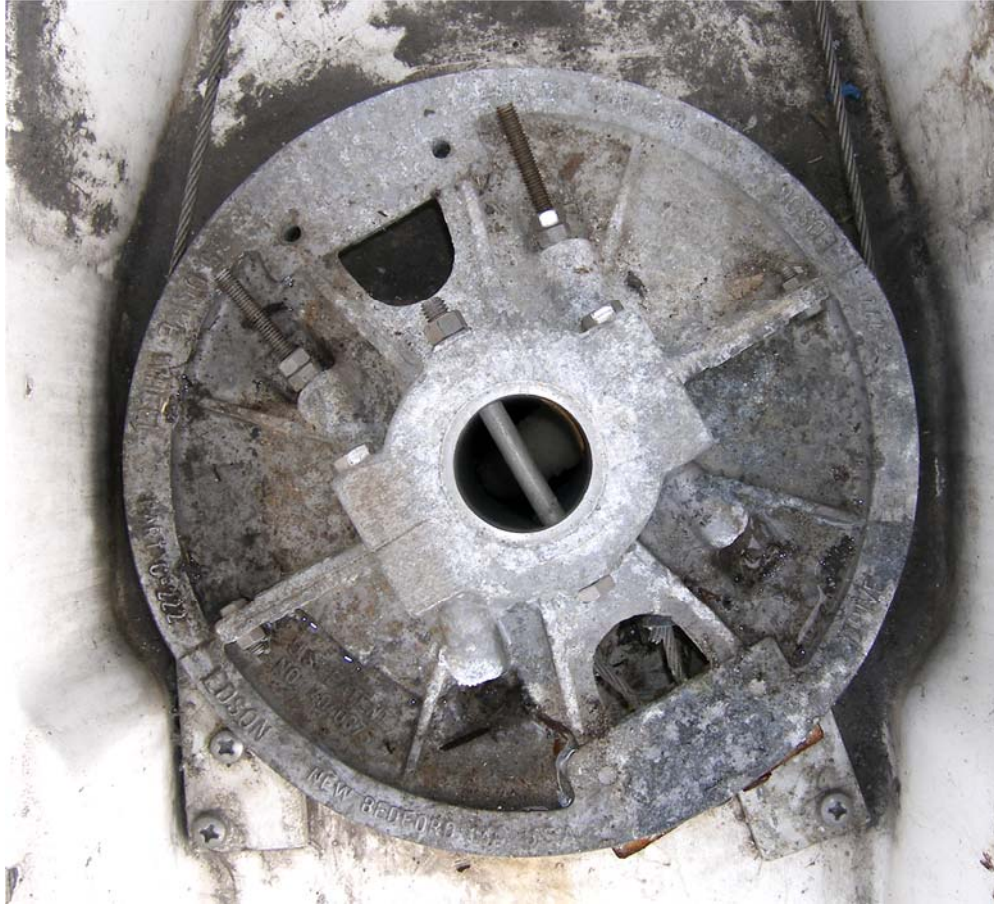
Pulleys directly below pedestal. They were in decent shape and were not replaced.

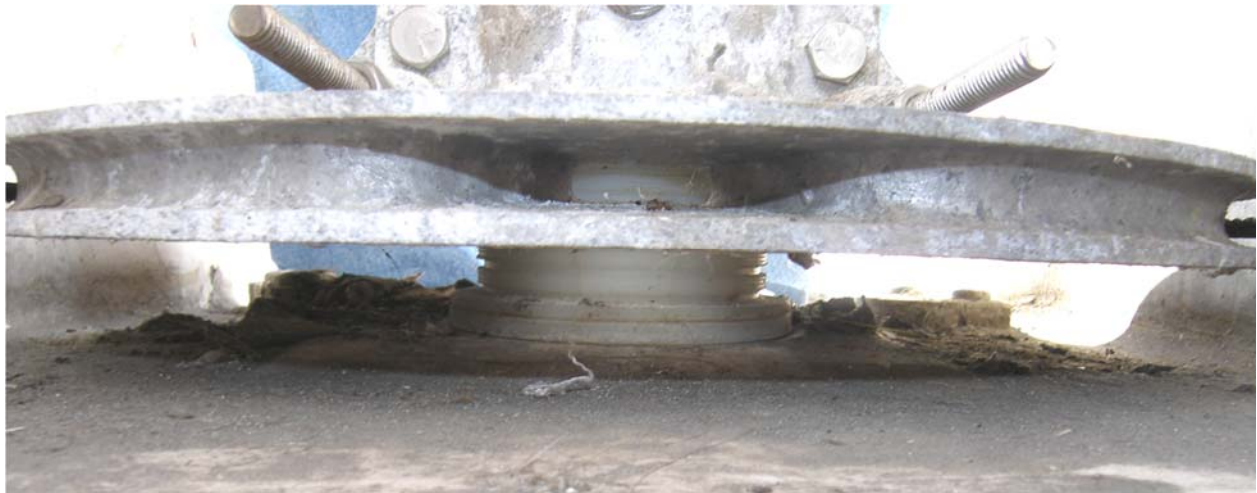
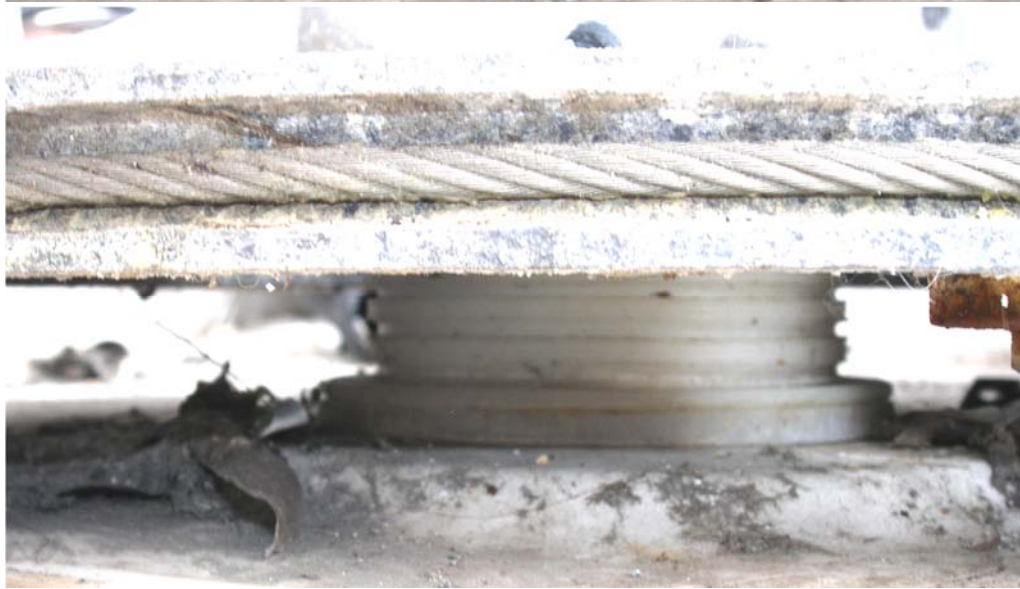
6.5-in (radius) Edson Radial Drive Wheel with deck cover removed.

Drive wheel is two halves that are clamped on to the SS rudder post. Edson bores new drive wheels to the measured diameter of the rudder post. The hole is bored a few thousands undersized so there is a good interference fit per some SAE standard for clamping on the rudder post.

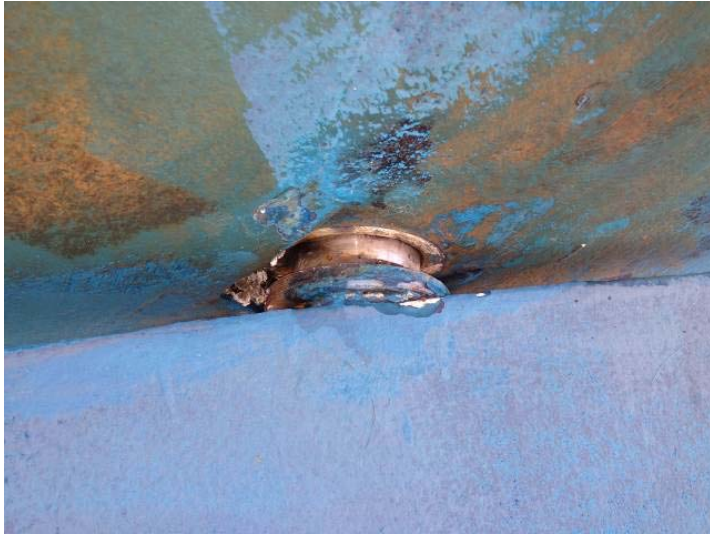
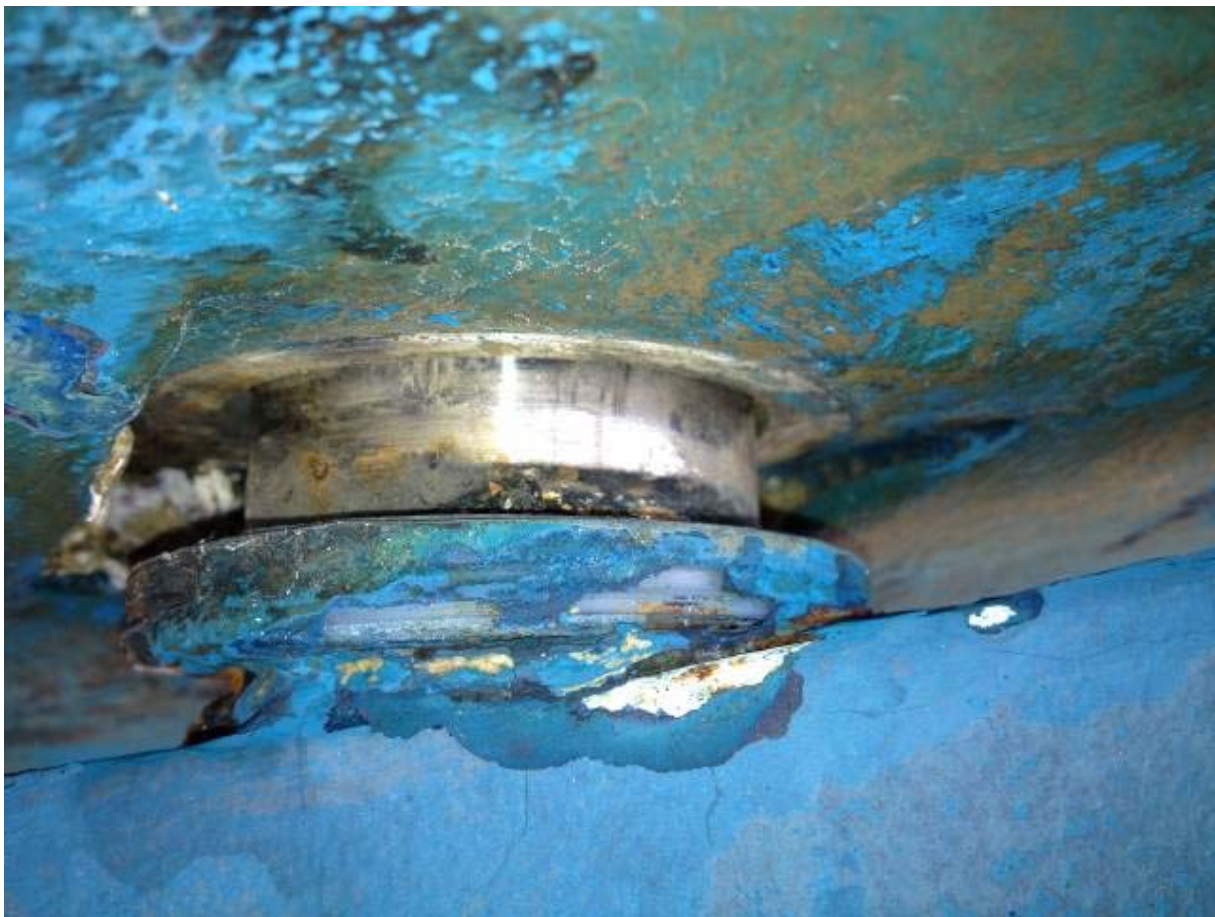
The white spacer supports the weight of the entire rudder system on top of the deck. There is a raised area on the deck for the spacer to rest on. The entire spacer and drive wheel were moving side to side between 0.125 and 0.25-in, which was the first clue something was wrong.

One inch drop of rudder post.

This is an image of the hull bottom and top of rudder blade. The SS rudder post is visible. A white (but painted) spacer sits on top of the rudder blade and bears against the bottom of the lower rudder

bearing. The lower surface of the lower rudder bearing can be seen, (white ring in bottom of hull surrounding the post) and is about 0.9-in thick. Exact dimensions are given below.

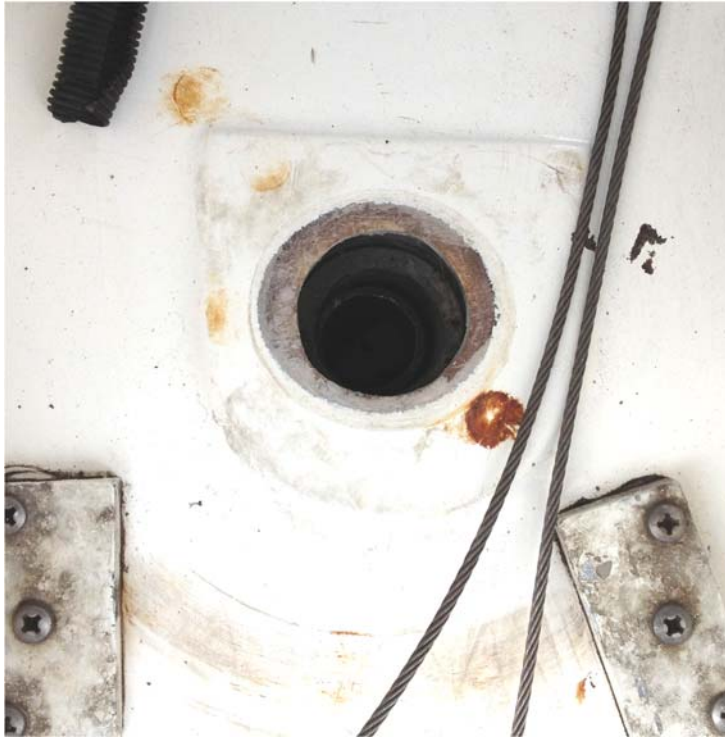
Below is an image of the deck with the drive wheel removed and the rudder dropped below the deck

surface.

The upper surface of the upper bearing is visible in the hole. It is loose, which is a good thing. Otherwise, the rudder would need complete removal, then a large dowel (think baseball bat) would be inserted through the lower bearing hole and the upper bearing driven out from below. The bearings were bonded in place at the factory with either 3M 5200 or epoxy.

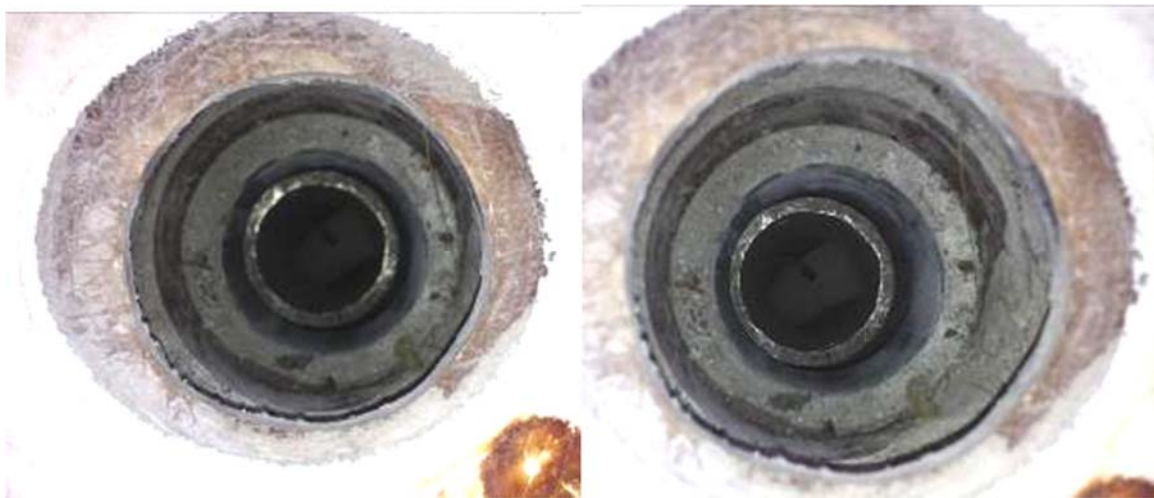
Believe it or not, the hole in the deck was a bit too small to pull the bearing out. So the hole was “professionally” opened to where the bearing could be lifted out.

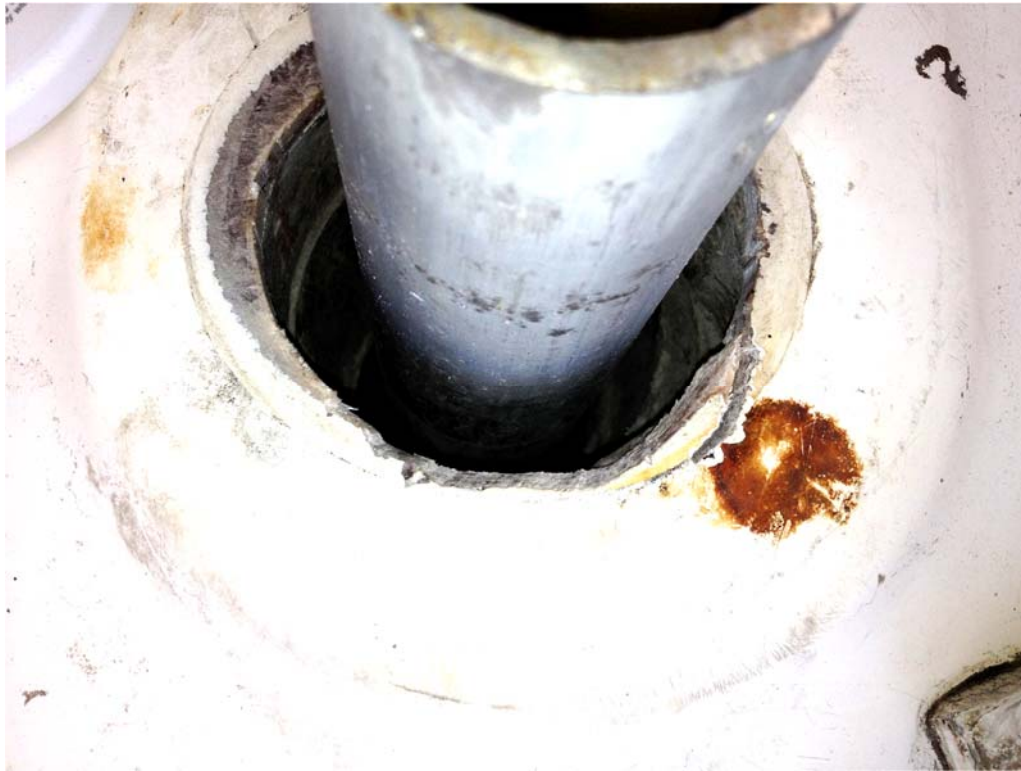
Upper bearing removed with post up in normal position.

A new bearing was made and bonded in place with 5200. In this image the top of the bearing would be about level with the small ridge that is about 0.75-in below the deck (visible on the left of the post). We decided to make the bearing double height to bring it up to the interface between the deck and rudder post tube (visible in upper left of hole). The tech did this without asking so I just went with it. That was before I was informed by Hunter the bearing was designed to pop loose if the rudder was hit or drop aground. I just have to be more careful now.

Unfortunately I do not have a photo of the new bearing in place. Sorry. But it is snug with the post to the lower surface of the deck and is about 4-inches in length versus the 2.875 length called for in the drawing.

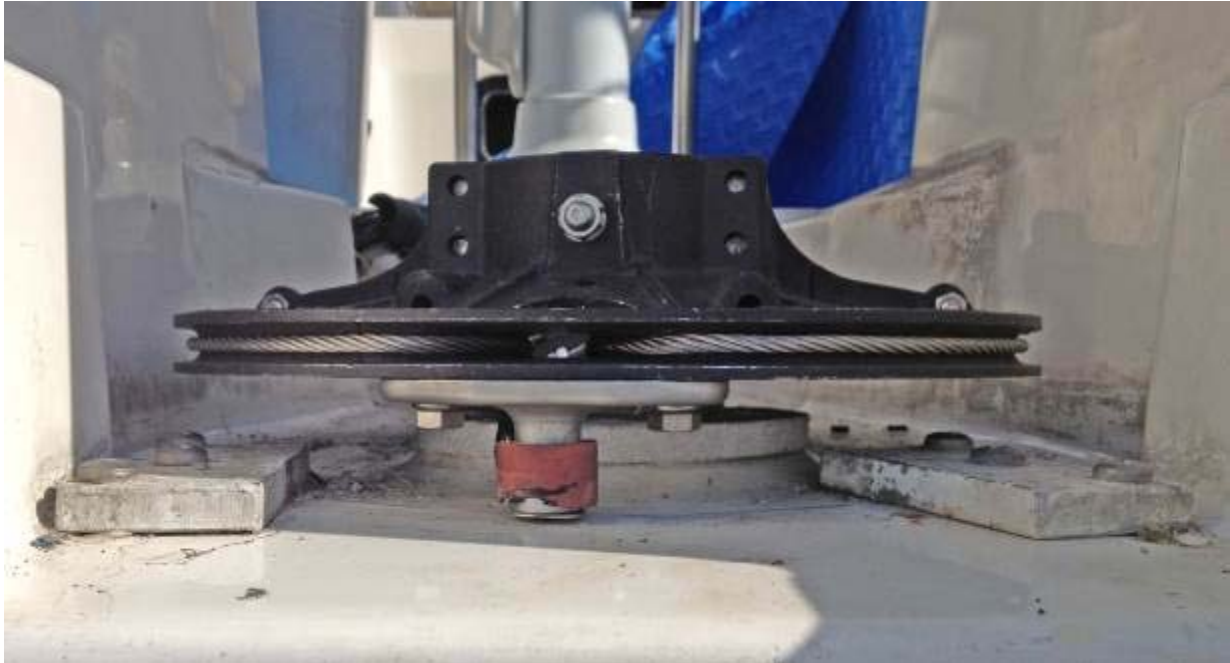
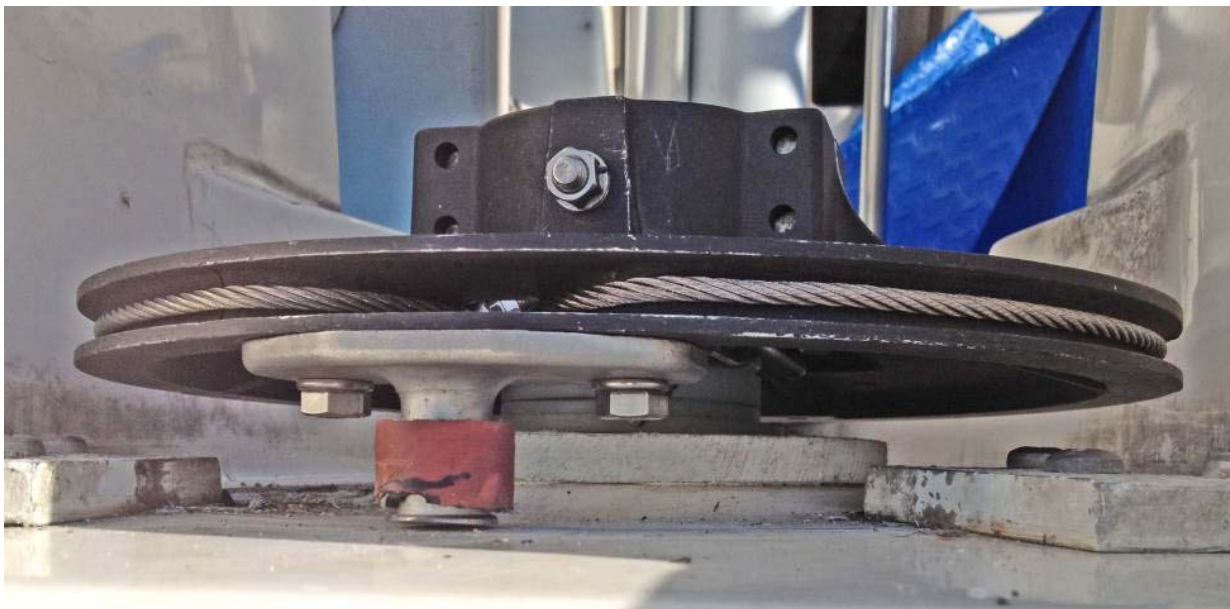
Note the original deck spacer is visible in lower photo. That spacer was cut down in height to compensate for the new cover plate. Looks like I need a better piece of hose for the rudder stop.

The next photo shows the new, black anodized radial drive wheel mounted on the rudder post in the final position. Note we added a half-inch thick plate of synthetic material over the deck opening to seal it against debris (a cover plate if you will). A carefully placed screwdriver and light tap will free this cover from the raised area of the deck if needed so the upper bearing can be serviced.
