H30T Compression post cartoon...

Compression Post Disassembly of a 1991 Hunter 30T.

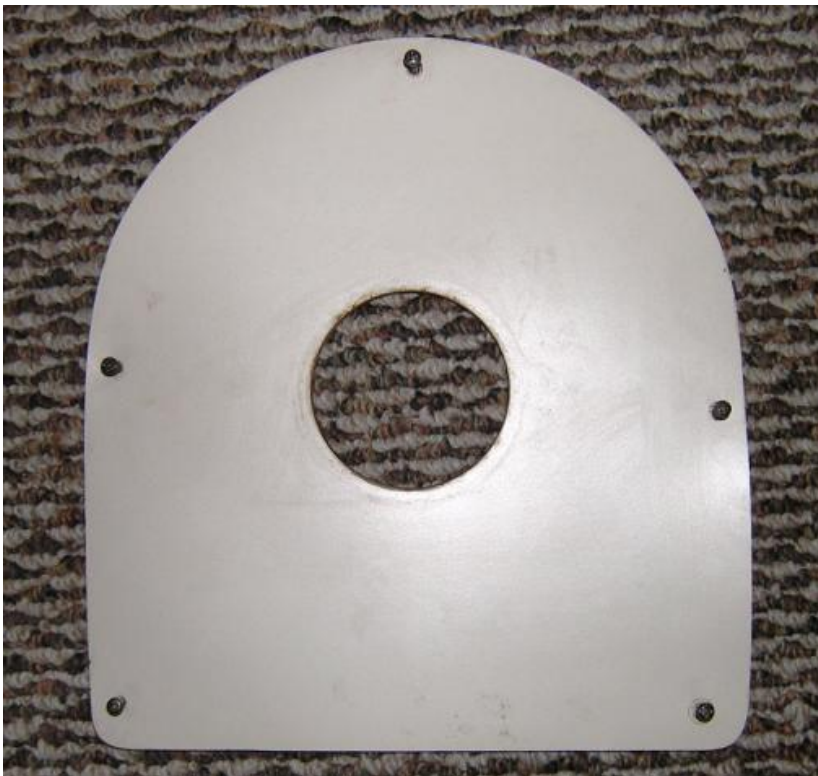
Most rust is at bottom of sleeve bands that tighten the sleeve to the post. One cause of rust is that it is unpainted steel (inner diameter surface).
