# UNITED STATES COAST GUARD

## **TALL SHIP BOUNTY**

**123 MILES OFF THE COAST OF CAPE  
HATTERAS, NORTH CAROLINA ON OCTOBER  
29, 2012 WITH LOSS OF ONE LIFE AND  
ANOTHER MISSING AND PRESUMED DEAD**

**MISLE ACTIVITY NUMBER: 4474566**

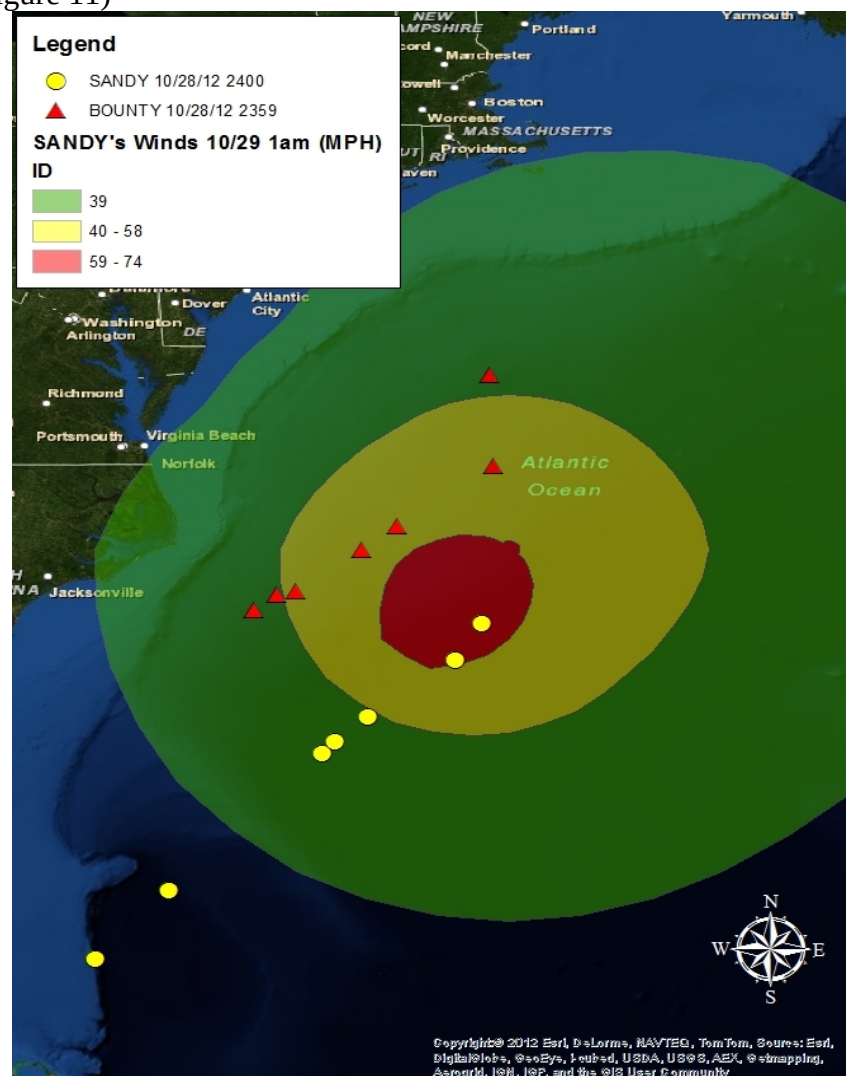
Figure 11 Hurricane Sandy is approximately 170.6 NM from the Center of Hurricane Sandy.

189. At approximately midnight, 0000, the port generator and starboard main engine failed. BOUNTY was drifting.

190. At midnight, BOUNTY was approximately 170.6 NM away from the center of Hurricane Sandy. (See Figure 11)

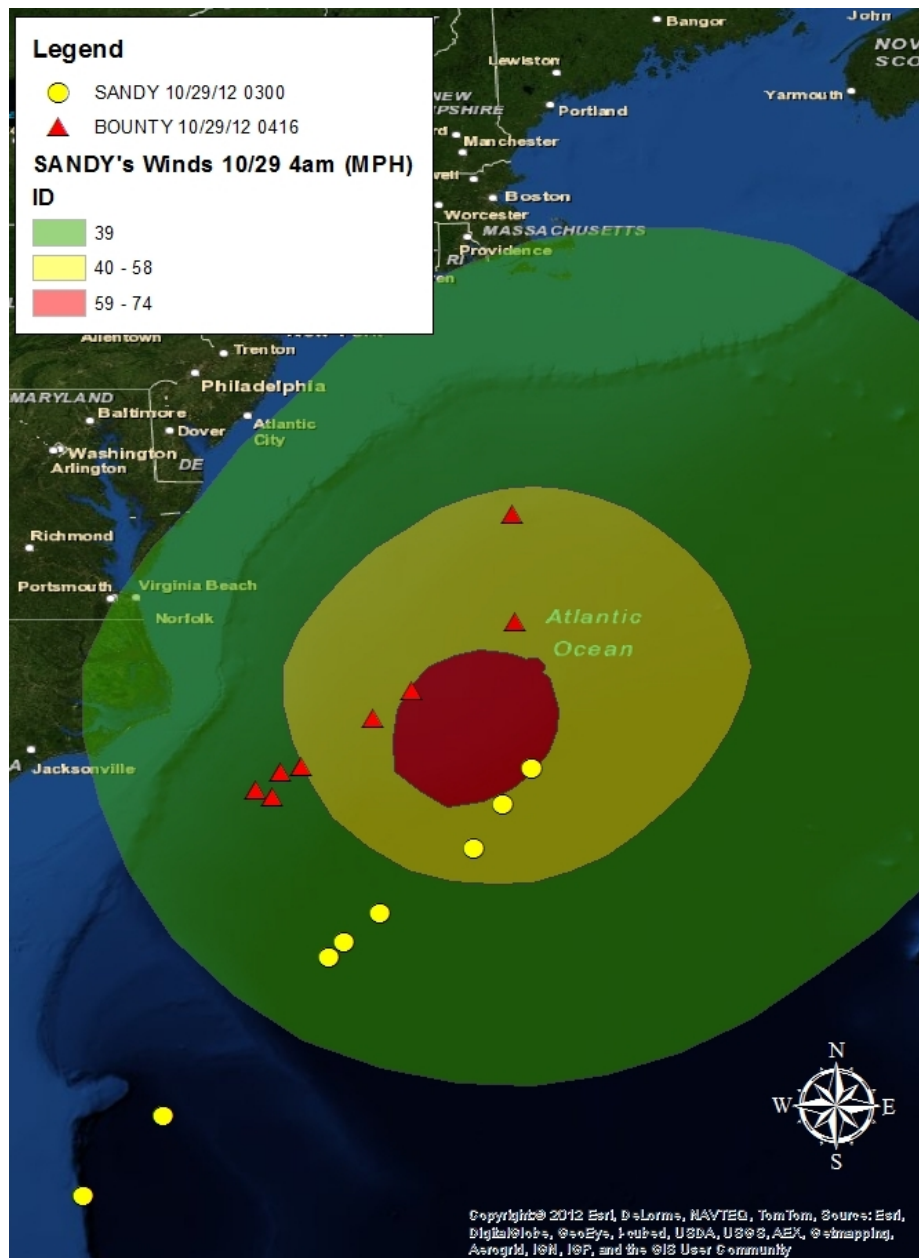
Figure 12 BOUNTY is approximately 181.3 NM away from Hurricane Sandy

205. At 0400, BOUNTY was approximately 181.3 NM away from the center of Hurricane Sandy (see Figure 12)

208. At 0426 on Monday October 29, 2012, BOUNTY heeled over to her starboard side and buried the bow. CM [REDACTED] informed Capt. [REDACTED] that the fore deck was underwater. 3/M [REDACTED] testified that he heard the exchange, and heard Capt. [REDACTED] reply, "we need to go." However, before the crew could abandon ship, the BOUNTY rolled to starboard on its beam ends, with her rigging going from vertical to horizontal at the water. All hands were now forced to enter the water, and they attempted to make their way aft away from the vessel. Before leaving the vessel, CM [REDACTED] informed CG 2004 that they were abandoning ship.

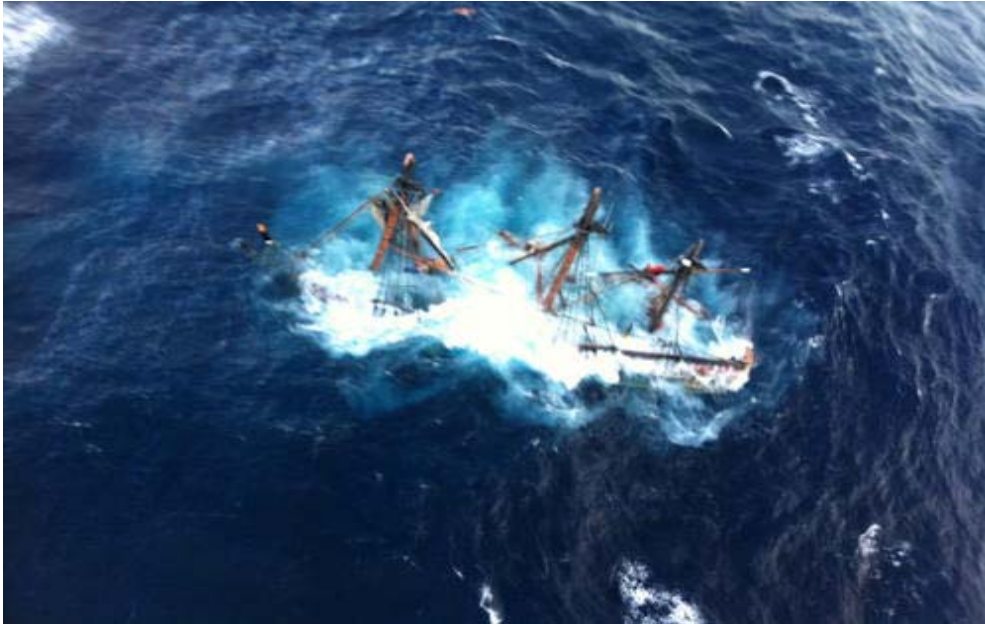
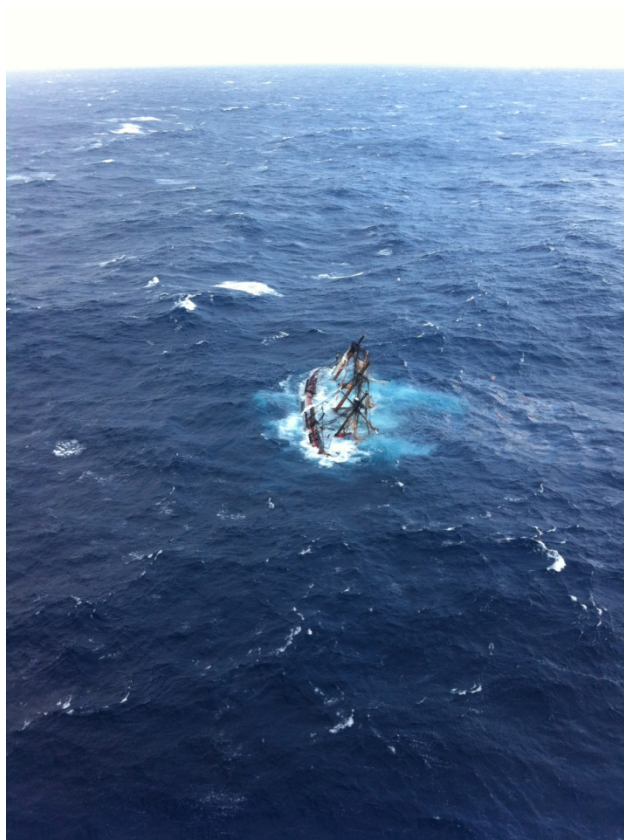
220. CG-6043 arrived on scene and hovered right next to BOUNTY and searched the rigging visually utilizing the aircraft's elctro-optical/infrared sensor system (ESS), getting as close as 40 yards away from BOUNTY. There was no heat signature to indicate anyone was caught in the rigging. However, there were empty immersion suits on deck and in the rigging. An air crew member took photographs of BOUNTY foundering. (see Figures 13 and 14)

Figure 13 photo of BOUNTY taken by CG 6043 air crew member

Figure 14 photo of BOUNTY taken by CG 6043 air crew member

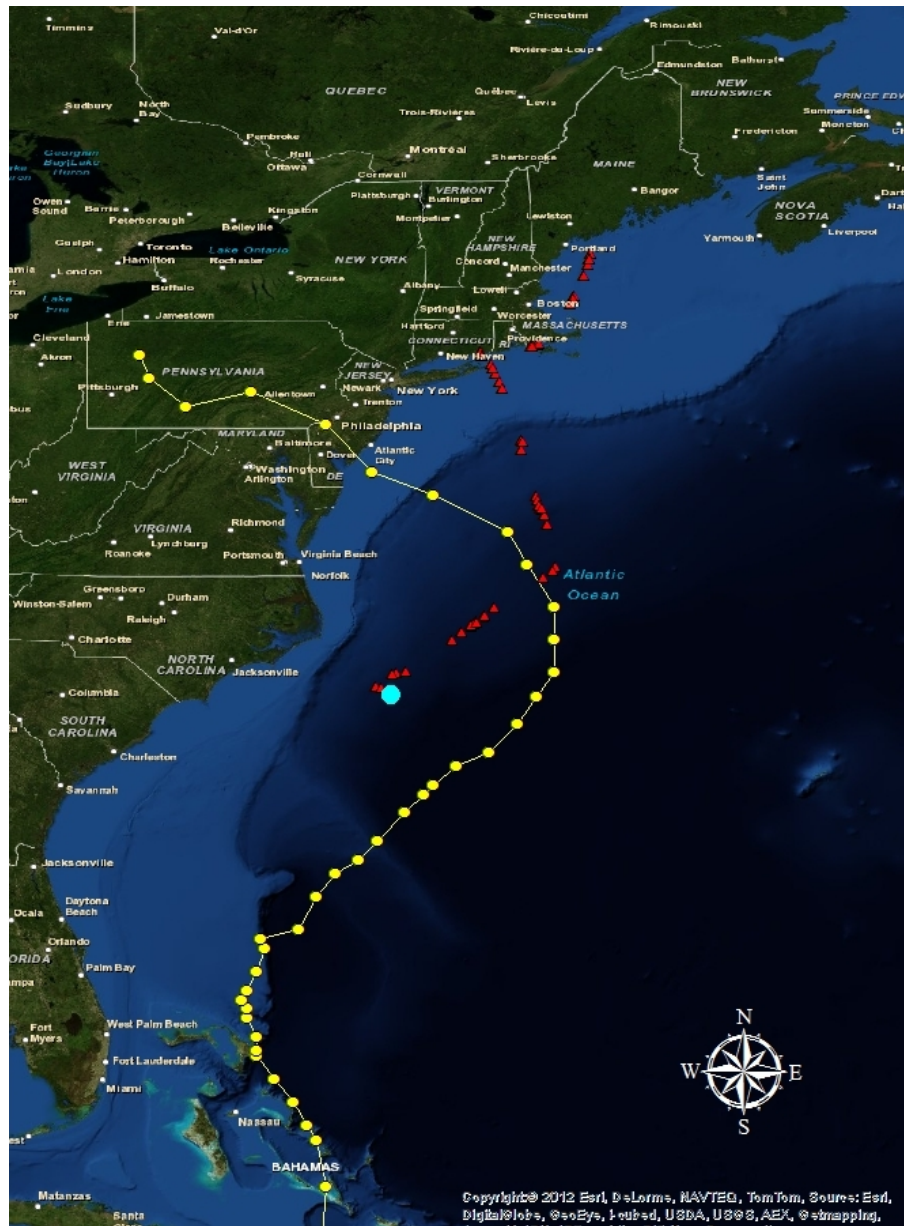
Figure 16 complete track for BOUNTY and Hurricane Sandy.

8. An analysis of the BOUNTY’s voyage track was prepared by the Coast Guard Investigations National Center of Expertise. The analysis is based on maritime practice and the documented actions taken by Capt. [REDACTED]. This analysis utilized the vessel’s track data and environmental conditions experienced during the voyage. The analysis is valid for this voyage only and uses scientific and meteorological principles for the sea area of the BOUNTY’s voyage track. (See Figure 16)

Upon changing course southwest, BOUNTY faced an opposing Gulf Stream current averaging four miles per hour, which caused a reduction in the vessel's speed over the ground. Hurricane Sandy continued northeast at 14 miles per hour. This was only exacerbated when BOUNTY lost her port main engine due to lack of fuel. As the BOUNTY proceeded southwestward with winds from the east northeast and northeast over the stern and port quarter, high steep waves and confused seas with shorter wave periods would be experienced due to the opposing Gulf Stream current. Breaking waves over the stern increased as the wind speed increased while BOUNTY

navigated closer to the hurricane center. The opposing currents and water temperatures creates a well documented phenomenon termed the North Wall Effect, and this is ultimately the consequences experienced by the BOUNTY and her crew.

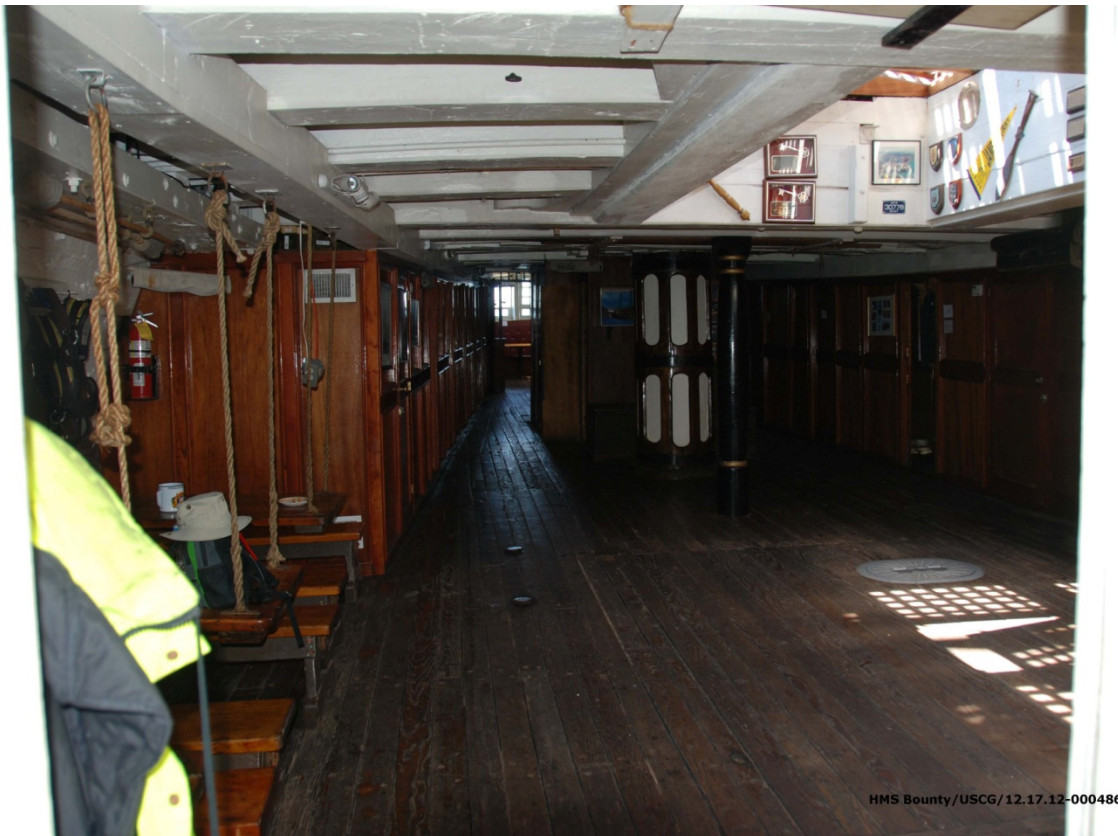
Figure 18 Tween Deck

- The tween deck (Figure 18), which had been designated as the freeboard deck by the owner, was observed as having a large area of free surface and only one 6 inch scupper on the port and starboard side.
