Hunter 34 Compression Post Replacement Project

November 2017 to March 2018

Brian J. Gallagher

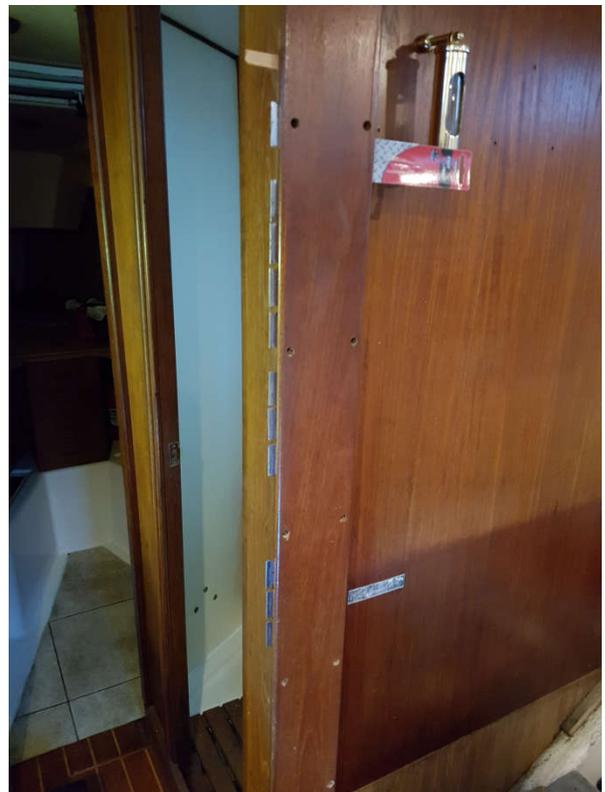
Not being sure of the internal construction of the post, I took the front face off first. I drilled out the teak plugs and removed the screws. Many of them didn't come out peacefully, even with a screw extractor, and some of the holes were damaged (later fixed by using larger teak plugs). Once the screws were out, however, I discovered the wood was very securely glued on. I hammered dozens of single-edged razor blades in the joints, and eventually got it to come off.

The damage to the beam was now much more visible and quite a bit worse than I thought. Also, there was significant rot of the douglas fir post within the teak.

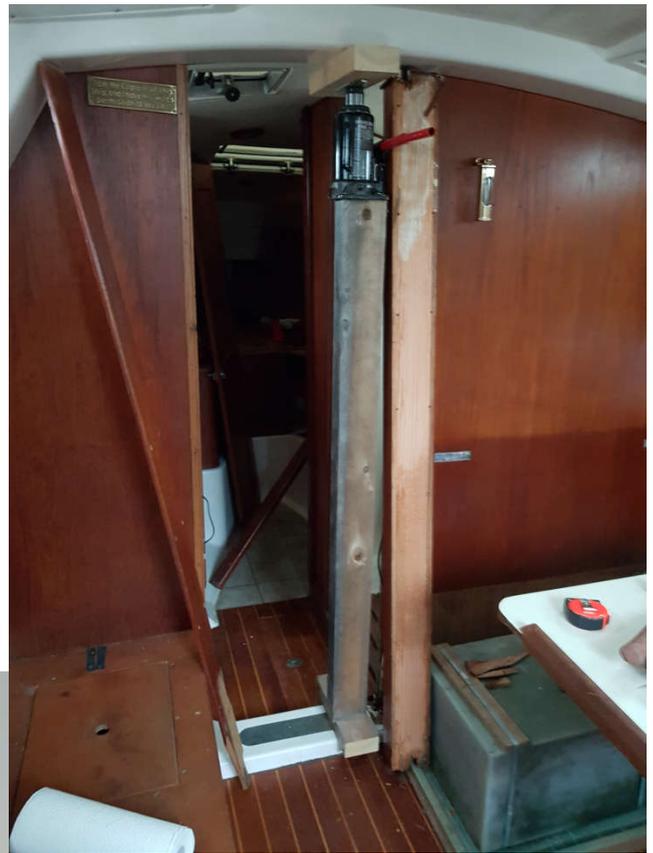
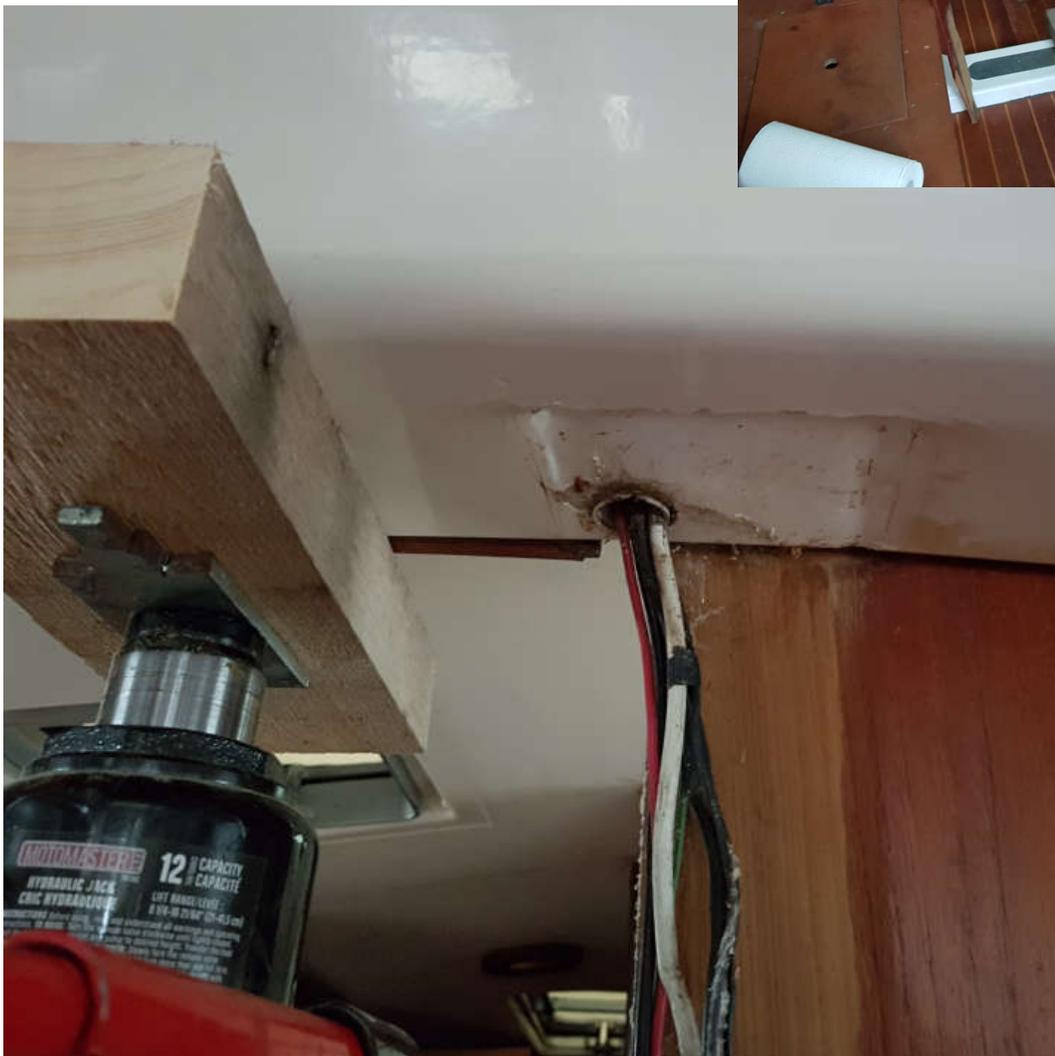
I had concluded that I could do this with the rig up (and in the water, not on the hard), unlike the approach taken by most others. In fact, I didn't know anyone else had done it this way until afterward. I figured with the standing rigging loose, the mast couldn't weight more than about 500 lb, and I could deal with that. So the next step was to loosen off the rig. Not sloppy loose, just not tight. Then I used a 4x4 with a bottle jack and 2x4s at each end to spread the load, and gently jacked the coachroof up. After every little bit I jacked, I went above and checked the tension in the shrouds, loosening it a little if need be. I had to lift it nearly 1/2" before I could get the post out. The picture to the right is with the post loose for the first time.

Later, once I started cutting into the beam, I used a second jack on the starboard side to support the beam on both sides since I was weakening it in the middle.

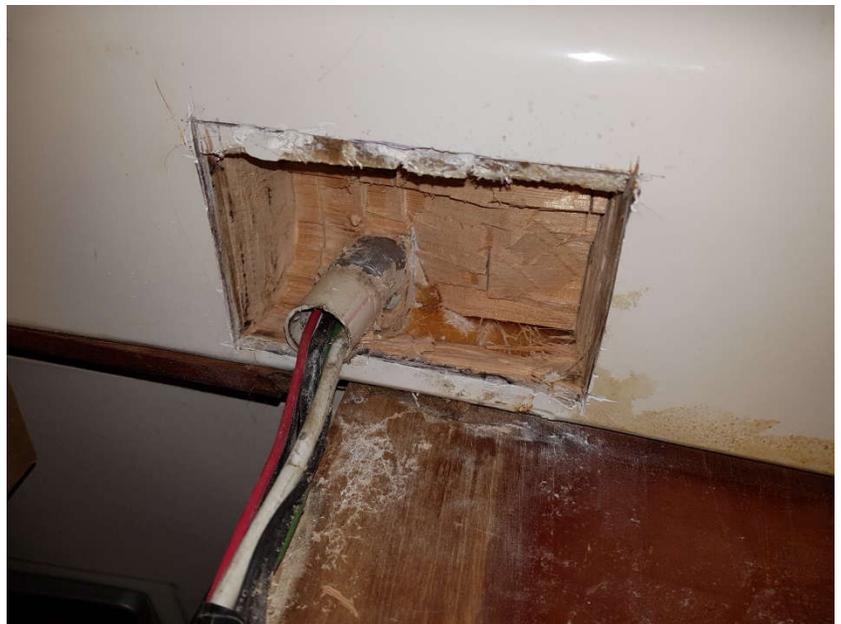
I was quite surprised at how sound the wood was inside. There was no sign of rot. The wood had simply crushed.

I looked at the yield strength of douglas fir perpendicular to the grain, and have seen numbers ranging from 340 psi to 625. The post only bears on $3.5 \times 3.5 = 12.25 \text{ in}^2$, so even at 625 psi the wood will only support about 7,600 lb (and that's to failure, not design). That is not nearly strong enough to take the compressive force of this boat.

I continued to use a chisel, Dremel, oscillating tool, and anything else I could find to dig out enough wood that my planned aluminum header would fit in. This took a really long time, and was the most difficult part of the job. I couldn't finish the design of the post until I had the wood out, because I needed to measure the length the new post would need to be exactly.
