ELECTROLYSIS IN SMALL YANMAR ENGINES

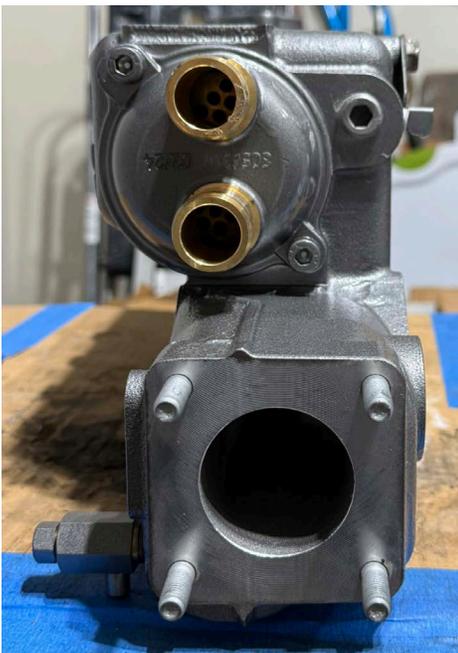
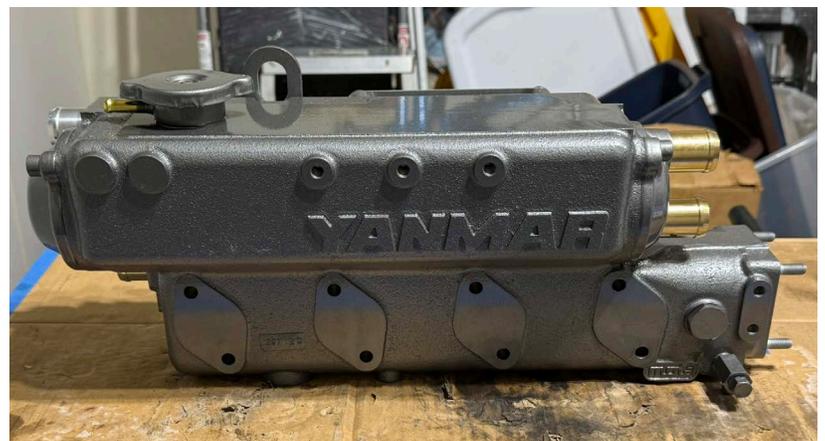
That is when I noticed the telltale accumulation of salt at the 5 o'clock position on the forward end-cap of the Heat Exchanger (p/n 129670-44911); that part of the engine that includes the manifold and Tube Core assembly ("Cooling Pipe" in Yanmar vernacular). Once I got the cap off, the damage was more than apparent.

A little while later, antifreeze started dripping out of the forward end-cap. That meant I had two problems: antifreeze was getting by the 'O' ring that surrounded the end of the Tube Core assembly (this is the barrier between the raw water and the antifreeze) and it was leaking from the end-cap. That would result in a raw water leak and eventually a failure of the alternator mounted under it!

- The tolerances were far too tight to repair the damage without extensive time & money (those magic ingredients) which may have approached the replacement cost.
- The Tube Core Assembly needs to be removed every so often for thorough cleaning. Especially where the Tube Core makes contact with the Cooling Assembly block on its ends. All this should be done when changing the antifreeze which Yanmar recommends happen every 2 - 3 years or 2,000 hours.
- Yanmar does, in fact, make a 'zinc' for their small block engines. Below are two pictures of that sacrificial metal: The Heat Exchanger. It is a rather expensive fix so keep a good eye on the one that you have!
