DATE OF SURVEY: June 15th, 2022

TYPE OF SURVEY: Insurance and Pre-

- BUILDER: Beneteau
- MODEL OF VESSEL: *FIRST 375*
- YEAR BUILT: 1985
- HULL CONSTRUCTION MATERIAL: Fiberglass
- HULL/DECK/TOPSIDES MATERIAL USED: Fiberglass

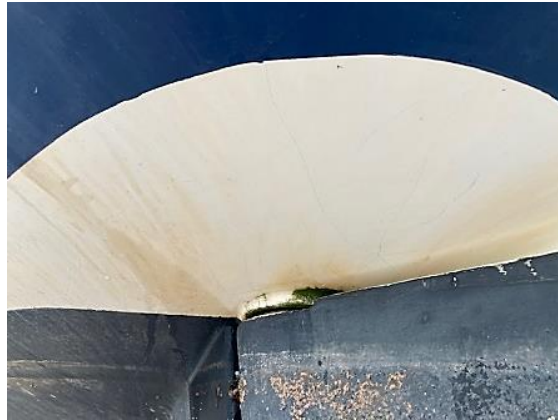
- PORT HOLES/WINDOWS: Fair condition; the windows/skylights are sun crazed.
- DOORS/ENTRANCEWAYS: Fair condition
- STRUCTURAL ANY INDICATION OF JOINT FAILURE CAUSED BY DE-LAMINATION OR COLLISION: No de-lamination or joint failure issues were noted; there's some gel coat cracking along the outside hull and more prevalent on the port side and rudder area.

DEFECTS/RECOMMENDATIONS/FINDINGS: Before purchasing this vessel, I would recommend a fiberglass repair person give an estimate on the gel coat repairs to the outside hull; these cracks in the gel coat are most likely caused by stress or poor gel coating, a mechanical type person should also be called to estimate cost on changing the rudder shaft bearing, the keel bolts are quite rusted and if hit with a hammer a big percentage of the bolt head would likely fall off, so these should be safety checked, also the engine should be started to hear it running. The inside upholstery repair/replacement costs and mold issues could also add up.

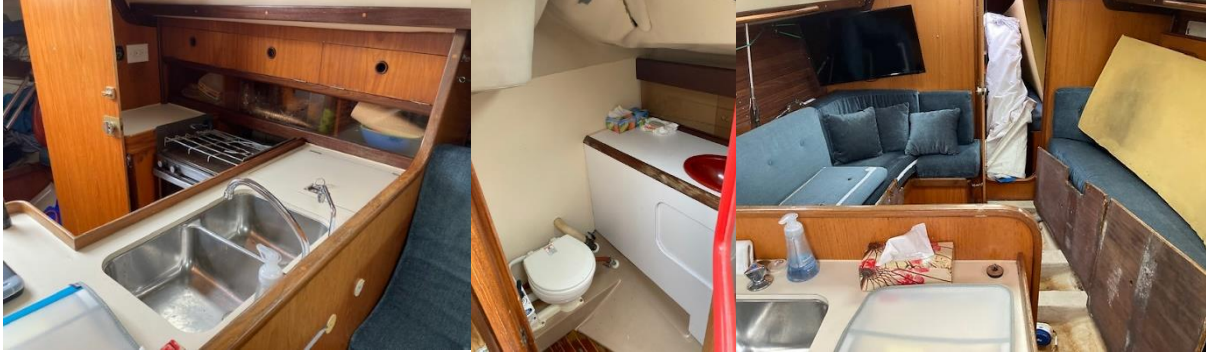
- **ACCOMMODATIONS:** 8 - single berths, full galley (fridge doesn't appear to be working) 3 - cabins and 1 - head.
- **SIGNS OF ANY MOLD OR MUSTY SMELL:** There's mold in several areas onboard.

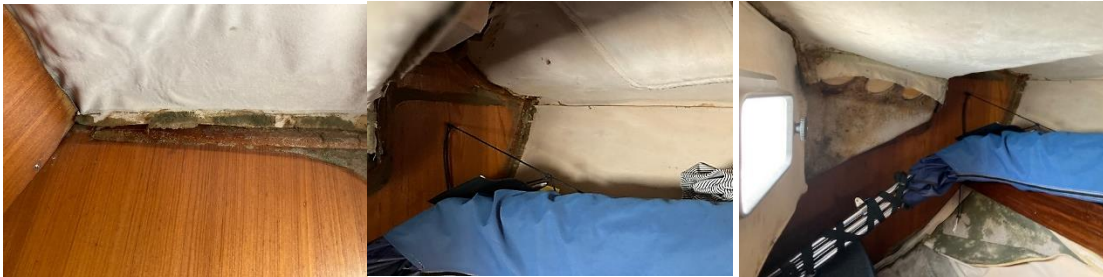
- **FRIDGE/ICEBOX:** The fridge doesn't appear to be working.
- **WATER STAINS:** A few stains around the overhead hatch in the lounging area.
- **OVERHEAD DECK HATCHES, CONDITION:** Fair condition, sun crazed.

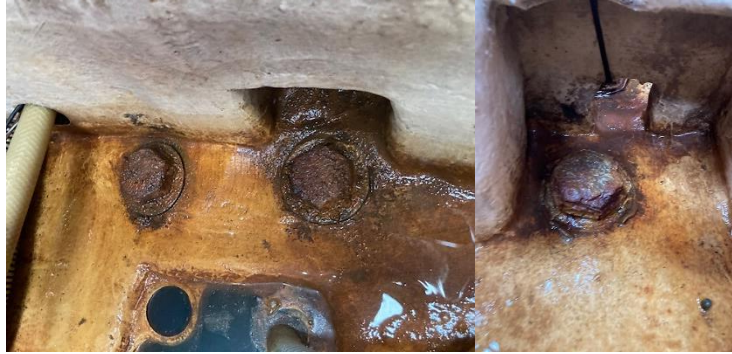
- **KEEL BOLTS:** The keel bolts are rusted and questionable.

- 1- The rudder shaft bearing appears worn and should be replaced.
- 2- The keel bolts should be safety checked.
- 3- A shut off valve should be installed on the propane line behind the stove.
- 4- Oil absorbent pads should be available onboard.
- 5- A Safe-T-Alert alarm or smoke alarm should be installed.
- 6- The two fire extinguishers should be mounted easy and accessible.
