November/December 2008 --

This will be my last haul out in the SF Bay area, and also my last major project. This time, it's the keel. It's a long story, but my keel has always been a concern. I think that the leading edge was weakened when the [mast step cracked](#), long before I bought the boat. That put an extraordinary load on the smaller leading bolts, which worked a bit and let water into the joint. Then, in 2004 I got seriously stuck in the mud while the tide was going out, and I powered out of it. After that, I had a leak. Three years ago, I did a temporary repair, but knew that the repair trapped salt water around the bolts. Stagnant sea water turns acidic and can cause deep crevice corrosion in stainless steel. I have seen this. So, I need to take it apart and make it right.

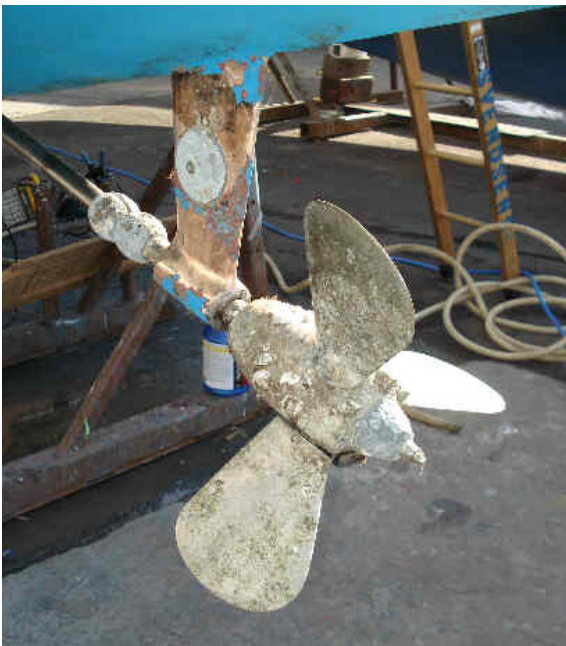
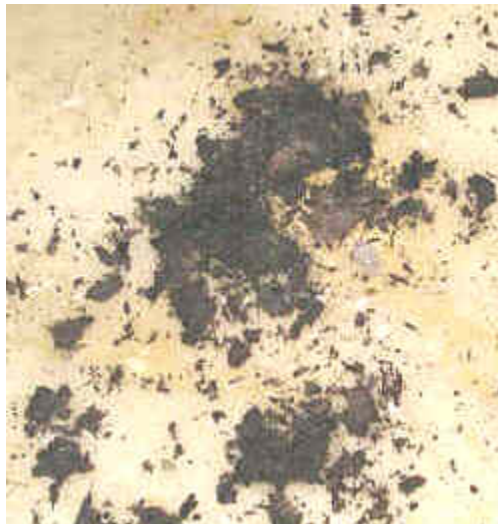
Above, the keel after power washing. I'm really pleased, as [all the work I did three years ago](#) has held up. I really hate to mess with it, but I know it was just a superficial repair. Three years ago, I wrapped the ends of the keel with fiberglass and packed some epoxy in the joint, to provide some support. I also took the keel down to the lead and primed it again, because it was failing all over. That has held up well, and there isn't a single failed spot.

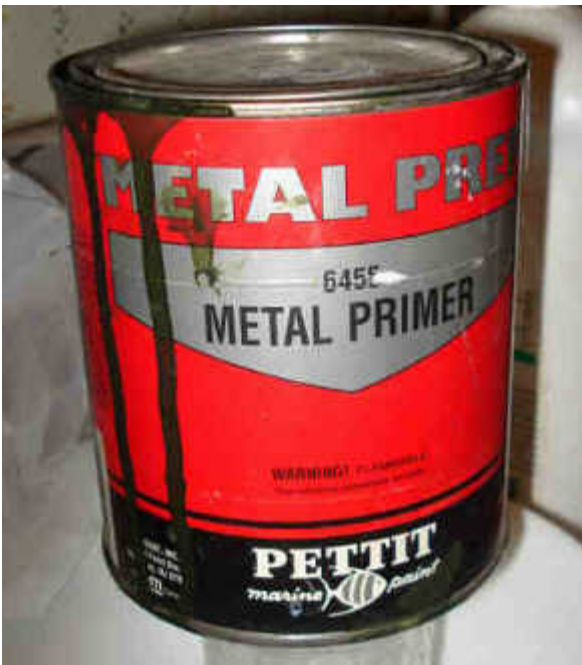
It's starting to get really cold, as we're having a series of weather fronts move through. I tented off the entire bottom of the boat, and the yard lent me a couple of 1500 Watt heaters. That was kind, since I was doing the work myself and not paying them for tools or time. I think the guys started to respect my effort, since I was willing to do the dirty, time consuming work.

Inside the plastic, it was about 75F degrees. The entire joint was covered with a bit of thick epoxy putty of West Systems and colloidal silica. Then I laid down a four inch strip of X cloth with Mat, and a six inch strip on top of that.

X Cloth has two layers of unidirectional fiberglass, set at right angles to each other, and a layer of mat, all sewn together. So this was better than laying up six layers of fiberglass over the joint. This thing is never coming off, or leaking again.

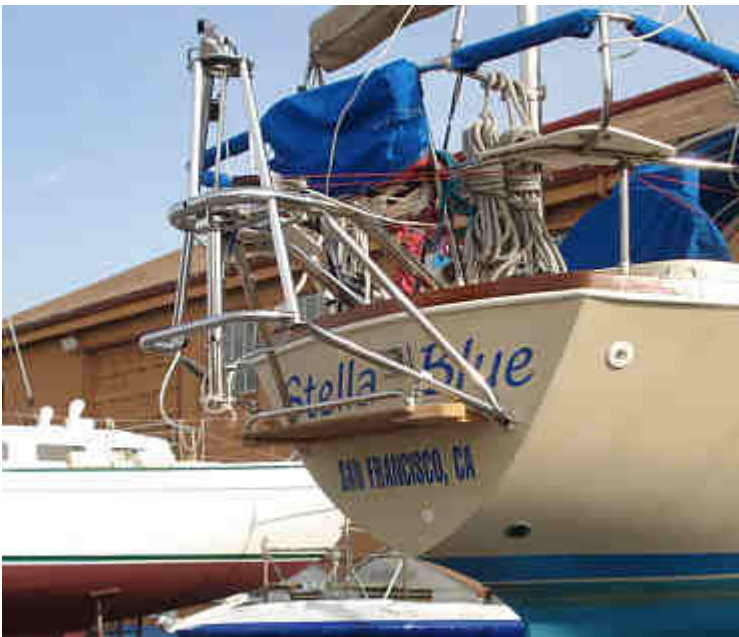
The epoxy shim was well coated with 3M 4000UV. That's a UV resistant white caulk. In addition to making them look pretty, it will protect the epoxy from UV degradation. Another little thing done on this haul out. I pulled the anchor rode, and painted the chain and primary anchor white. My old "code" for tracking rode length wasn't orking for me, so I just put white stripes on the chain every 20 feet.

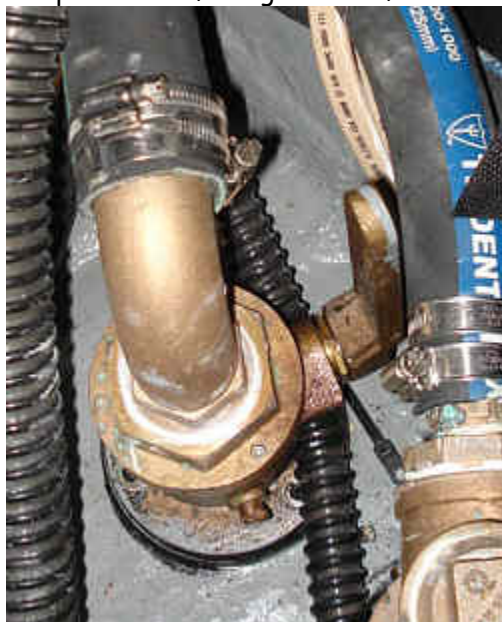
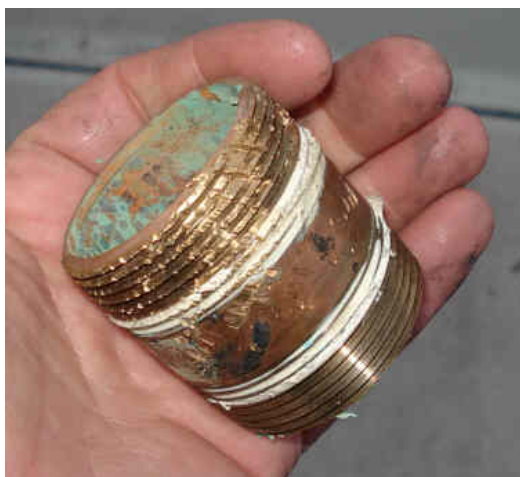
I replaced the fitting on one of the cockpit drain sea cocks, so that it's a single bronze fitting.

When originally installed, I'd planned to put two drains into each sea cock, since I was adding cockpit drains during the whole [sole recore](#) project. However, there wasn't room above the [new engine exhaust](#) elbow, so I didn't add a drain there. The starboard sea cock fittings have a red brass nipple joining the bronze sea cock to the bronze hose fittings. I just can't find cast bronze Male/Male fittings anywhere. But I've always hated the thought of that red brass under the waterline. Now, at least, I can close that sea cock when I leave the boat, and leave the totally bronze one open, and not worry about a red brass failure. Note, though, the condition of the replaced nipple. It's just fine, after three years in a "hot" marina. That makes me feel a bit better. Having been in the yard for nearly two months, my entire life is in disarray. I can't find anything.
