## Replacing the fresh water cooling pump on a 2008 Yanmar 3YM30

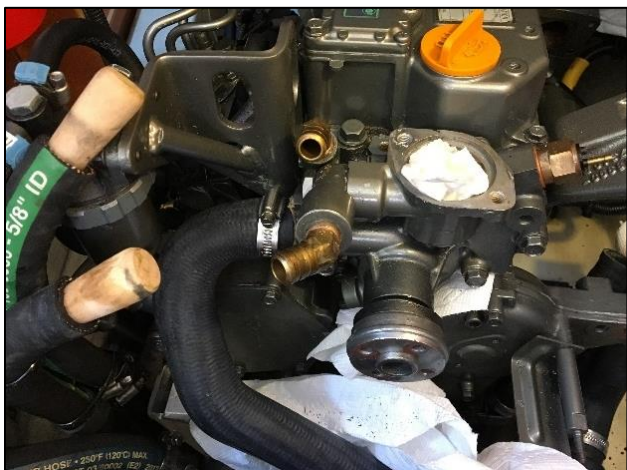
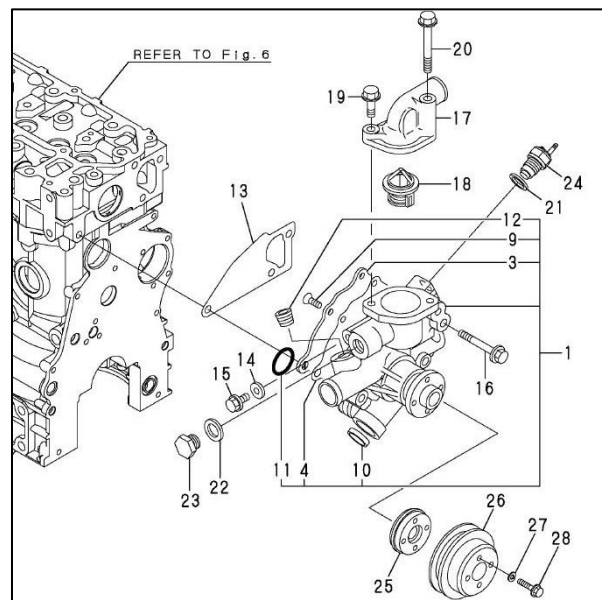
**Finally – Replacing the pump.** The alternator was already off to remove the heat exchanger and coolant was already drained. The raw water pump was loosened from the mounting bracket and the fresh water hoses removed from the fresh water pump. The raw water pump was moved so there would be room to work and clean/paint the front of the engine. Impeller replacement was easier too. The photo below shows the hot water heater hoses removed and plugged (kept the hoses full of coolant). The lower radiator hose was removed followed by the three bolts (#16) that hold the water pump to the engine. A word of caution when “prying” the pump away from the engine. The gasket (#13) and O-ring (#11) held the pump to the engine after the bolts were removed. The gasket (#13) freed by just shaking the pump. A small wooden wedge was useful to pull the pump straight away from the engine because the O-ring (11) was tight in the engine block. Do not

pull off angle or the O-ring sealing surface in the block could be scratched, although the pump is aluminum so the scratch risk is probably low. All the items marked #1 come with the pump assembly.

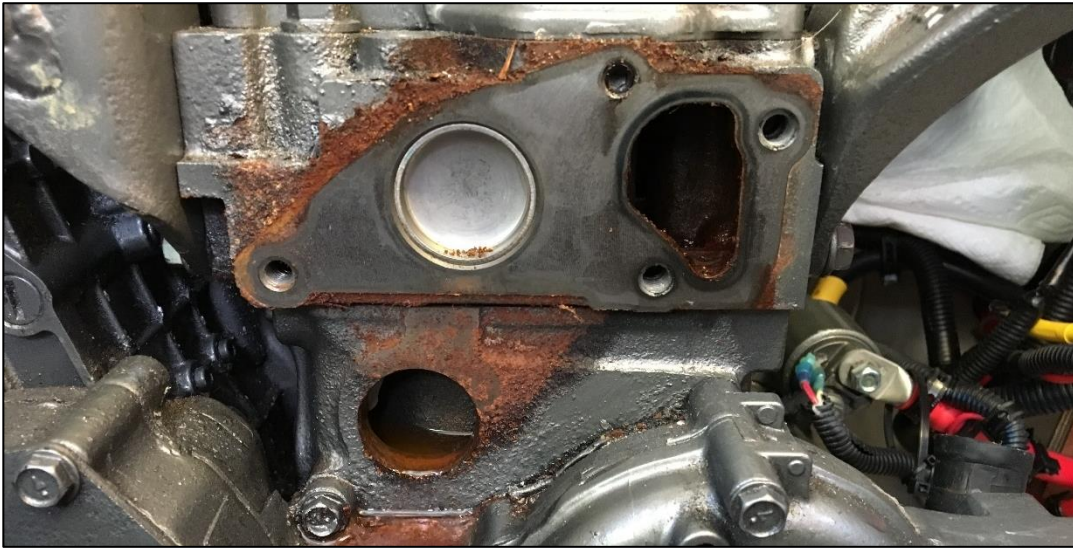
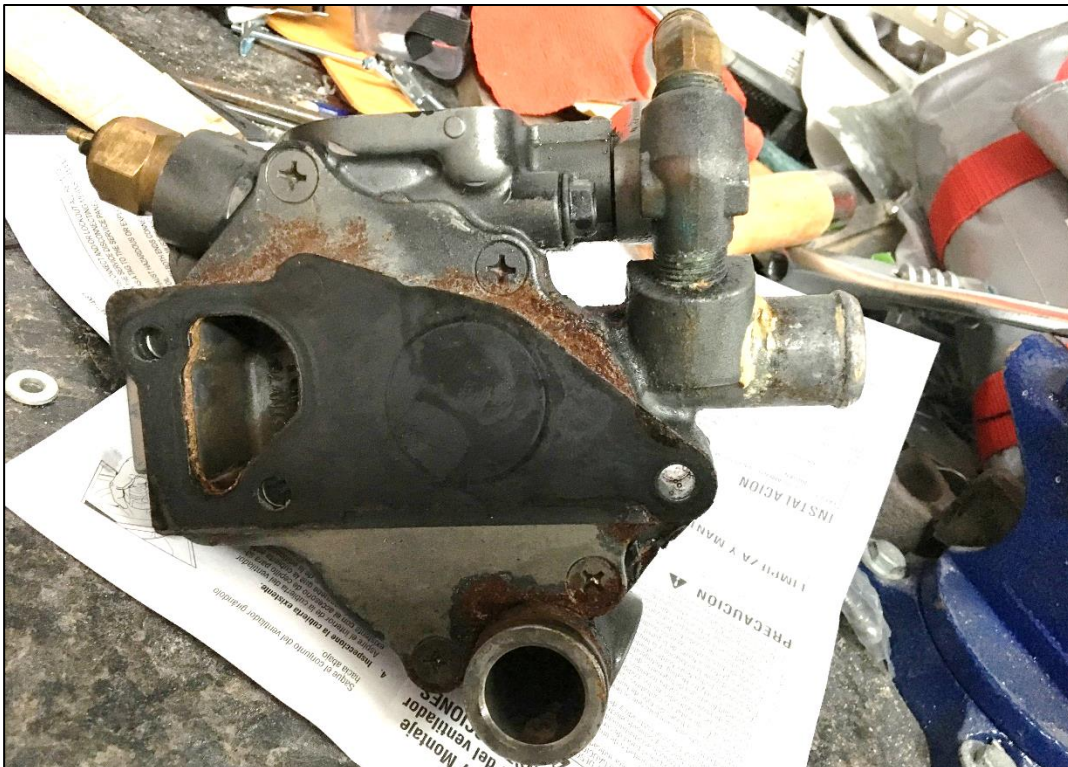
The front of the engine and pump are shown below.

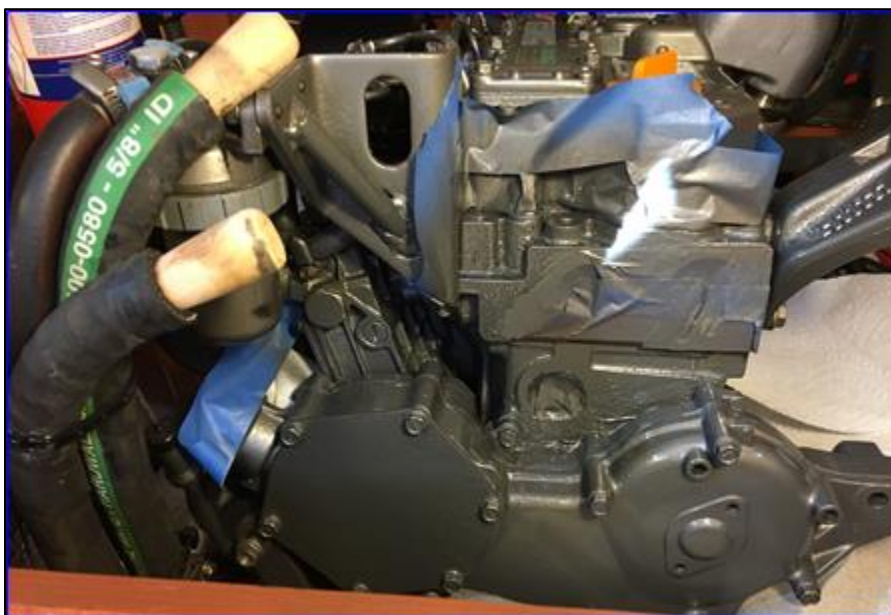
Primed the bare and lightly rusted spots with rust inhibiting primer.

Wiped down the surrounding areas with a degreaser and sprayed \$12/can with Yanmar gray. It must be a special marine enamel...

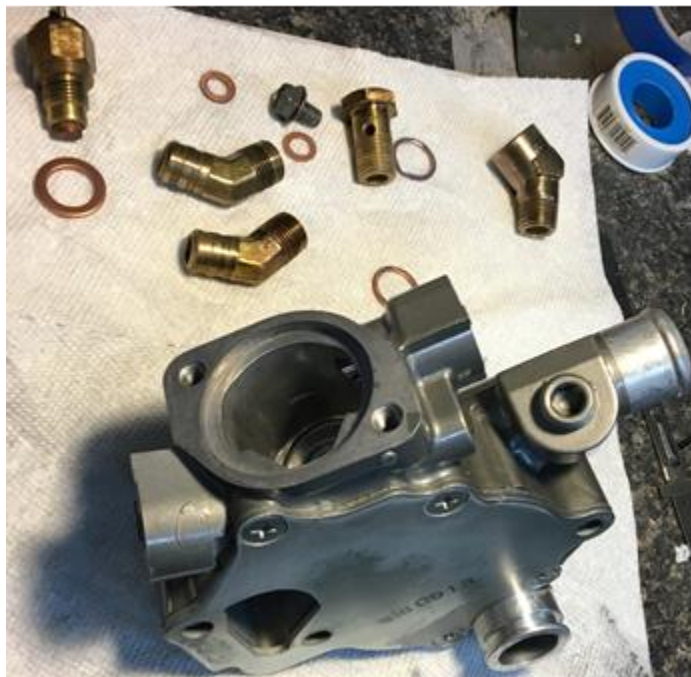
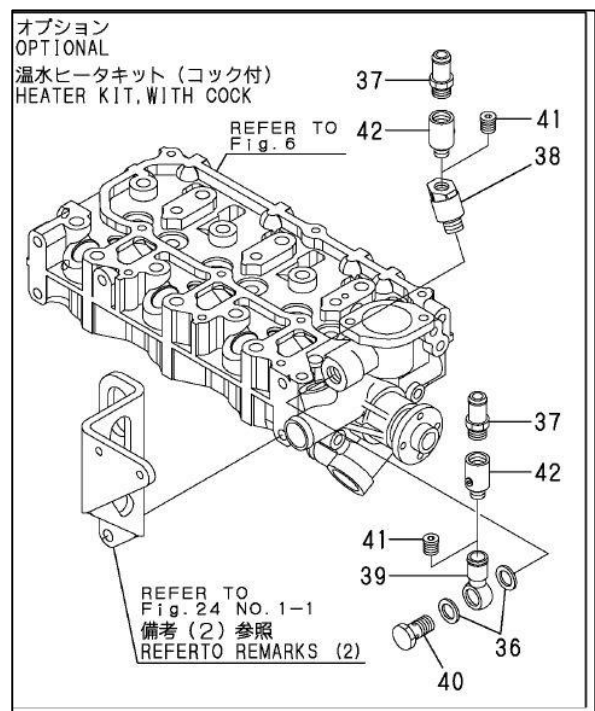
The new pump, like many Yanmar parts, comes unpainted. The pump was degreased, taped, primed and painted. I tried not to paint the gasket surface on the rear side of the pump. Shown above the pump at upper left is the water temperature sensor and copper gasket. The other items are the "Optional Heater Kit, With Cock" to supply the hot water heater. The parts were cleaned with a brass wire wheel and a light coat of clear lacquer was applied on the exposed surfaces to keep them looking nice. In the lower photo the gasket (#13) and O-ring (#11) are not shown, but come with the new water pump assembly (#1). Refer to pg 2. The short bolt (#15) is reused from the old pump. The five copper gaskets shown should be replaced to prevent new leaks.

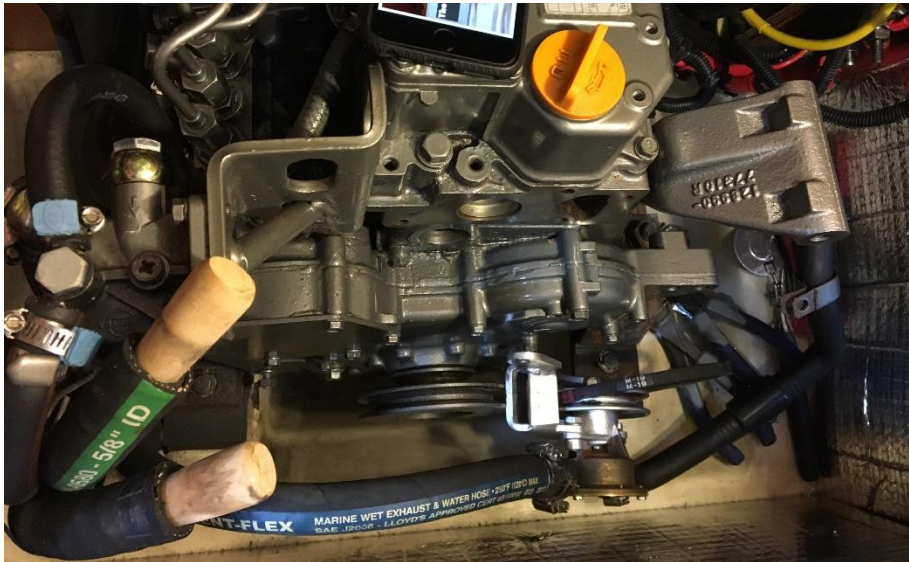
Engine paint dry and ready for reassembly. Note the raw water pump is free from the bracket and not yet mounted. Anytime I remove a part from the engine for whatever reason, it gets a fresh coat of paint (silver, black, or gray).

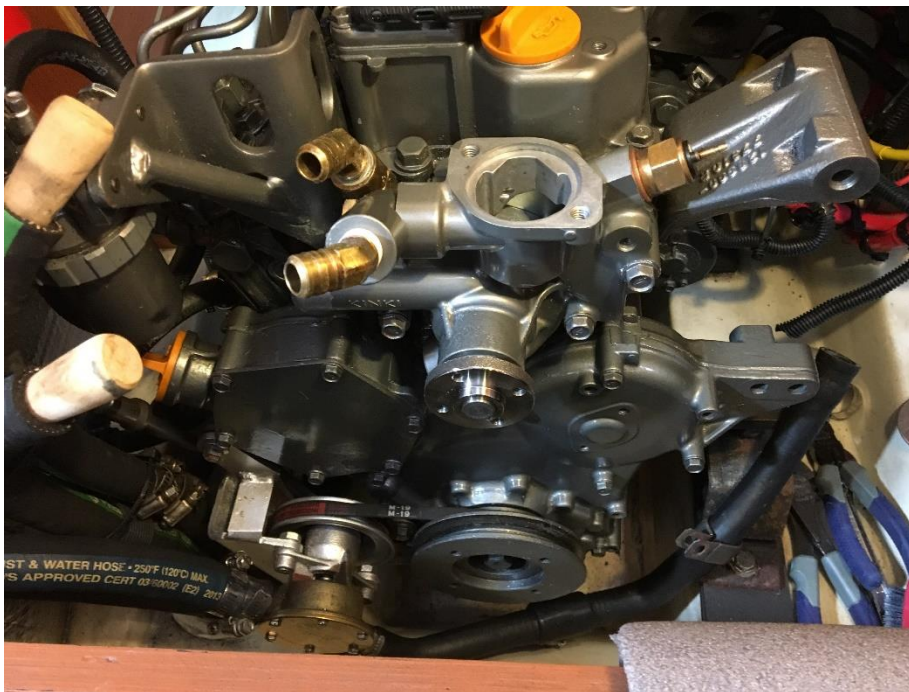
The raw water pump was reinstalled then the fresh water pump. Per the shop manual, both sides of the triangular gasket were heavily coated with an adhesive to hold it in place during assembly. Per the local Yanmar parts guy, I used a 3M spray adhesive. The O-ring was coated with a PTFE-based lube made for O-rings in order to make insertion of the O-ring into the block

easier. Medium thread locker was applied to the three bolts (#16) and were tightened in a round-robin manner (no pattern given in the manual) and torqued per the values in the manual. Getting the hot water heater fittings clocked into the correct orientation is difficult because of limited wrench space. If you can reassemble the fittings and tighten them on the pump ahead of time, that might be the way to go

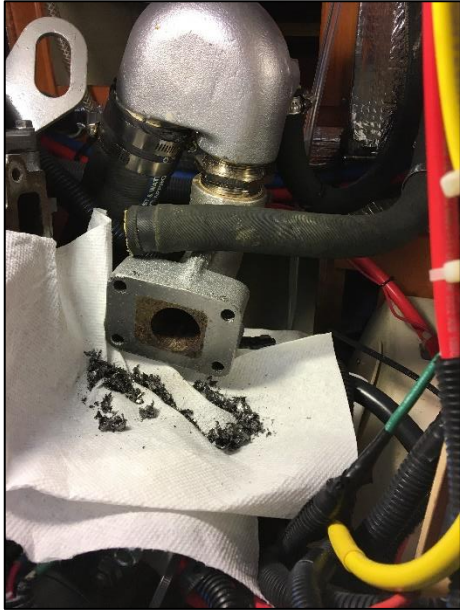
Before reattaching the heat exchanger and alternator, a sharp razorblade was used to scrape the old exhaust manifold gasket from the manifold. Removing the elbow from the exhaust hose and raw water hose is difficult. There was no reason to remove them in this case since the manifold, connector and mixing elbow were replaced about a year prior because of coking. During separation of the elbow, the stainless steel connector broke off in the manifold side. More boat bucks. A few coats of high temperature silver paint on the manifold and elbow back then may prevent them from rusting like they seem to do, but this is inconsequential surface rust.

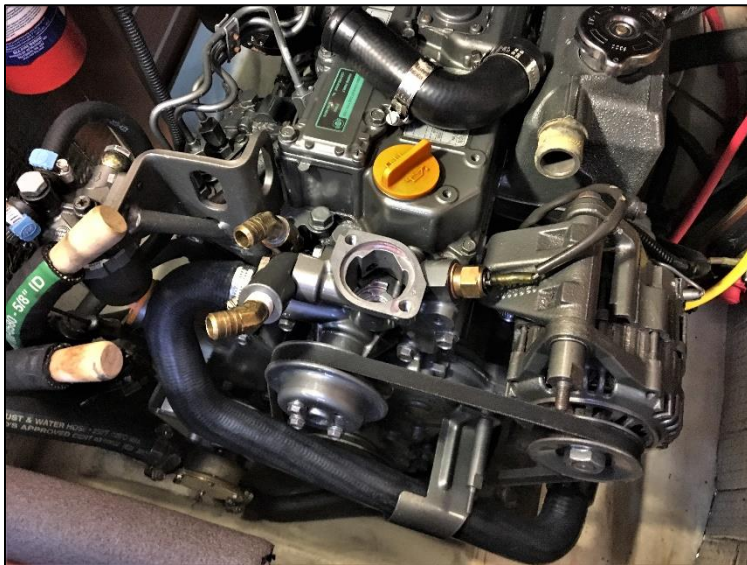
All of the parts are reassembled with the exception of the water heater hoses and the gooseneck/hose. Coolant was slowly poured into the thermostat opening to fill the block and pump. This seems to work well at eliminating much of the trapped air. The engine rake makes the thermostat and water heater hoses the highest part of the cooling system. Coolant was added until the block was full up to the sealing surface of the thermostat. Getting air out is important.

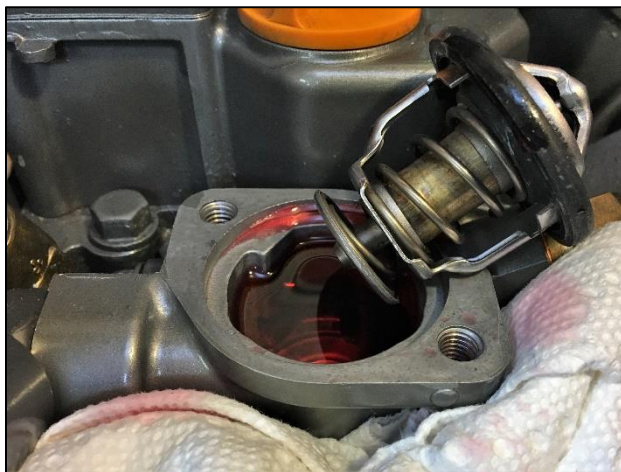
The thermostat was replaced along with the gooseneck and radiator hose. I use medium thread locker on all engine bolts.

The corks were removed from the heater hoses (middle photo above) and coolant added to top off the lines. The coolant was not replaced since it was only a year old. Coolant was then added through the top heater elbow

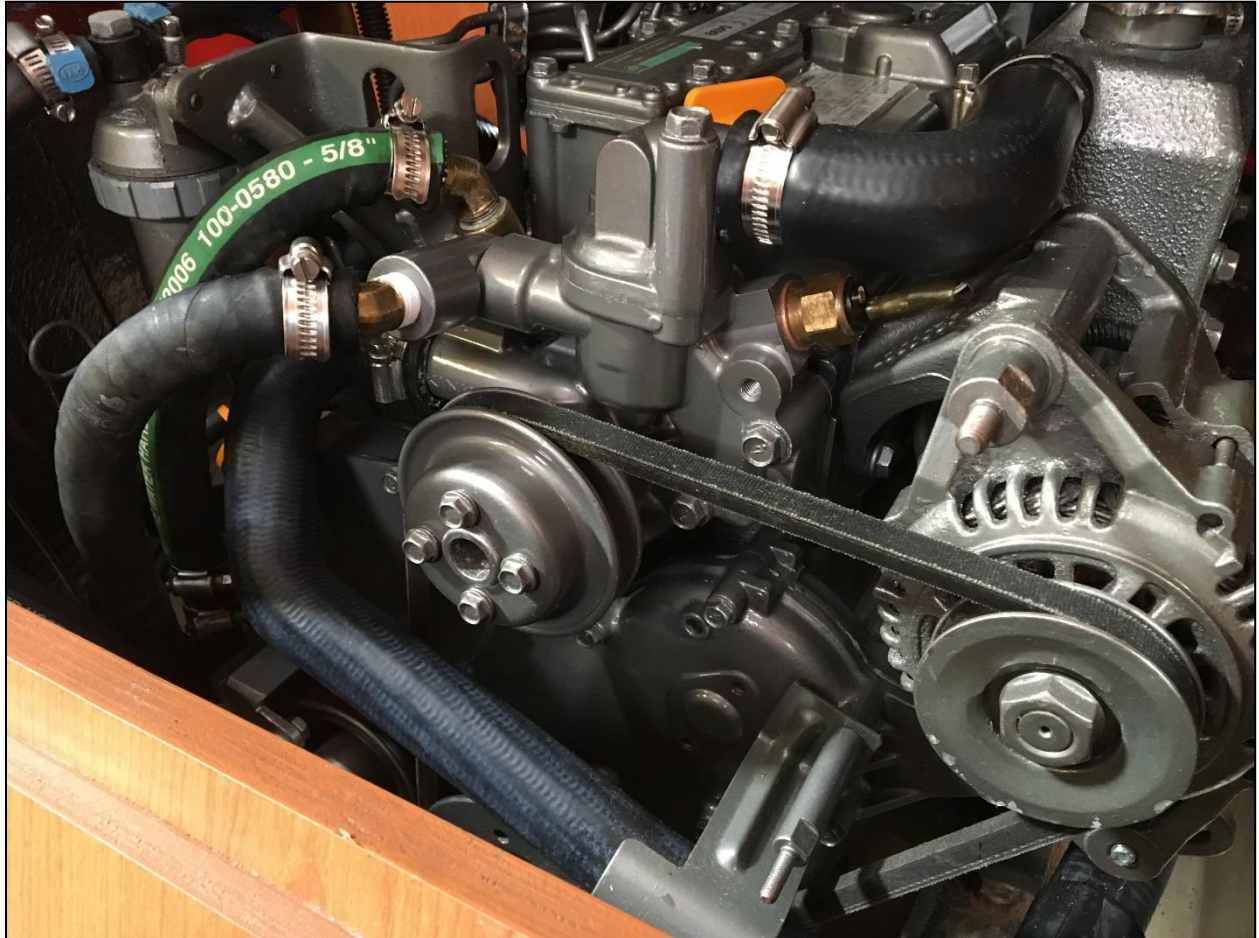
The coolant overflow tank was refilled in anticipation that the system will draw in some additional coolant after a few operational cycles as the air bubbles out (hopefully).
