So the job is finally done. New transmission, damper plate and engine mounts. Not a job for the faint of heart. Here is assembled engine front and rear: (my son's foot at the left)

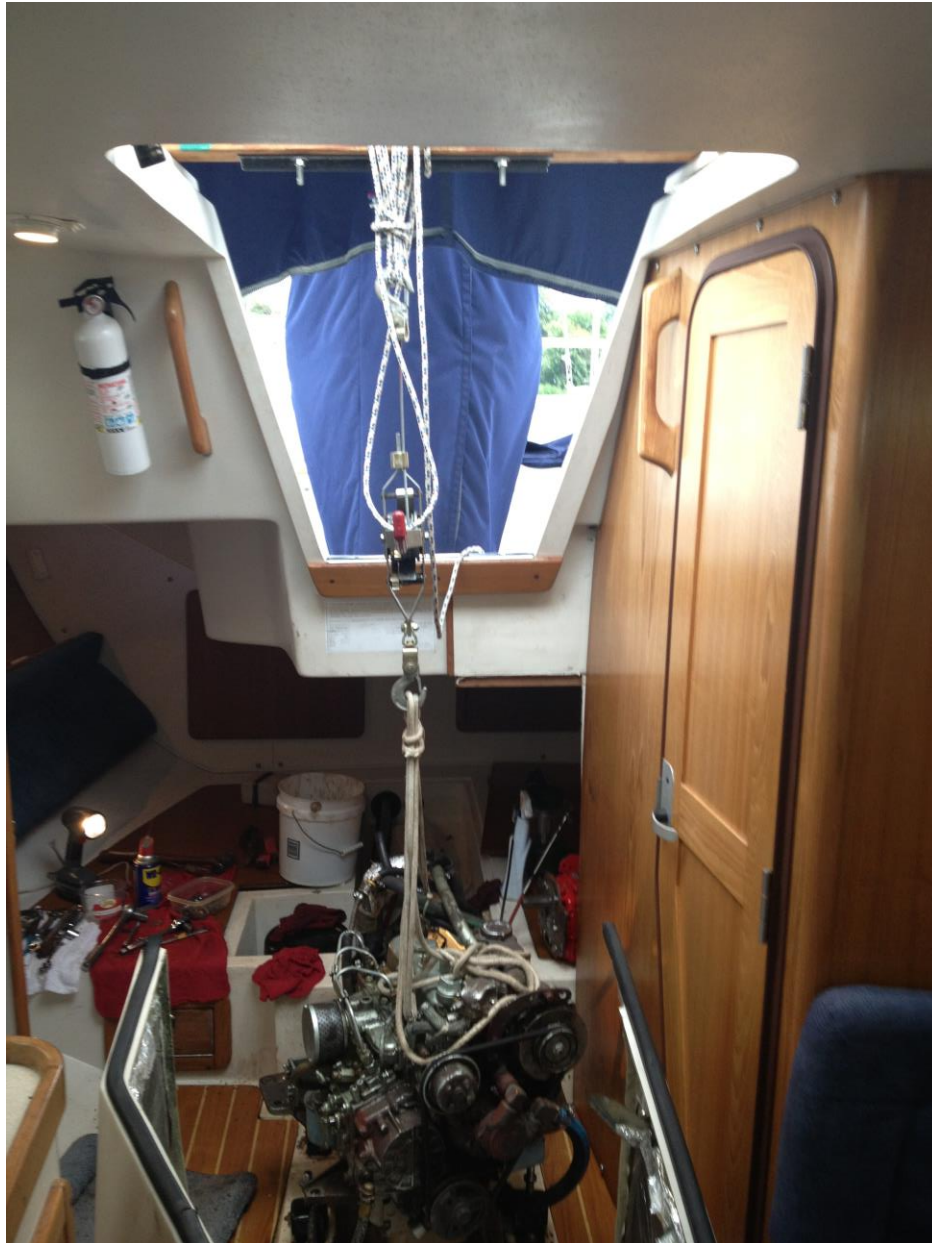
Here is the engine hanging from the come-a-long (2nd time.. has new tranny but old damper):

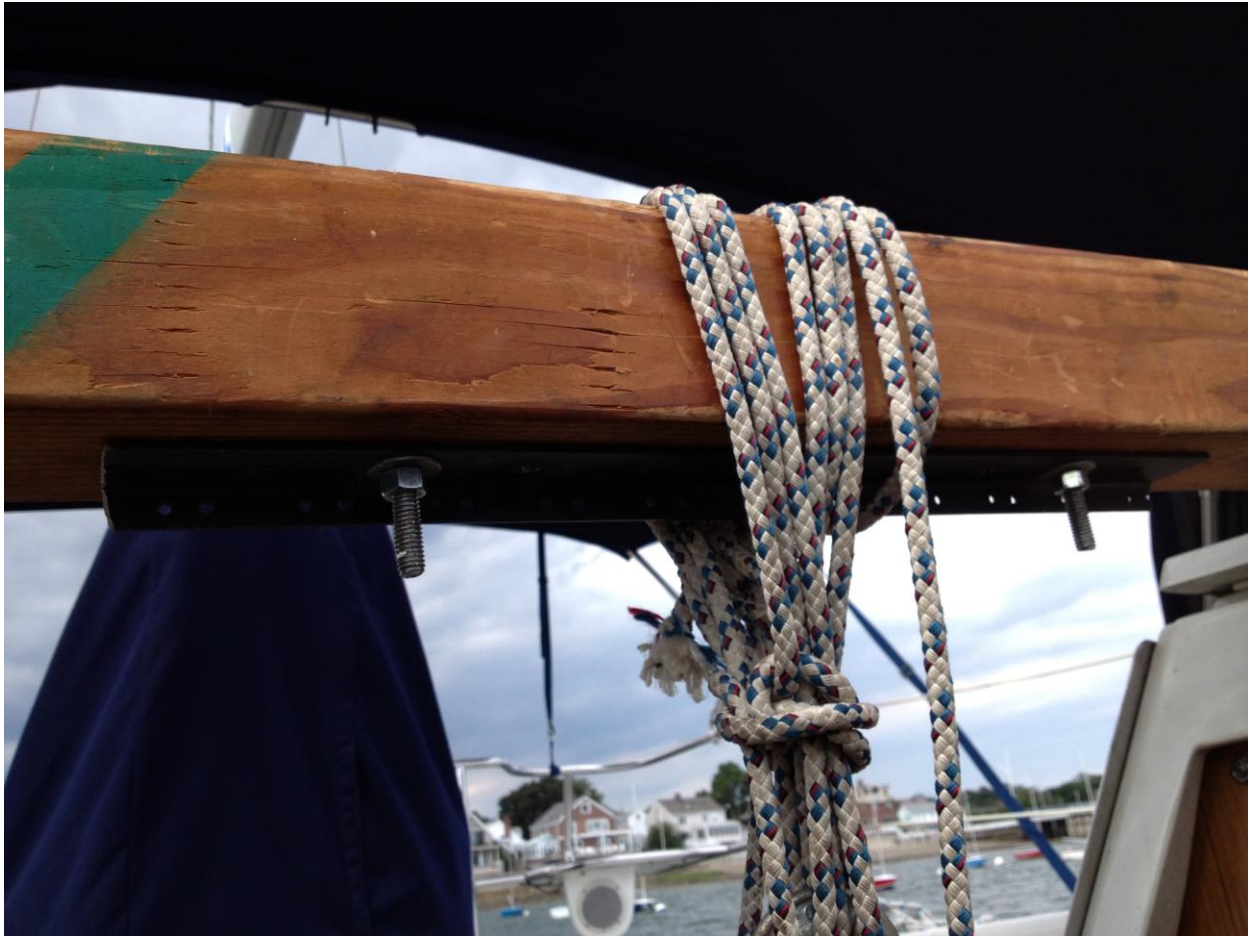
Note the steel plate bolted to the underside of the 4x4:

This was strictly to alleviate my paranoia about what would happen if the beam failed, especially if my hands were underneath the engine at the time. The beam fits nicely between the winches and the clutches.

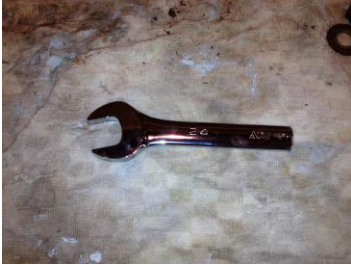
- 1) 24 mm socket (I used $\frac{1}{2}$ " drive with short and long extensions), also open end, and also and open end with a built in ratchet on one side. I also cut a 24 mm open end for the port side rear engine leveling screws:

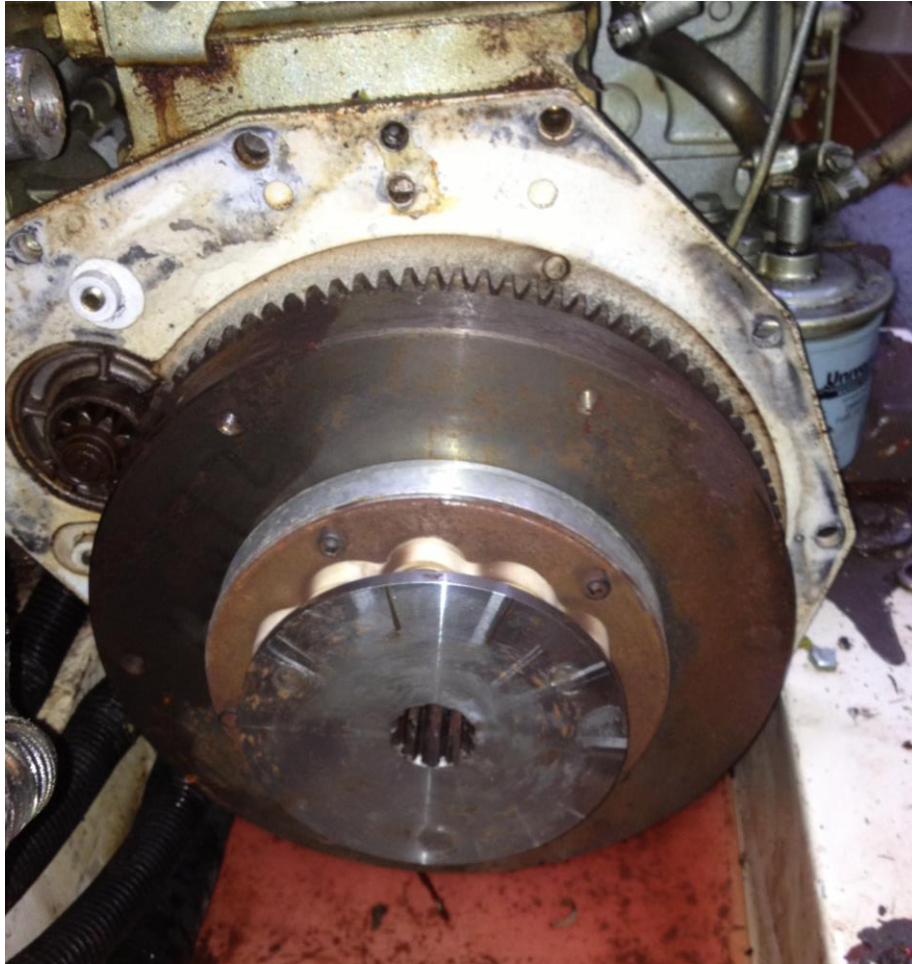
So here's what it looked like with the bell housing off:

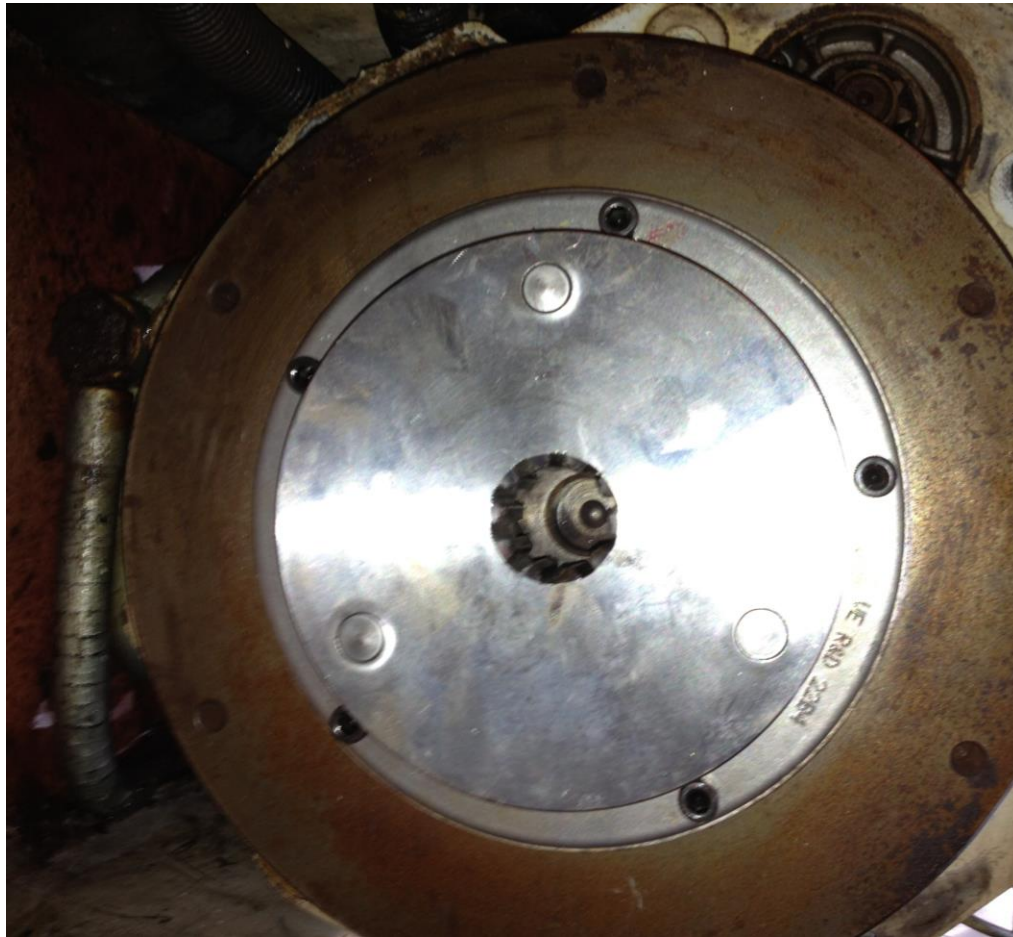
And here is face on view:

Which gave me good access to the cap screws, which I removed with a standard Allen head and a crescent wrench for additional leverage.
