DRIVE MOTOR

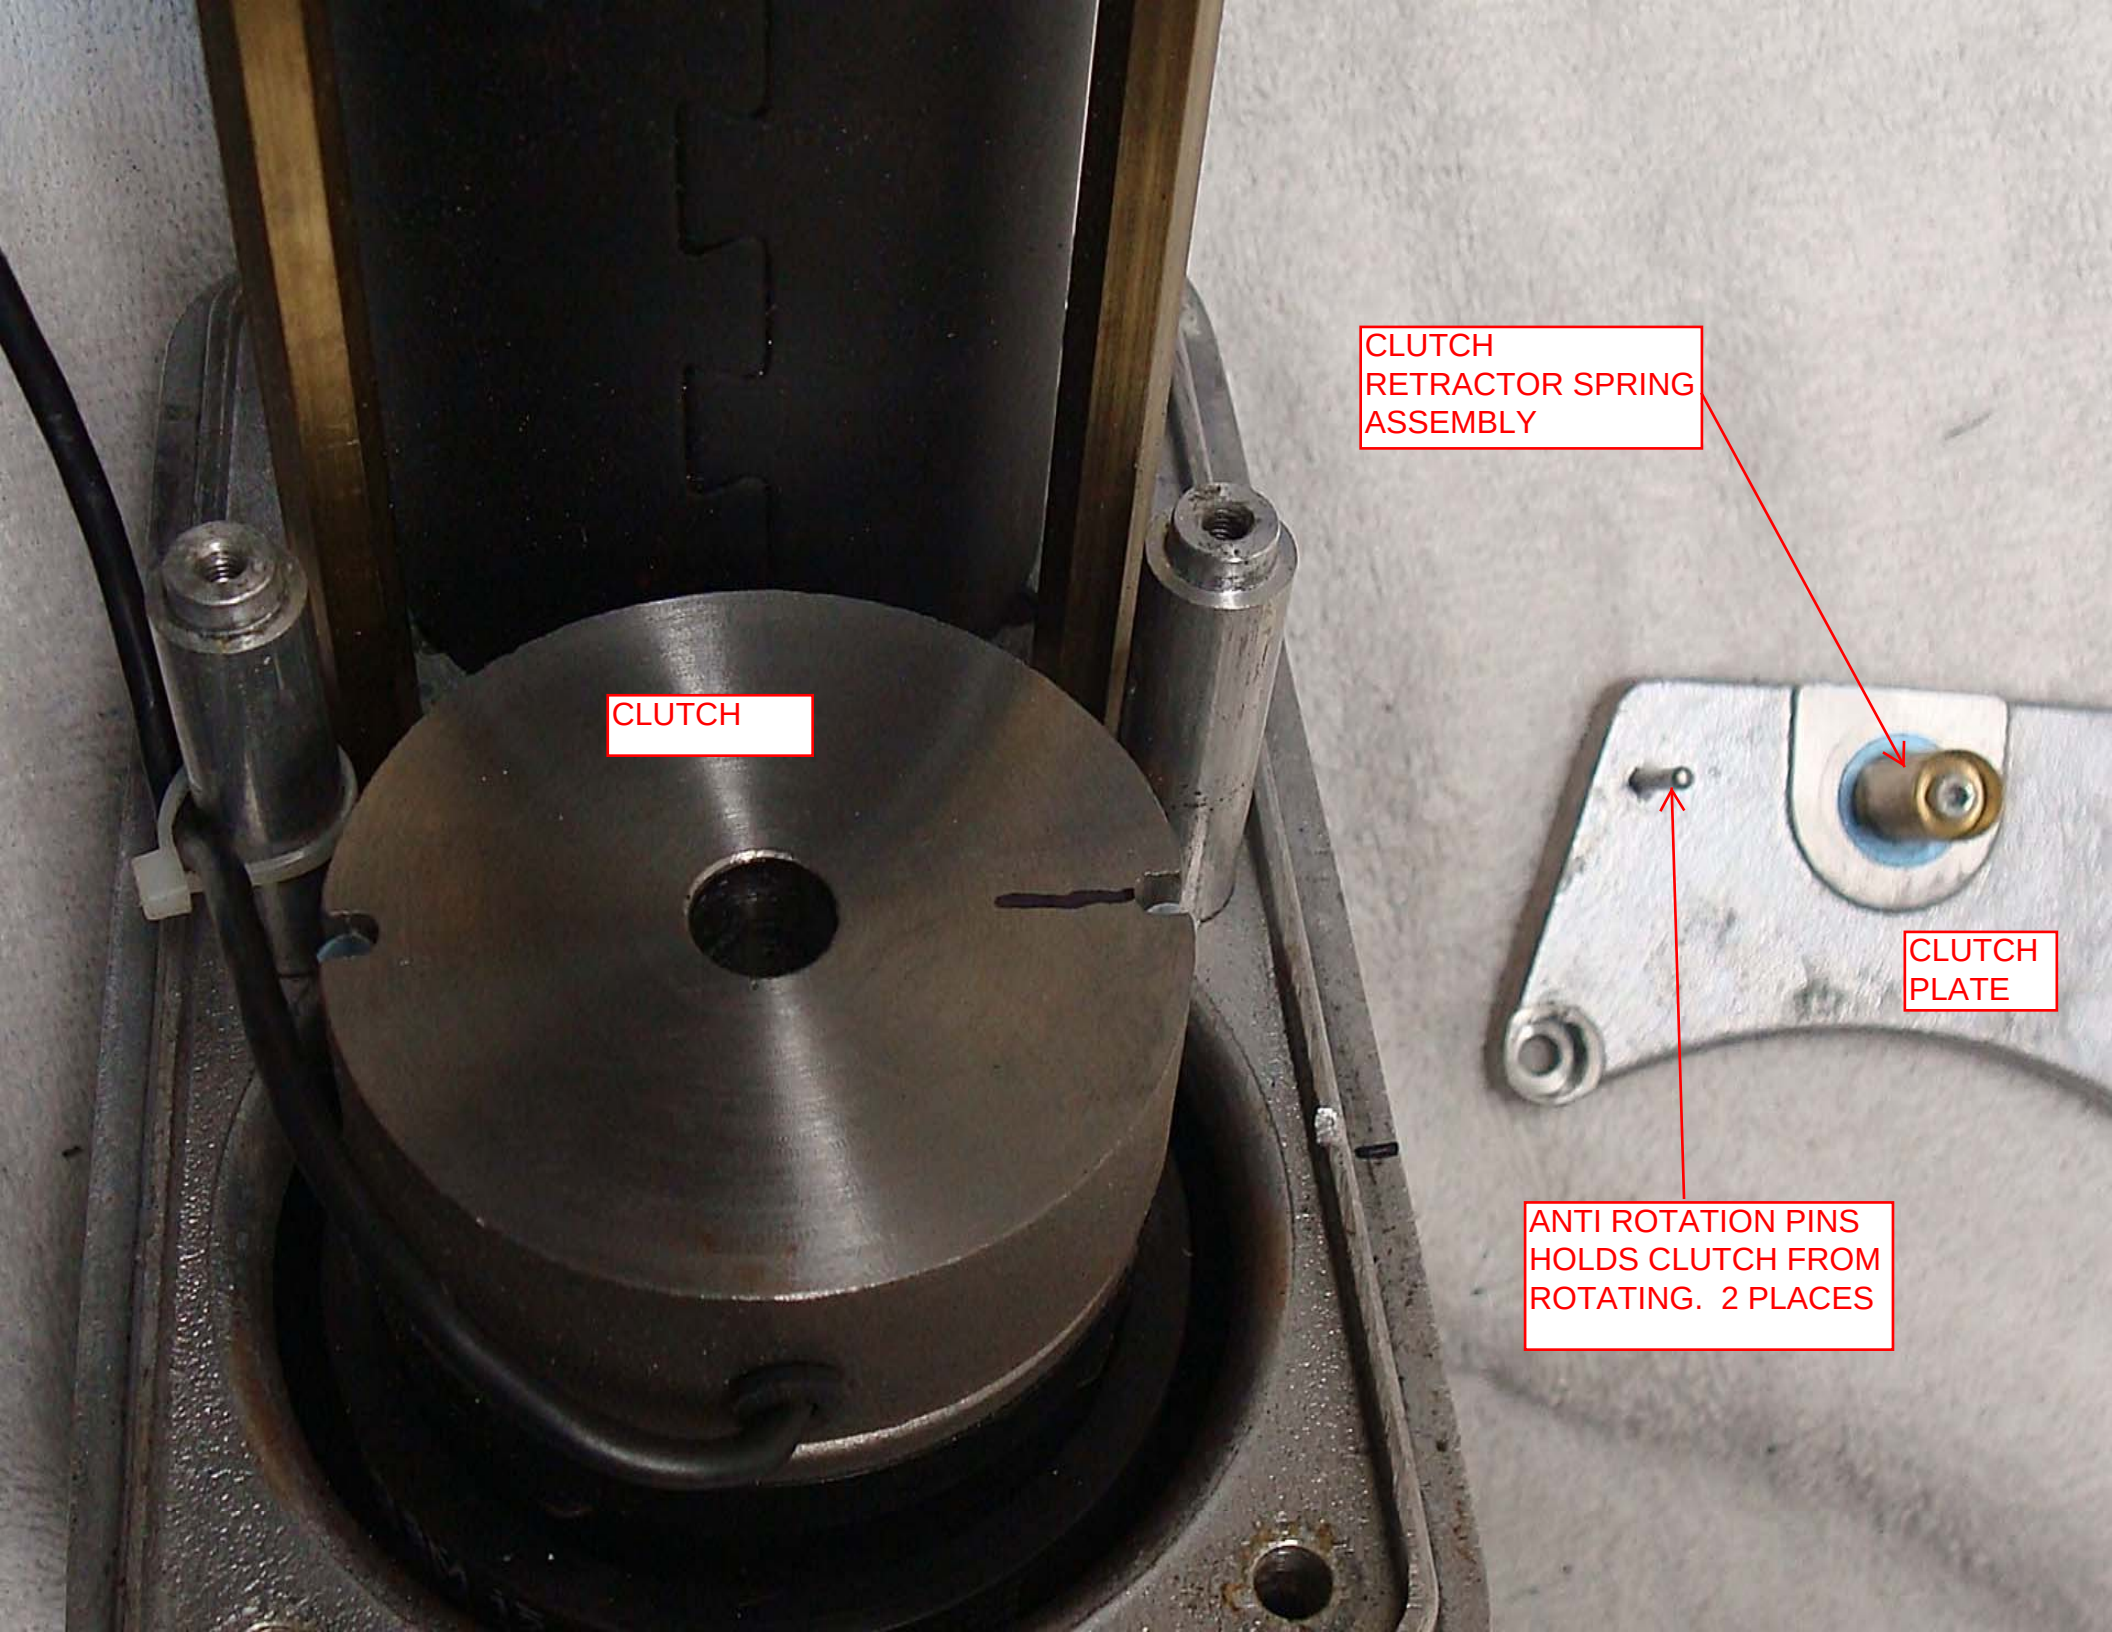
CLUTCH  
RETRACTOR SPRING  
ASSEMBLY

CLUTCH  
PLATE

ANTI ROTATION PINS  
HOLDS CLUTCH FROM  
ROTATING. 2 PLACES

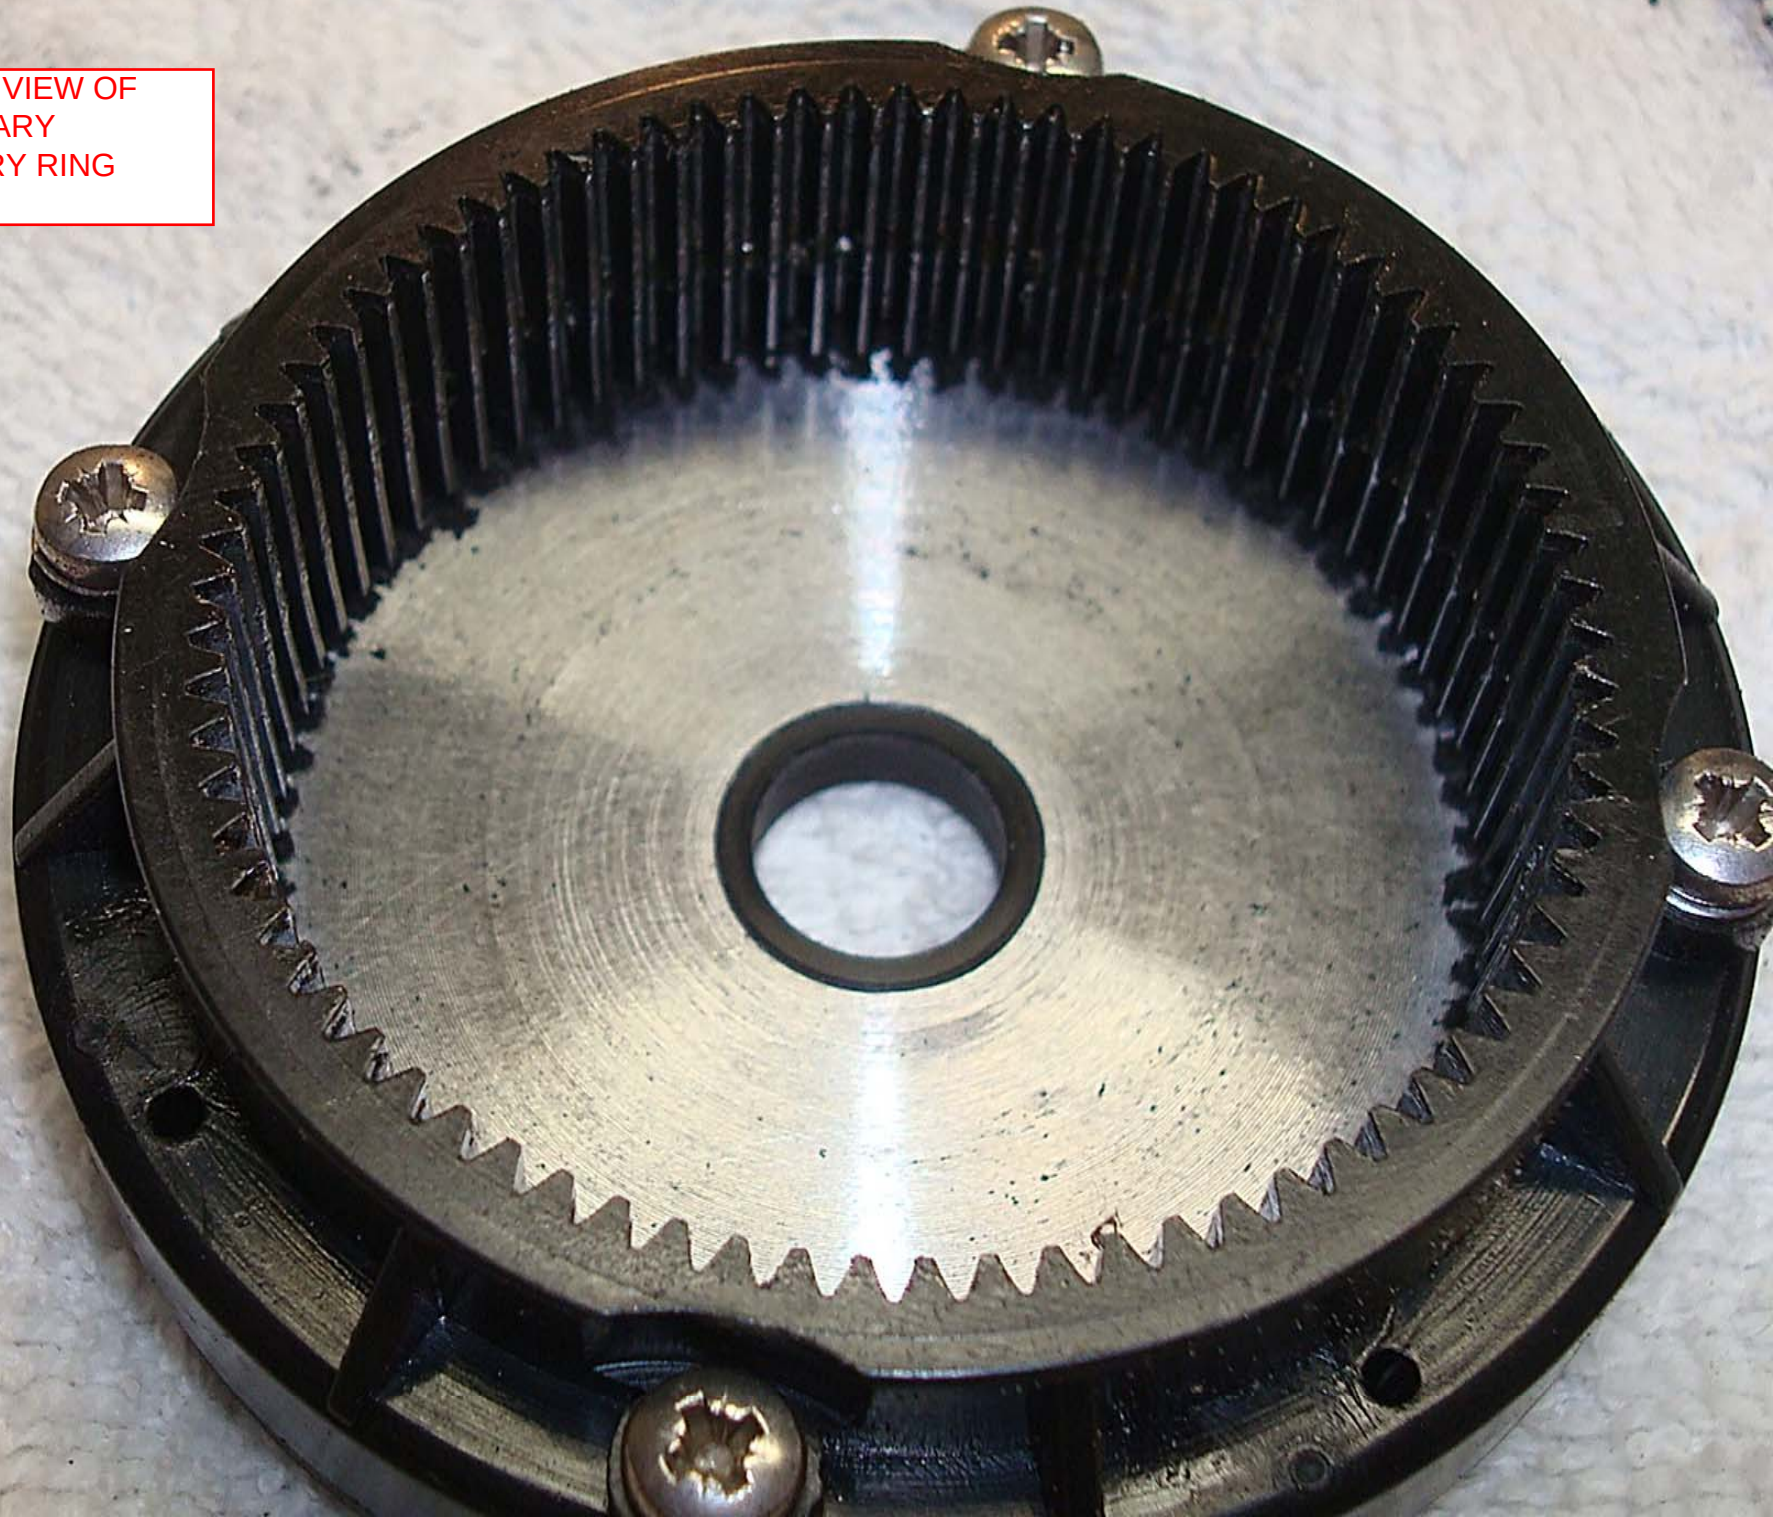
PRIMARY PLANETARY  
RING GEAR  
ASSEMBLY REMOVED  
- PLASTIC

PRIMARY PLANET  
GEARS - BRASS OR  
BRONZE. 4 PLACES

ANOTHER VIEW OF  
THE PRIMARY  
PLANETARY RING  
GEAR

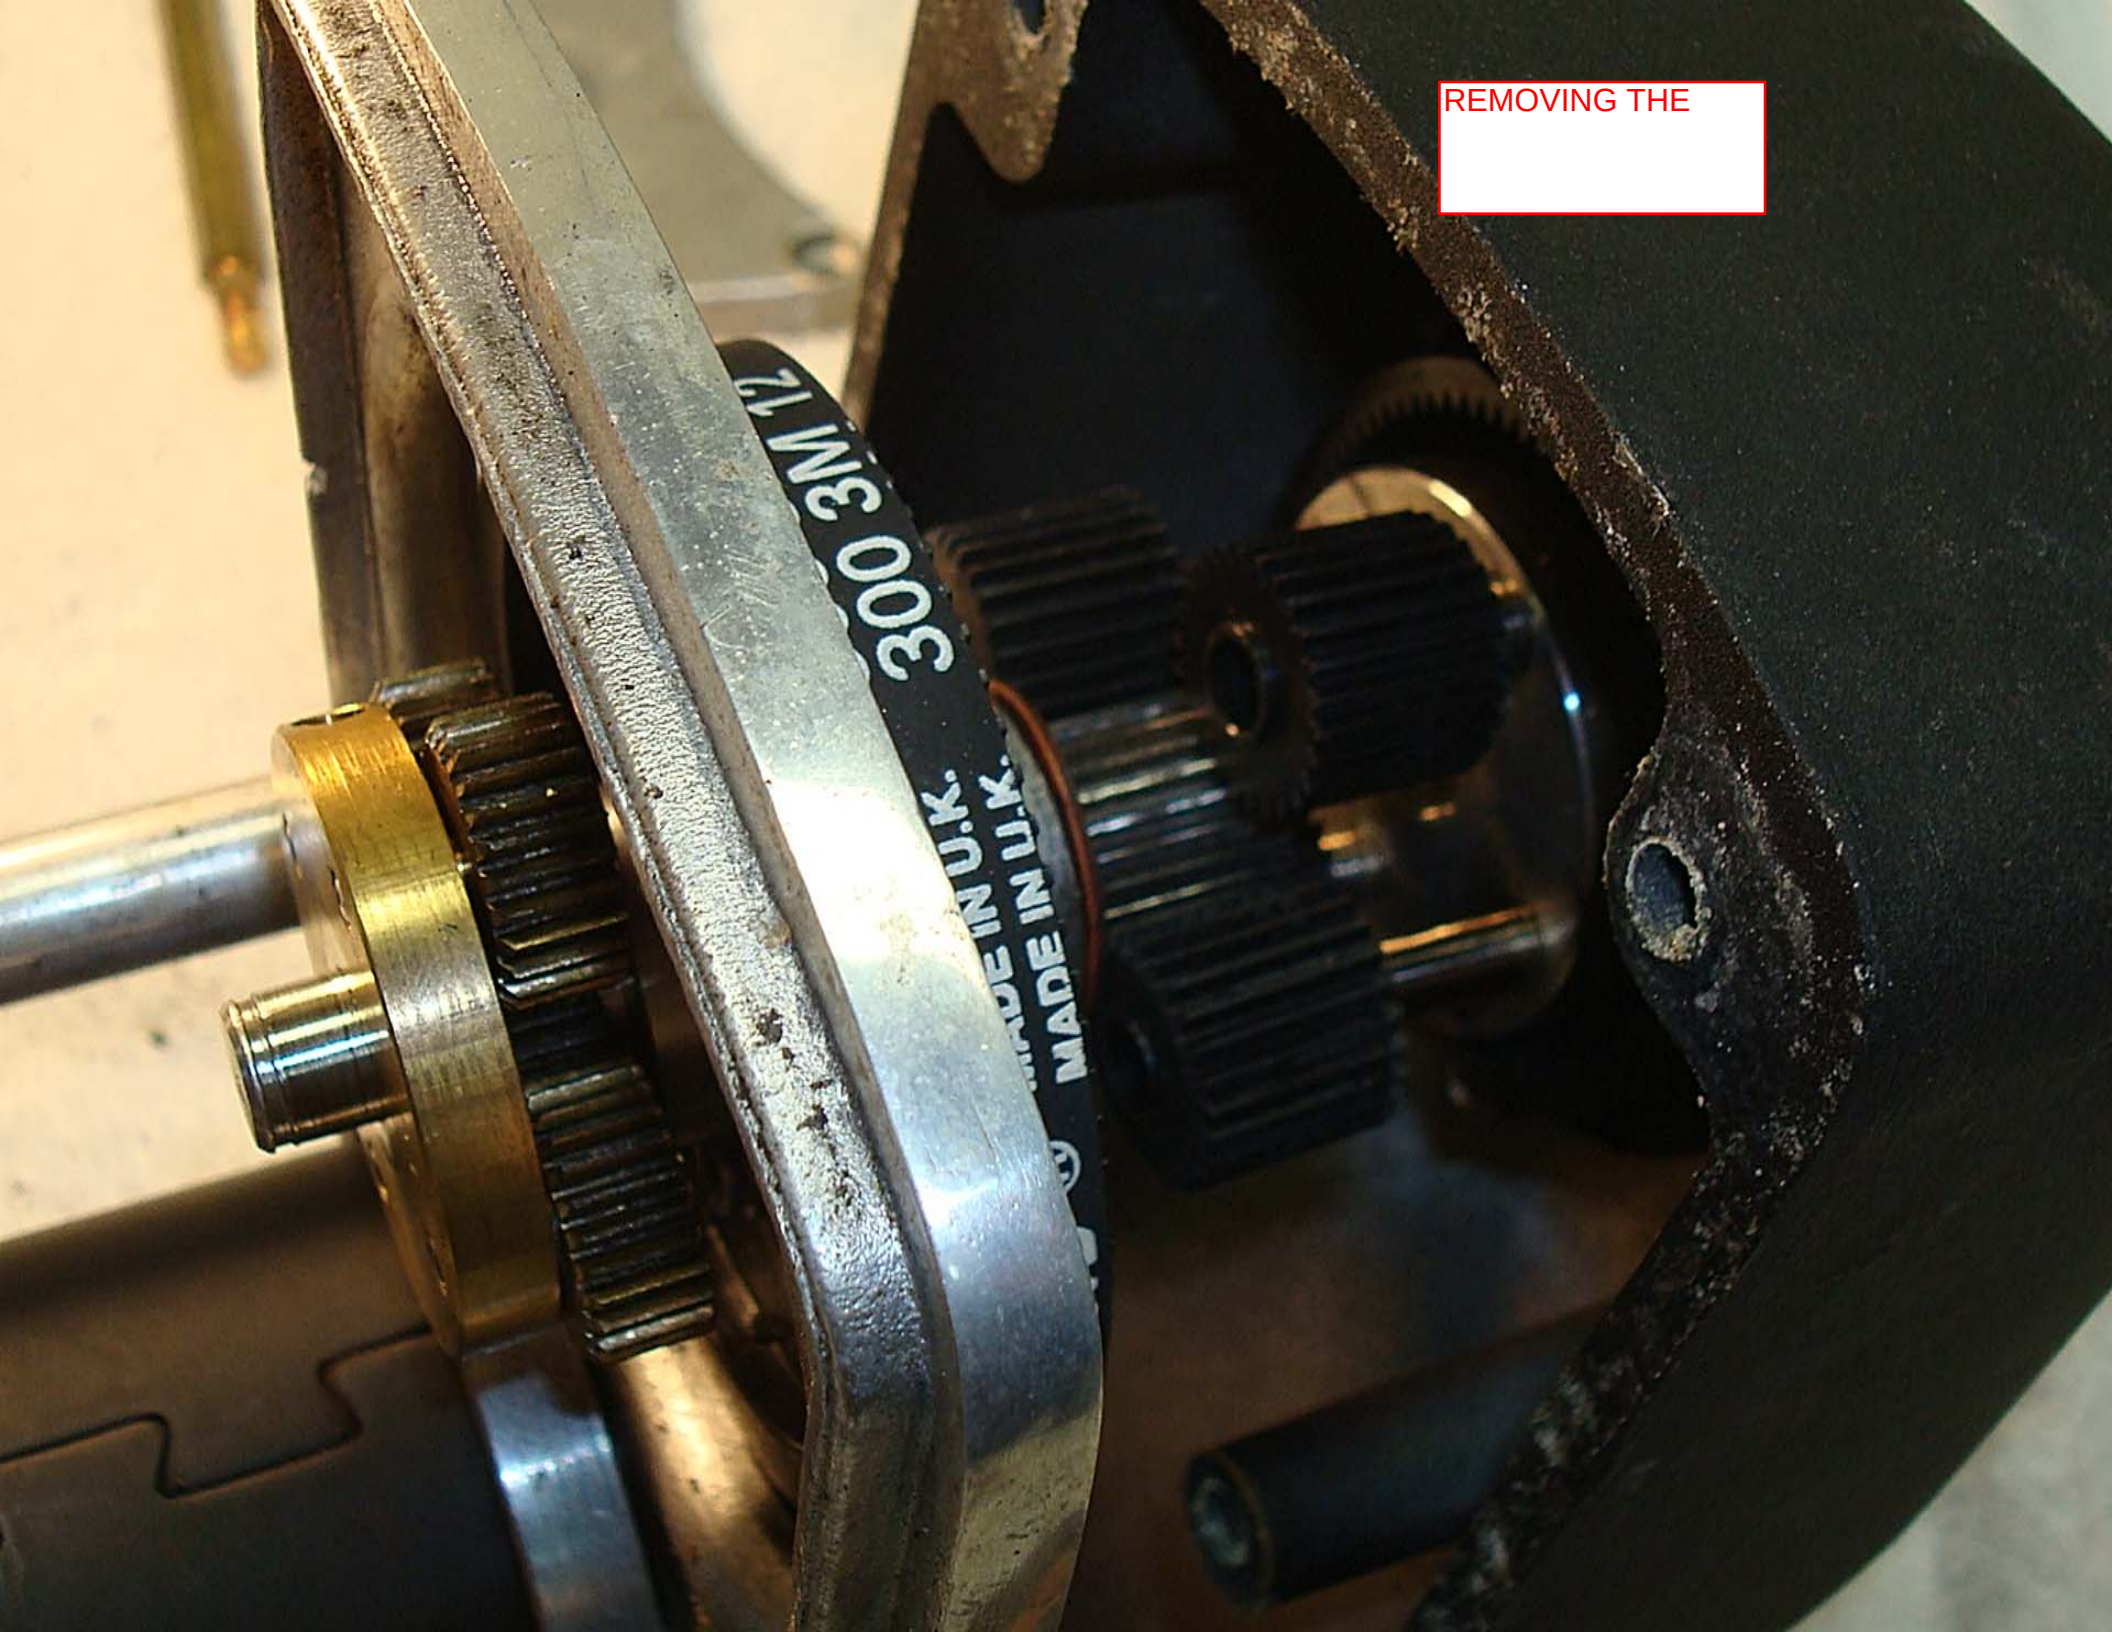
GEAR  
HOUSING

ANOTHER  
SHOT OF THE  
SECONDARY  
GEAR SET

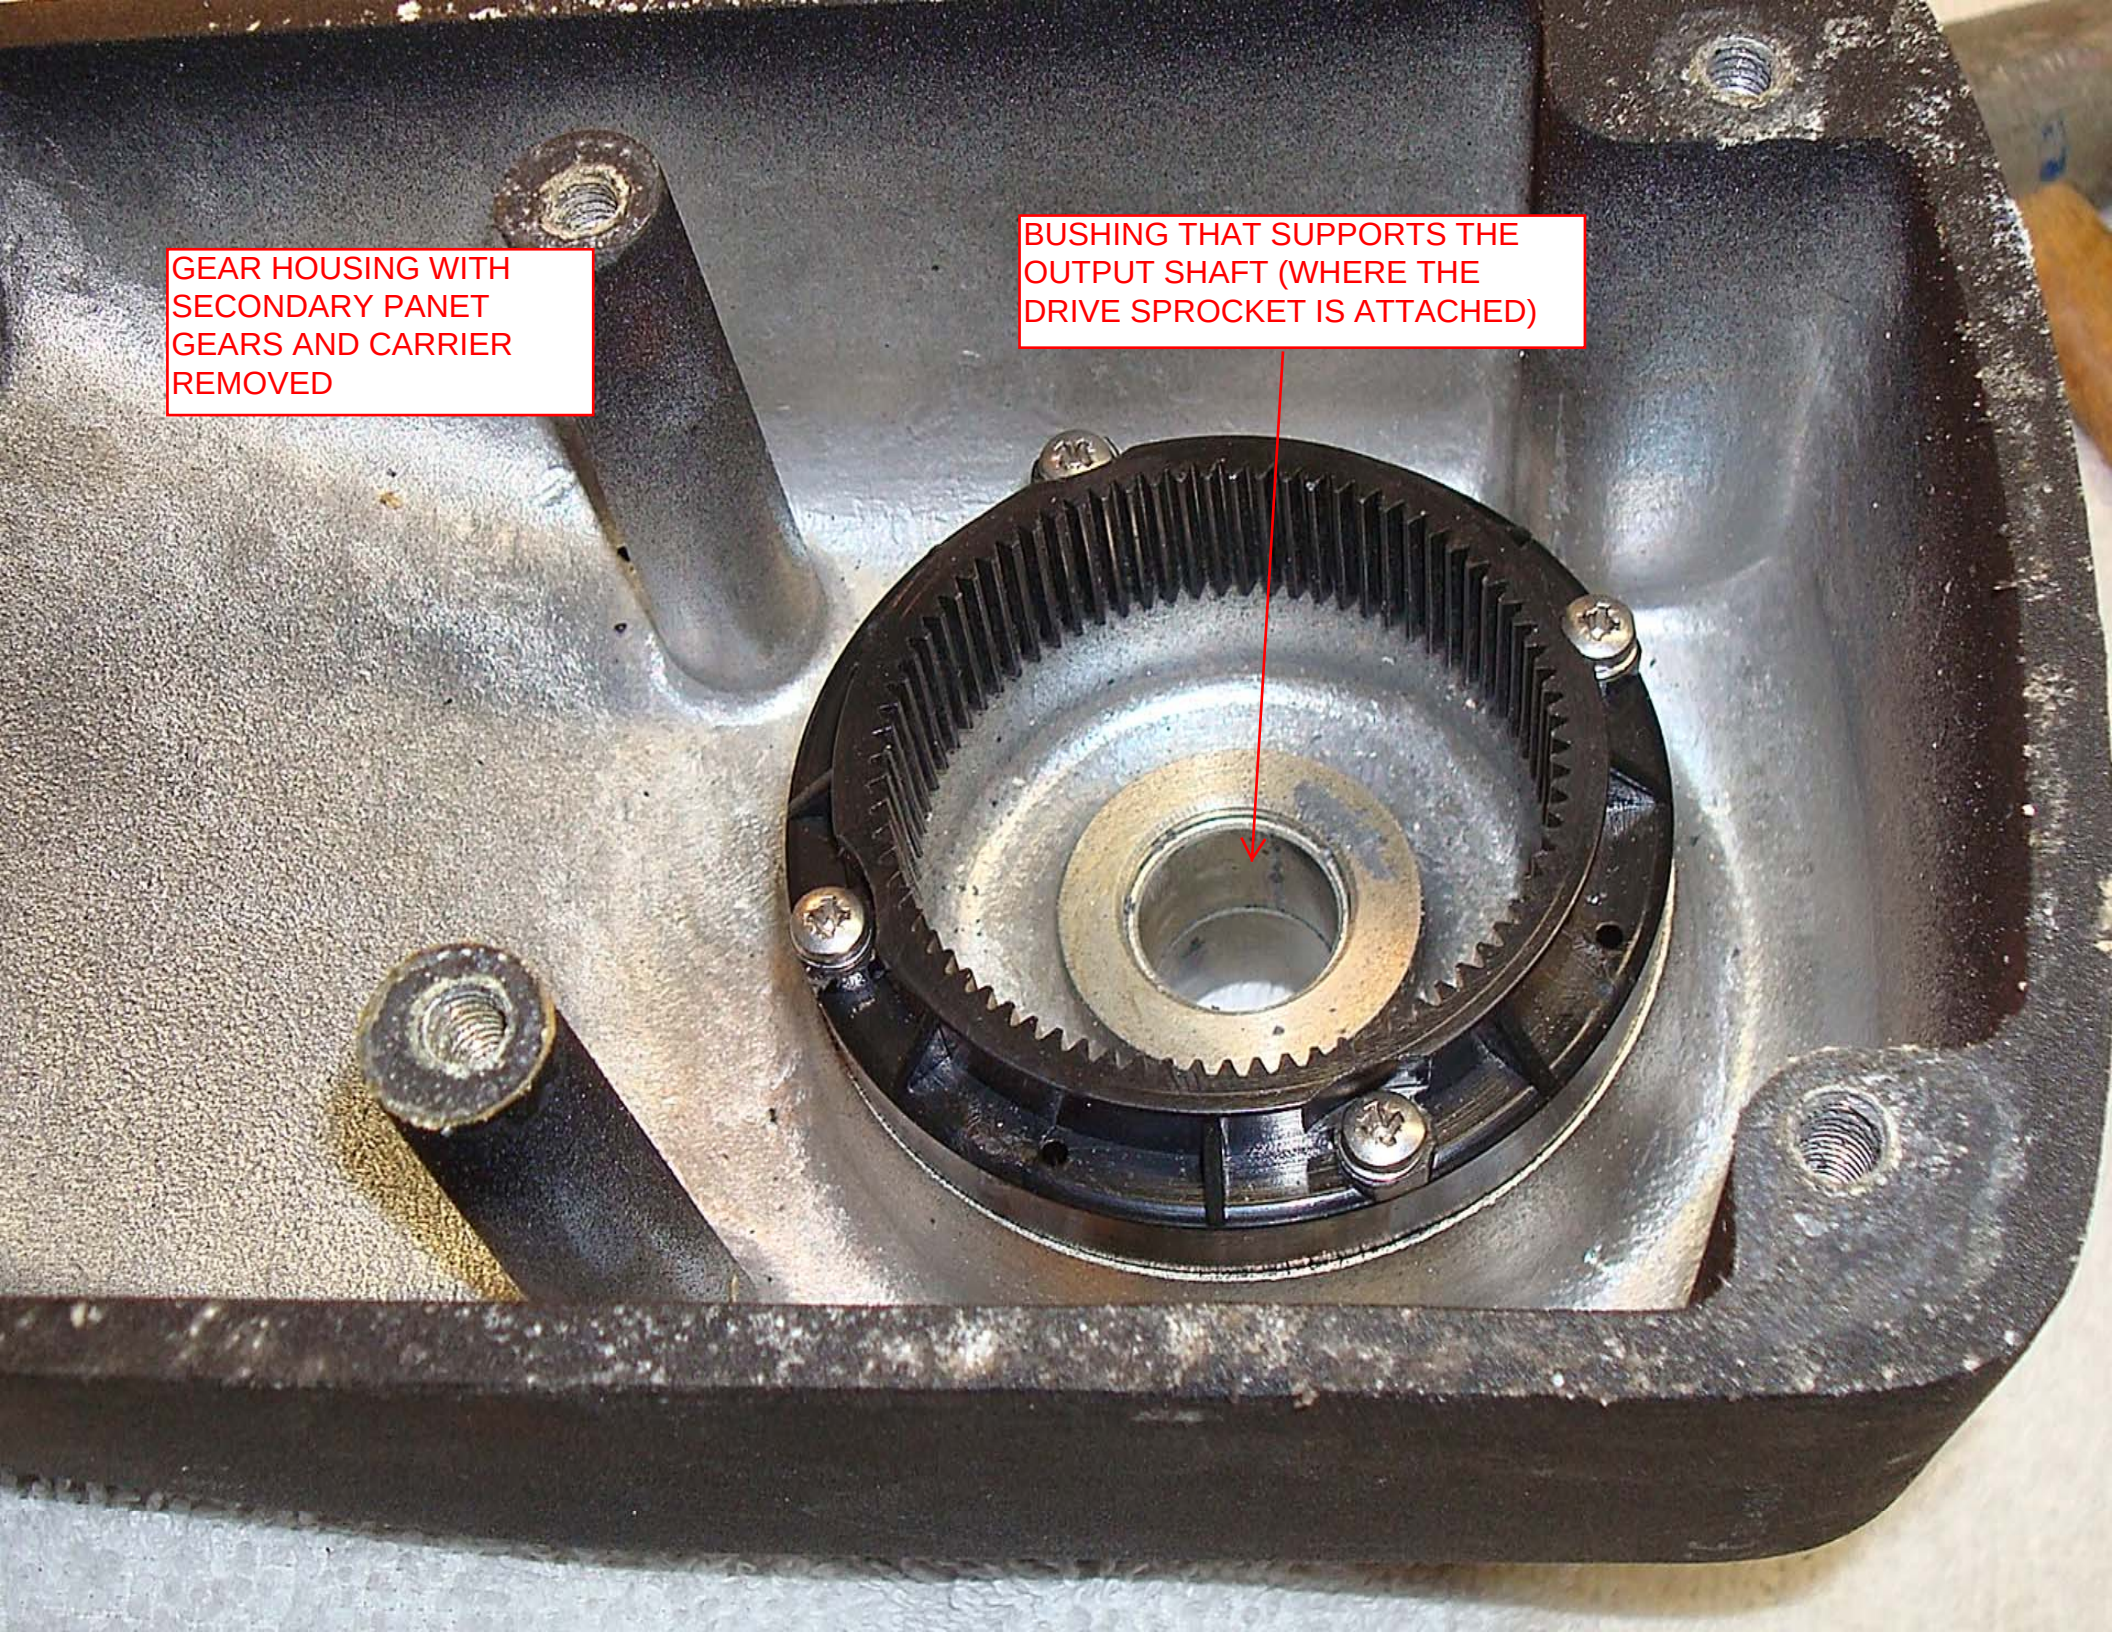
OUTPUT SHAFT BEARING JOURNAL -  
THE PHOTO LOOKS WORSE THAN IT  
REALLY WAS. THIS CLEANED UP  
WITH EMERY CLOTH AND WAS THE  
ONLY ITEM THAT I OILED DURING  
REASSEMBLY

GEAR HOUSING WITH  
SECONDARY PANET  
GEARS AND CARRIER  
REMOVED

BUSHING THAT SUPPORTS THE  
OUTPUT SHAFT (WHERE THE  
DRIVE SPROCKET IS ATTACHED)

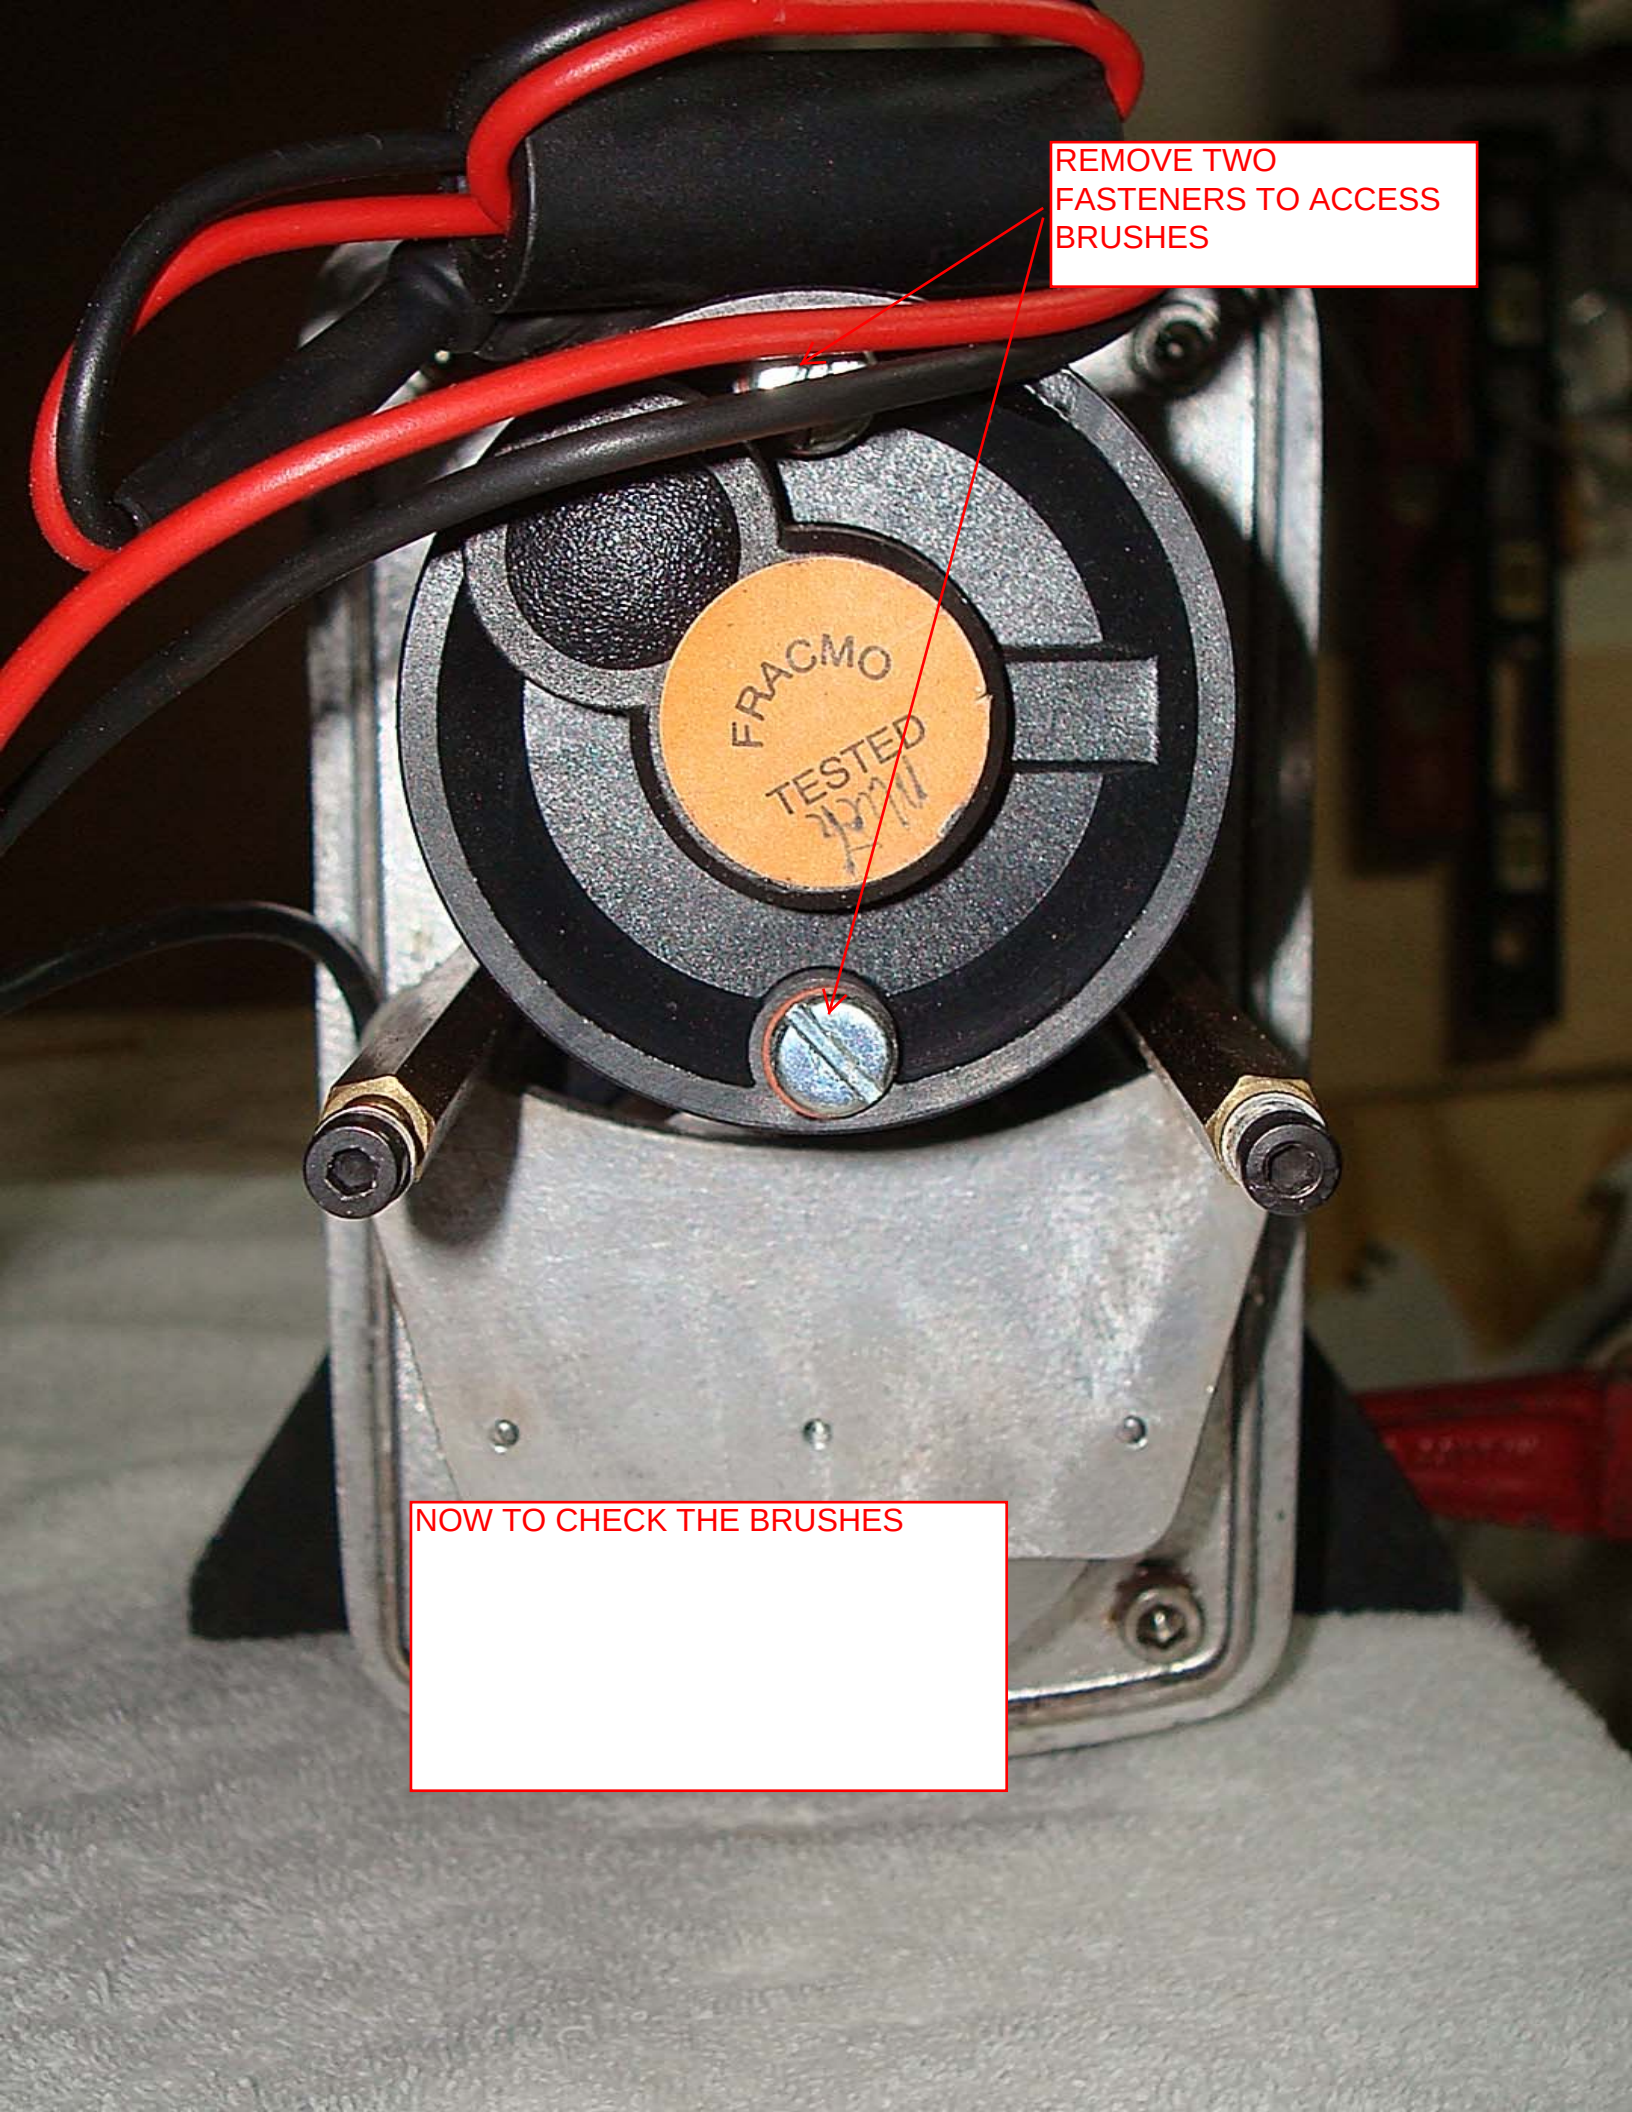
I DID NOTICE THAT THIS BRUSH WAS DRAGGING AND THE SPRING COULD NOT FULLY PUSH THE BRUSH DOWN IN THE SLOT. I FILED THE BRUSH DOWN SO IT MOVED FREELY. THIS WOULD BE ONE OF THE FIRST THINGS I WOULD RECOMMEND TO CHECK IF SOMEONE WAS HAVING PROBLEMS WITH THE MOTOR

BRUSHES - I DON'T KNOW HOW LONG THESE ARE WHEN NEW BUT THE WEAR IS MINIMAL. IN RETROSPECT THIS MAKES SENSE SINCE (I ASSUME) THE MOTOR IS DESIGNED FOR CONTINUOUS OPERATION. FOR THE AUTOPILOT OPERATION, THE NUMBER OF COMPLETE SHAFT REVOLUTIONS IS INSIGNIFICANT WHEN COMPARED TO NORMAL MOTOR OPERATION SUCH AS A FAN OR PUMP SPINNING AT 1700 RPM OR SO.

REMOVE TWO  
FASTENERS TO ACCESS  
BRUSHES

NOW TO CHECK THE BRUSHES

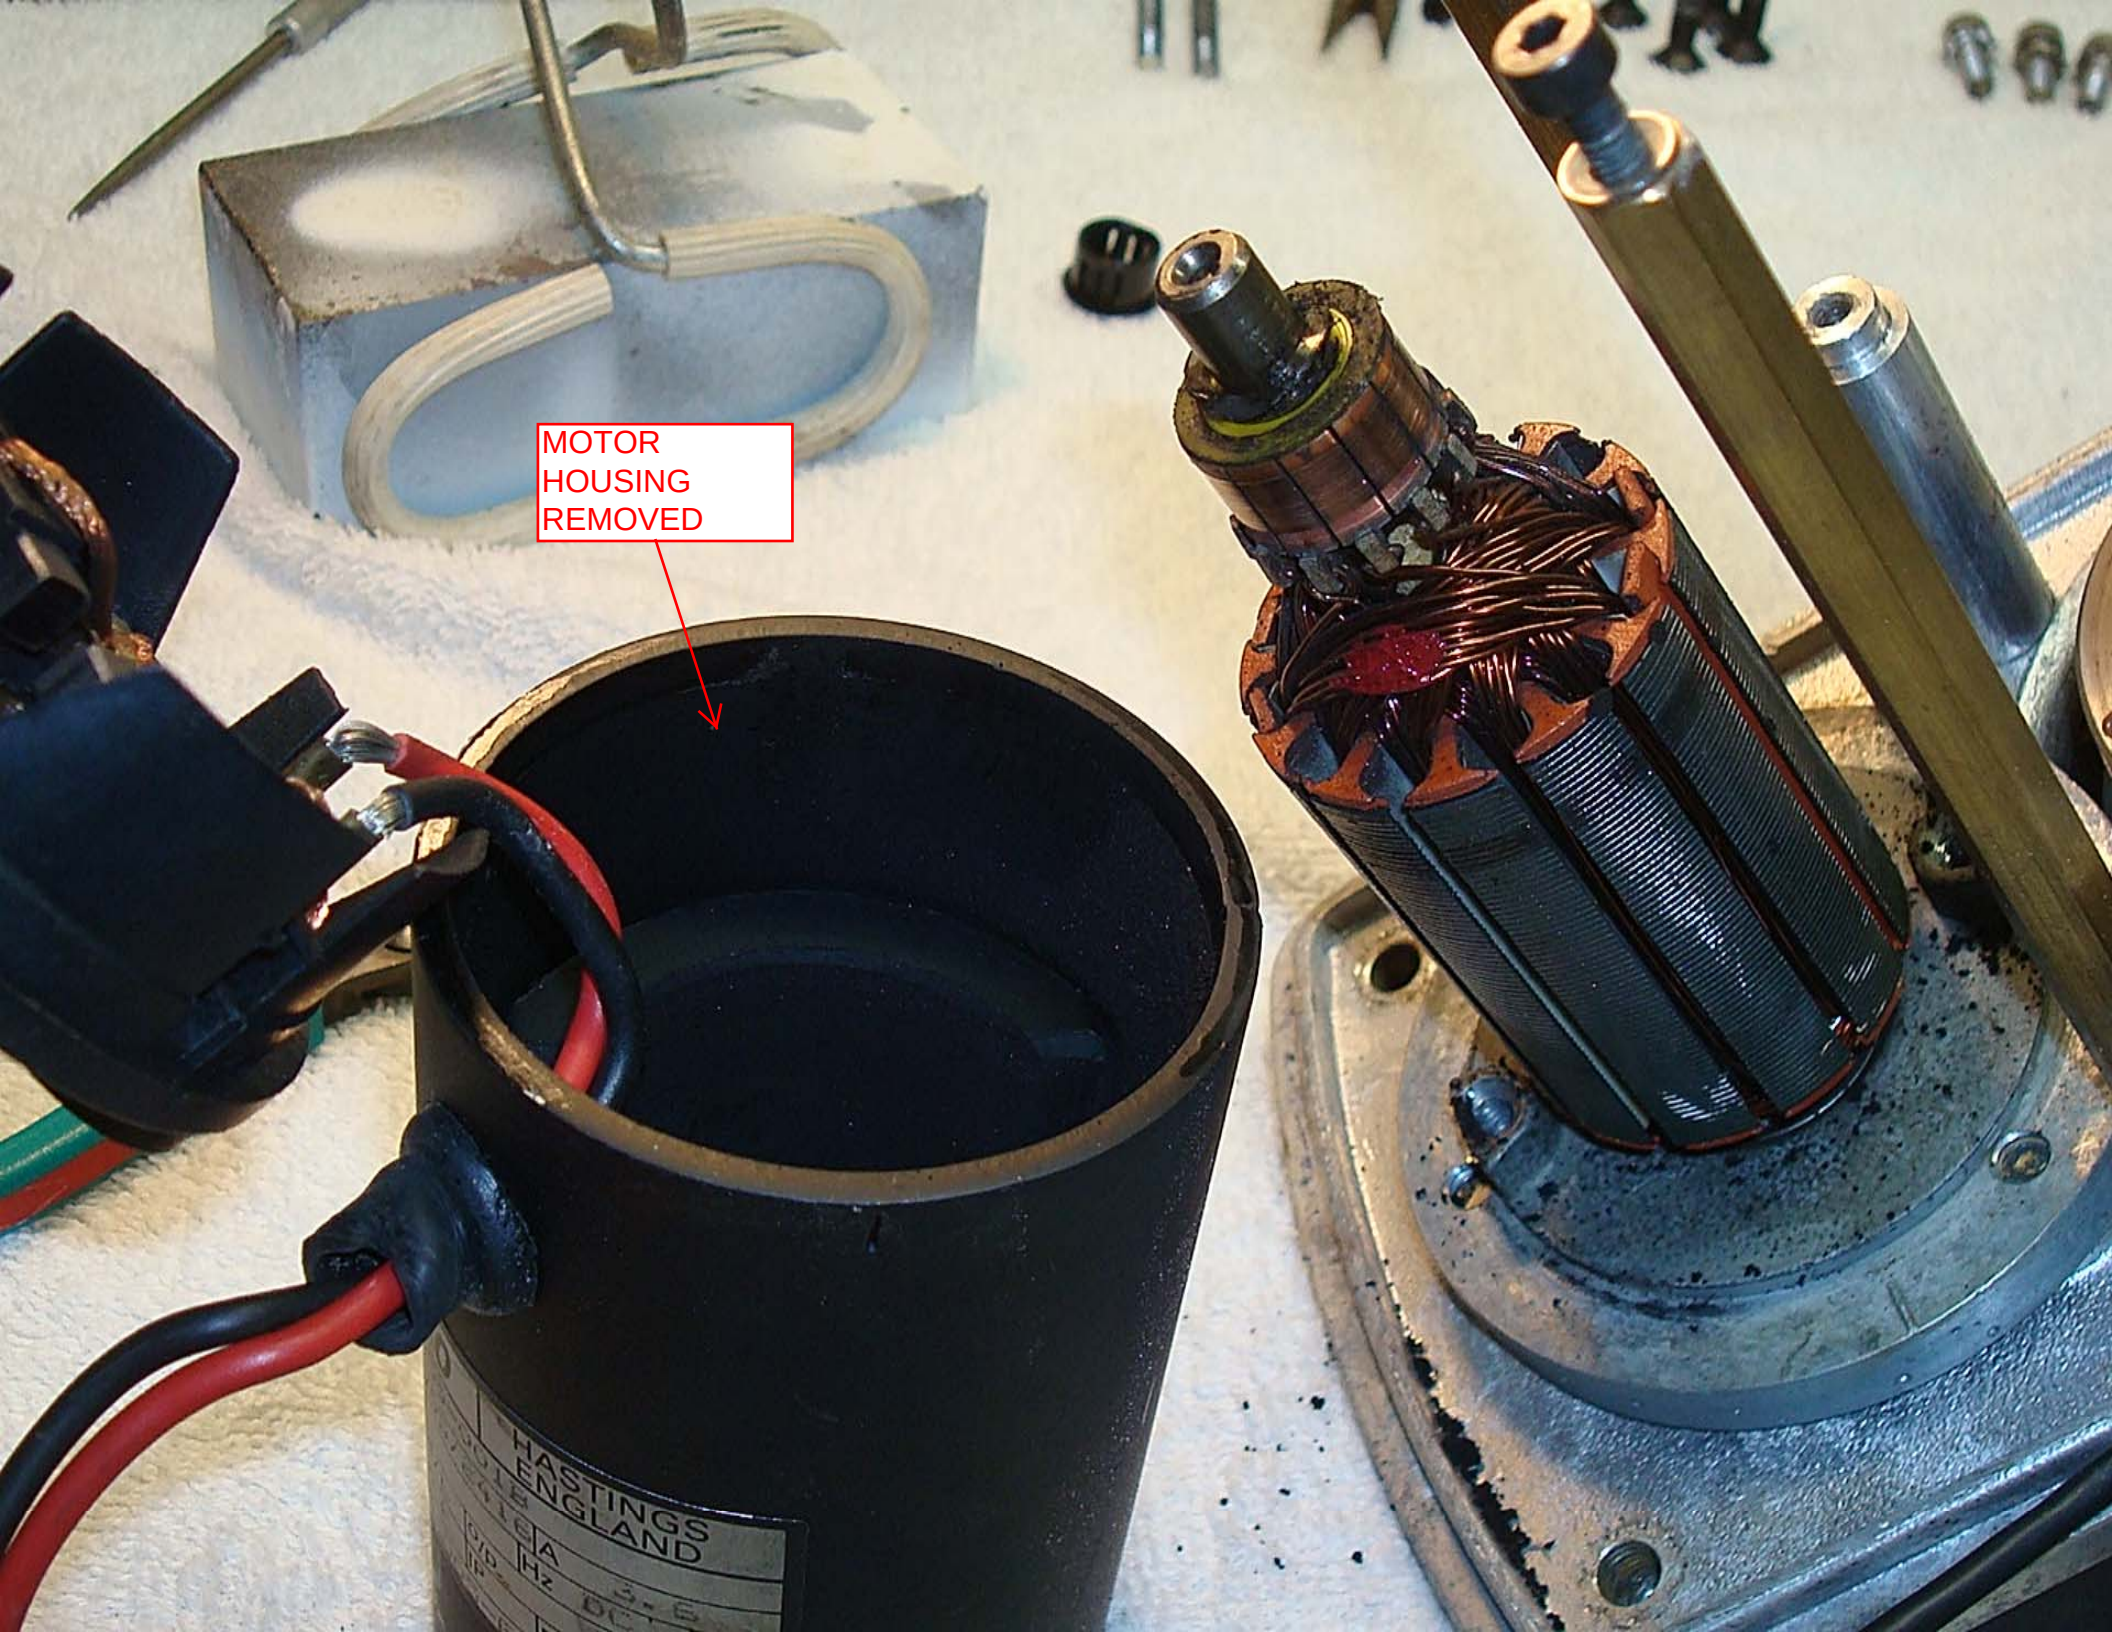
A BETTER SHOT SHOWING  
THE COMPARISON BETWEEN  
THE TRAVEL OF THE 2  
BRUSHES. I AM SURE THIS  
WOULD GIVE ME PROBLEMS  
IN THE VERY NEAR FUTURE

BRONZE/BRASS JOURNAL BEARING  
IN A SELF ALIGNING SOHERICAL  
SOCKET - APPEARS TO BE  
NATUALLY LUBRICATED. I DID NOT  
ADD ANY LIGHT OIL HERE SINCE I  
WAS NOT SURE IF THE CARBON  
DUST WOULD EVENTUALLY GUM  
THINGS UP

MOTOR  
HOUSING  
REMOVED
