# Replacing rudder bearings

***Simple original construction means a simple repair***

by Jim Craighead

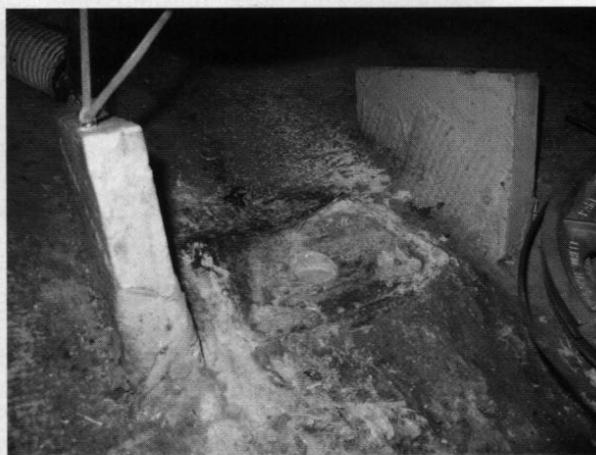
After pulling into the slip and pumping the bilge, I followed a small trickle of water back to my lower rudder bearing. The four lag screws fastening it to a block glassed into the hull had rusted away to tiny brown spikes. This, combined with the wooden block absorbing water and rotting, had caused it to work its way up the rudder post until it no longer provided a seal against the cold Lake Superior water.

The lag screws that secured the bearing to its block had corroded, allowing the bearing to rise up the rudder stock, above. The weldment is for the rudder stops. After removing the block, Jim prepped the hull for the replacement, below.

Using an angle grinder and an old chisel, I cut through the fiberglass covering the rotted bearing block and removed it. I was careful to keep it intact as it would be my template for the new one. I cleaned up the remaining fiberglass and the hull around it to provide a clean surface for mounting the new block.
