Centerboard Trunk Repair

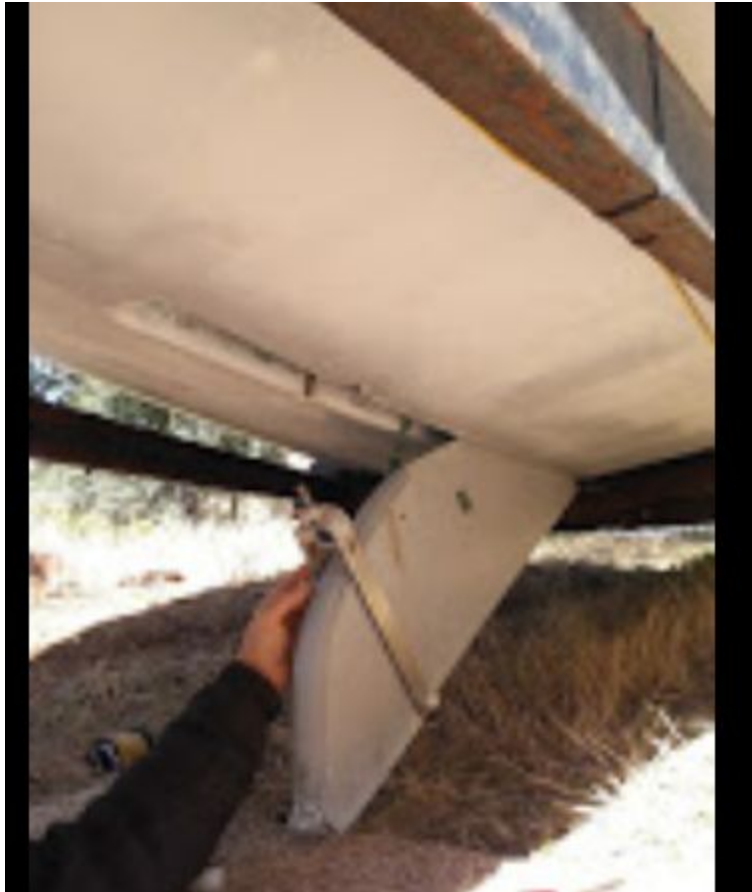
My ballast tank leaks profusely out the center board trunk when I haul it out full of water. I dropped the centerboard by releasing the bracket bolt accessed from under the v-birth. The centerboard lift rope allowed me to drop it easily while resting on the trailer... after the

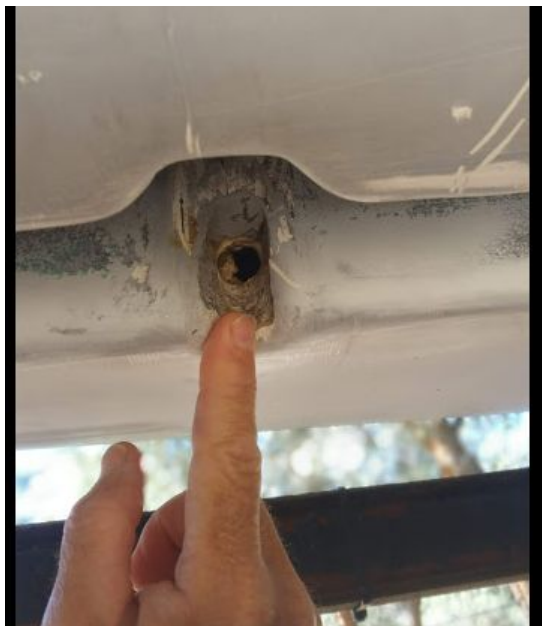
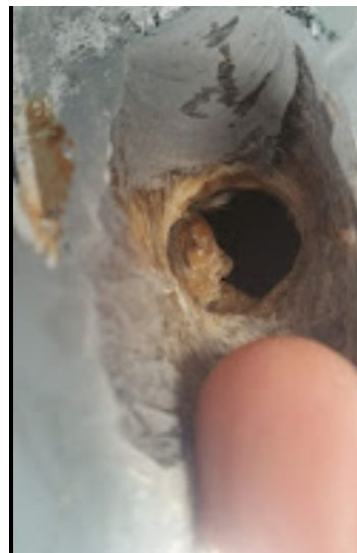
CORRECT bolt was released. (at first I mistakenly unbolted the compression post bolts)
A neat 7/16 inch hole was cleanly punched through the trunk into the ballast tank.

I cannot reach inside the trunk and appreciate all the help I am getting to see how best to patch it.
