THE MYSTERY of the WET FLOOR in the GALLEY

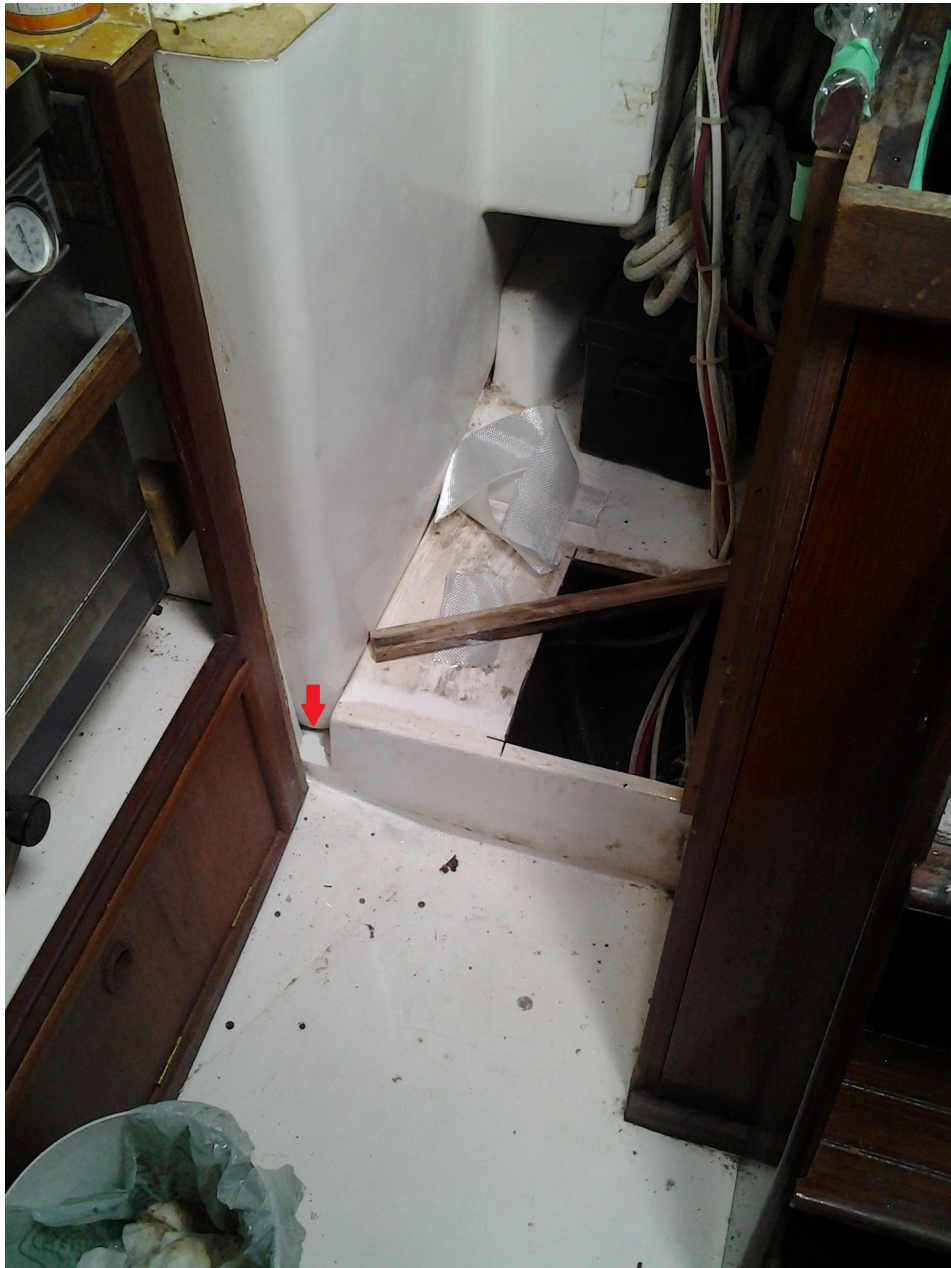
Many Hunter 37 Cutter owners have noted water appearing on the galley floor, especially while sailing on port tack. Eventually this leads to lifting varnish on the teak and holly sole and, ultimately, rot. Many of us have tried to find out where it comes from: the ice box drain, the cockpit locker...? One of the last repairs I did on my H37C was to address this water – find its source and fix it. This involved removing the four drawers to starboard of the engine and the plywood piece that has the drawer openings. Once this is done, a large space between the engine compartment and the inner side of the ice box is revealed. The bottom of this space is the same fiberglass pan that is the bottom the starboard cockpit locker. Where the pan meets the icebox, there is a small ‘step’ molded in to the pan at the point it turns down to meet the hull (just before the galley sole or floor starts). This is indicated by the red arrow in the picture. (BTW the large, square hole near the engine was cut by the factory to install wires and hoses)

When the boat heels and pitches underway, water in the cockpit locker (from wet mooring lines and fenders or any deck leaks you have) finds its way to this 'step' and cascades down like a small waterfall onto the galley sole. Because the end grain of the teak and holly plywood is exposed, damage ultimately follows. You can see how the floor pan is designed - the water has nowhere else to go! My solution was to give that water a path to drain to the bilge. In this photo, you can see I have drilled a one inch hole in the molding. Below this hole is the hull and any water will drain to the bilge.
