H U N T E R[®]
MARINE CORPORATION
AN EMPLOYEE OWNERSHIP COMPANY

August 11, 2006

It has come to our attention that a particular brand of ball valve installed by Hunter Marine in the boats bearing hull numbers listed below may fail under certain conditions or after an extended period of time. The suspected ball valves in question were manufactured by Marine Hardware and are most easily identified by their blue handles and the drain / grounding screw (please see attached photos) incorporated into the body. Failures have taken place when the ball valve stem corrodes prematurely leaving the handle unable to close the internal ball. If the valve cannot close, the connections may lead to water entry. Due to this possible failure, Hunter Marine has decided to voluntarily recall this brand (only) of ball valves. This voluntary recall is being launched and monitored under Coast Guard campaign number 060053T.

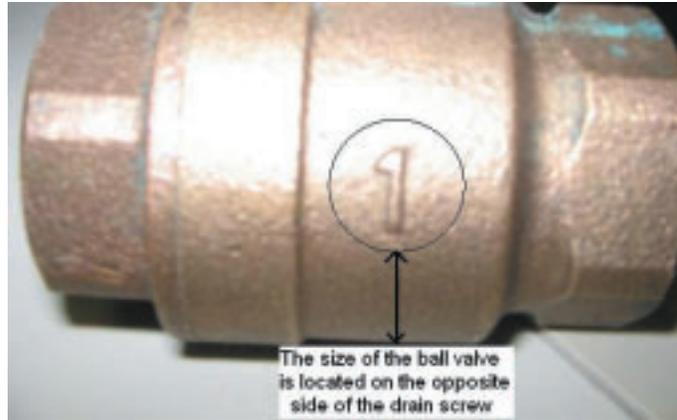
Location of ball valve size indicator

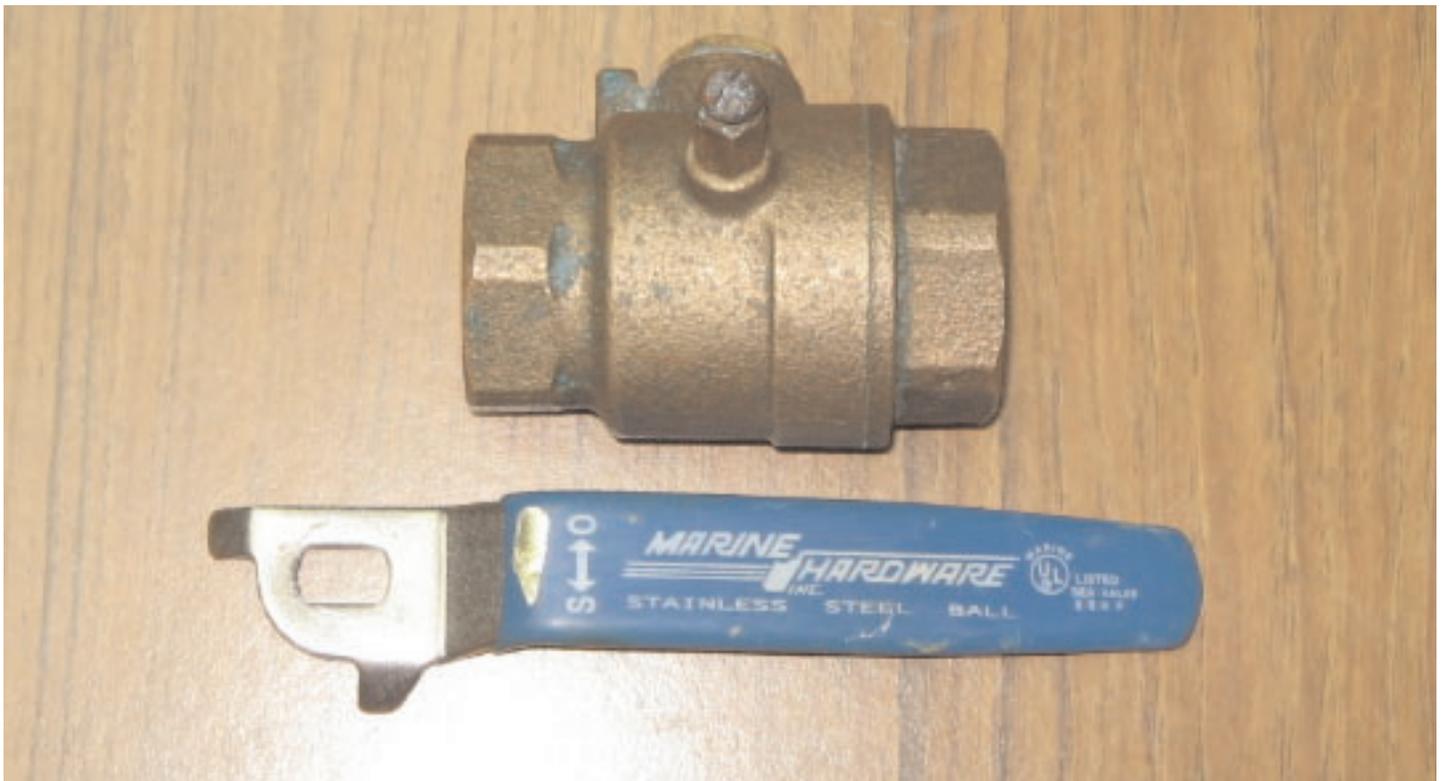
Appearance of typical ball valve
