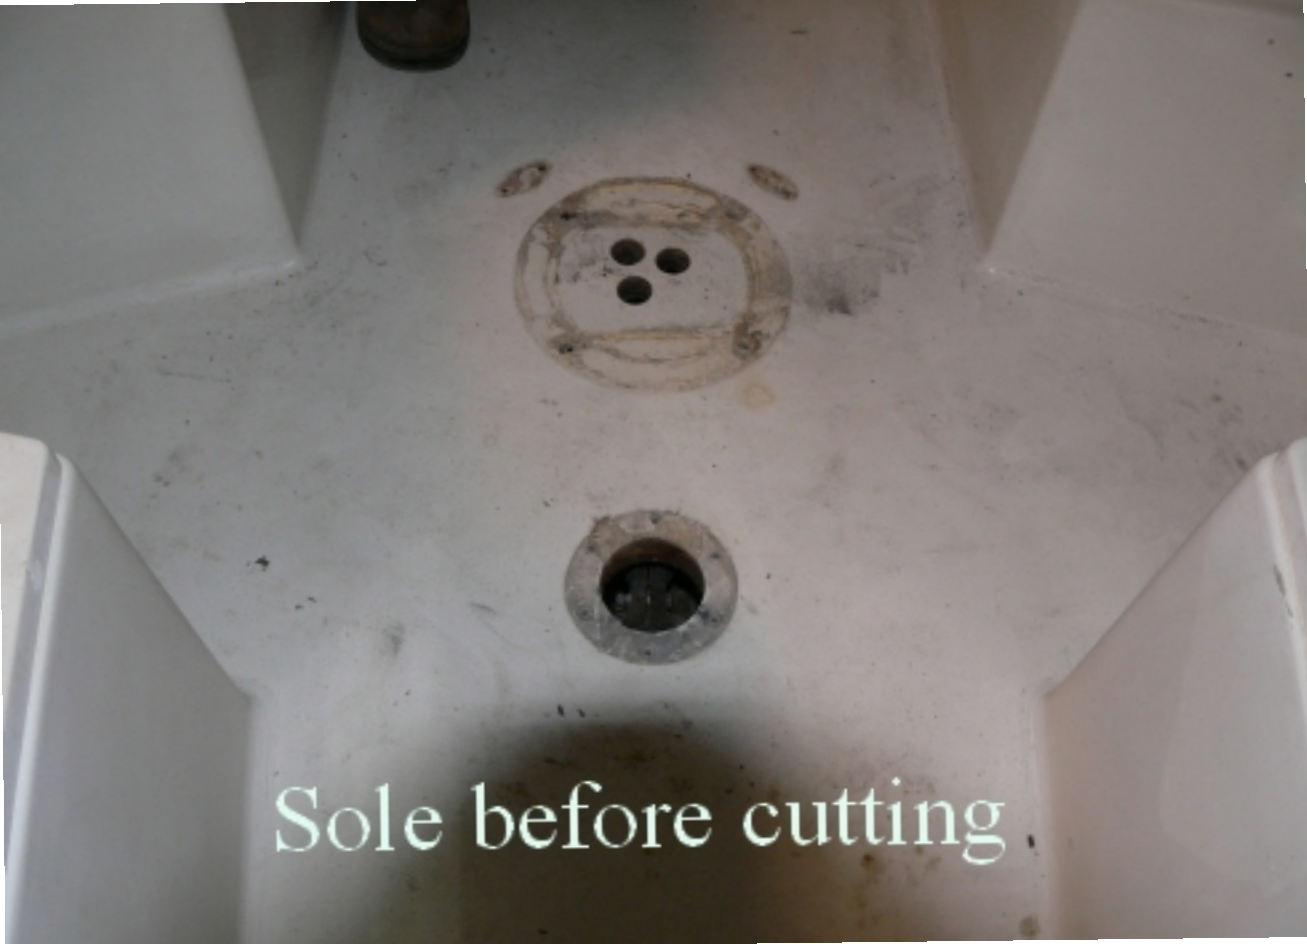
Sole before cutting

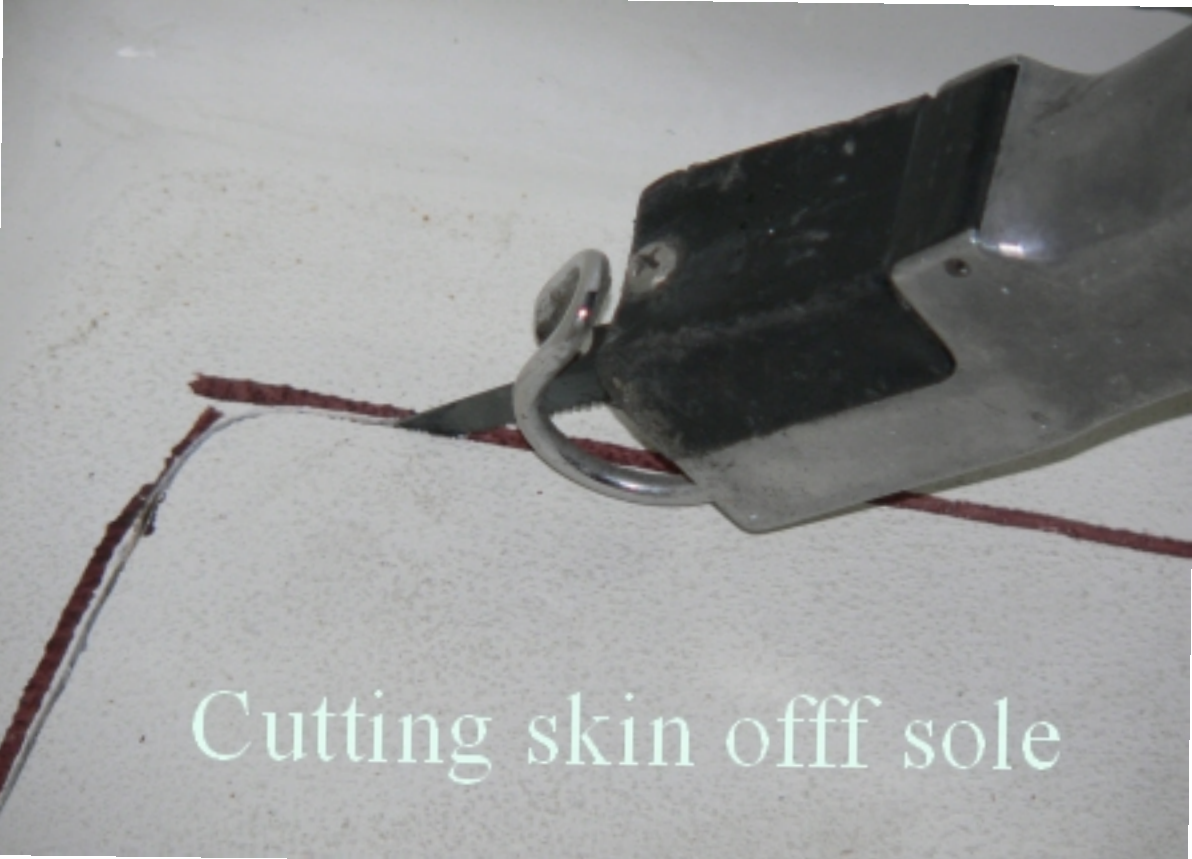
Cutting skin off sole

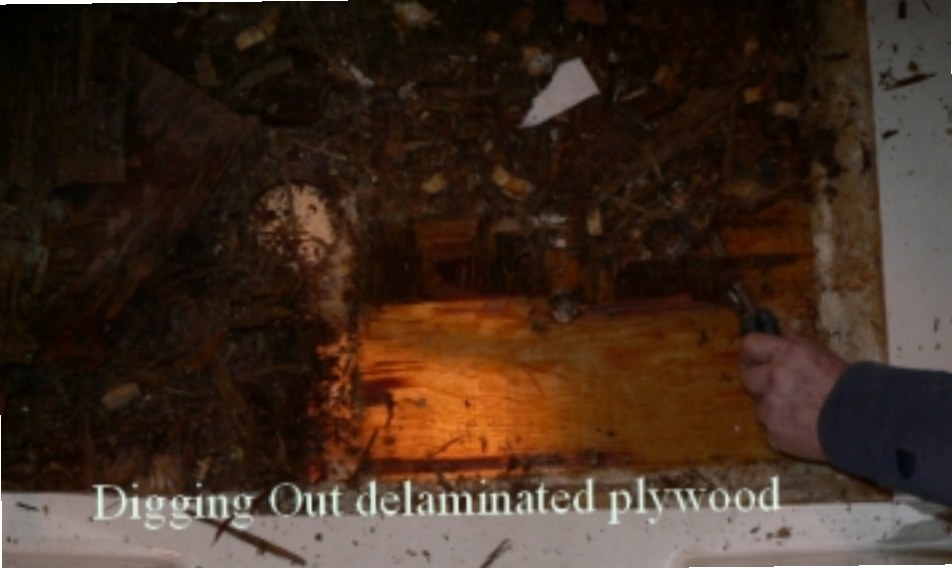
Digging Out delaminated plywood

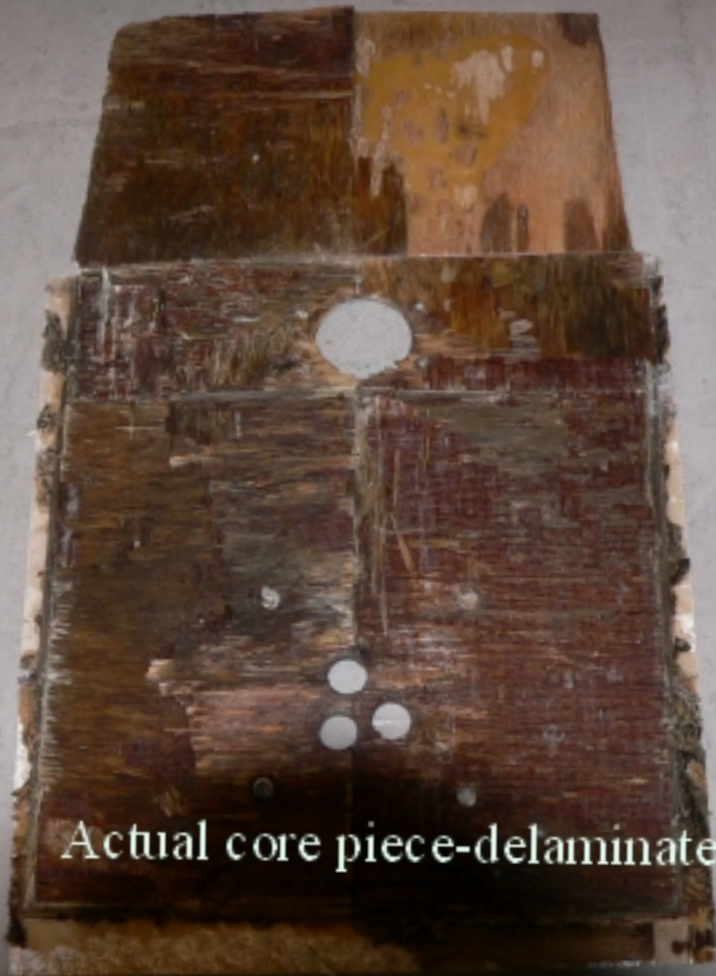
Actual core piece-delaminated

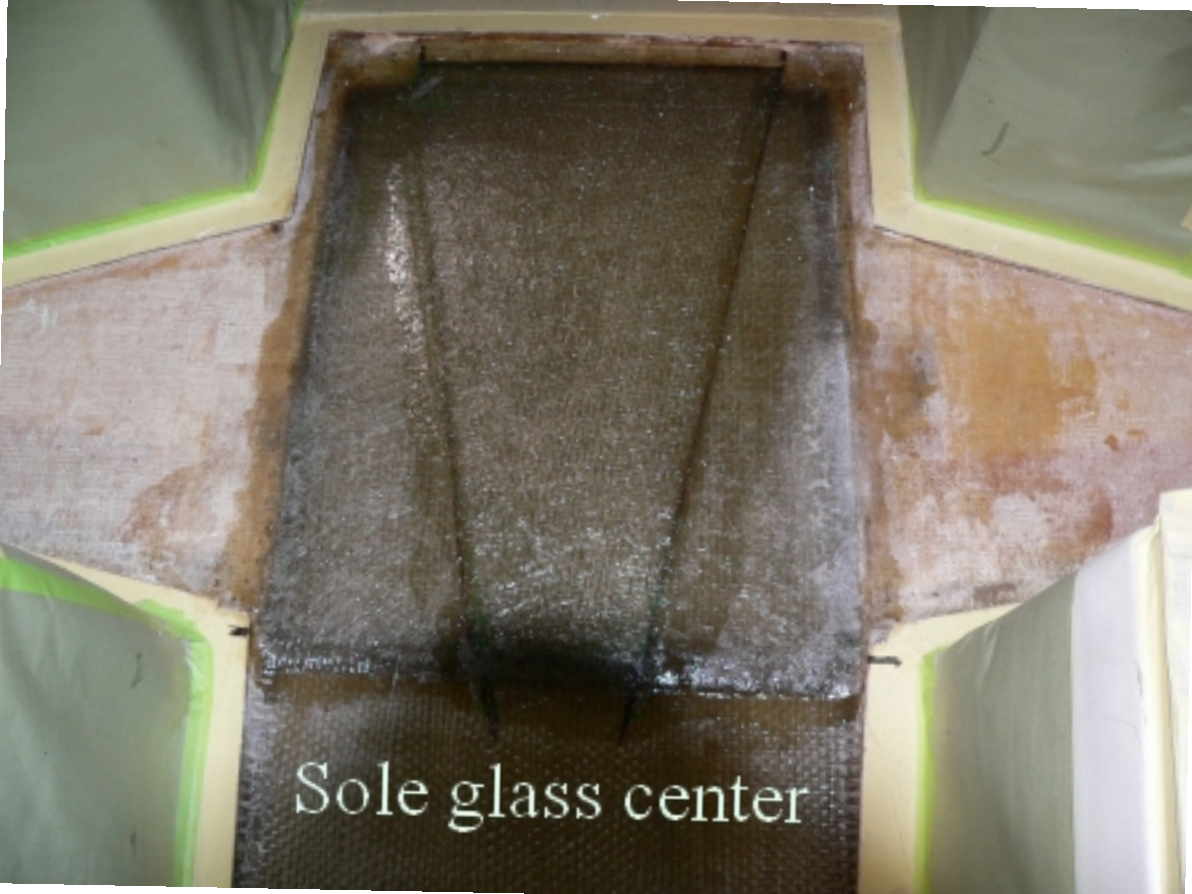
Sole glass center

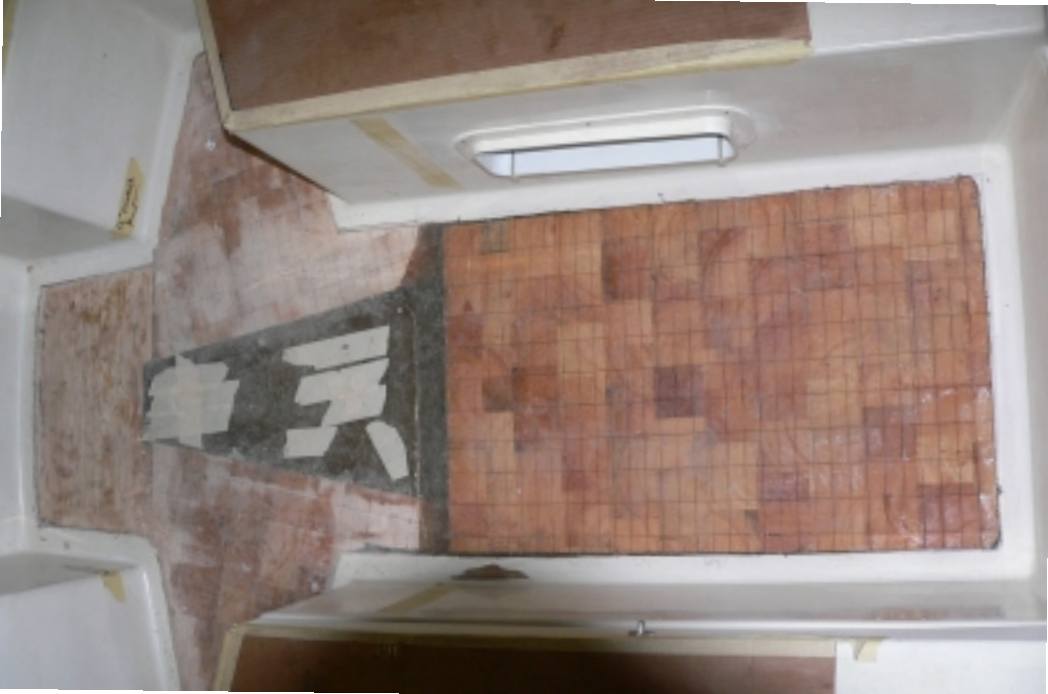
Using old sole cutout  
as template to place holes.

Note that old sole has no cracks despite having  
a completeley delaminated core.
